This study aims to gain insight into the behavior of the Fujinuma dam during the time of the earthquake by using the FE method. Both the observed motion and the simulated motion are used to determine the response of the dam during the excitation. The soil behavior of the dam materials is described by using the Mohr–Coulomb soil model available in the Plaxis FE code [25]. Dynamic analyses of the model are conducted, and the overall dam behaviors presented. Discussions and comparisons between the simulation results and existing facts are expressed.

2.1. Fujinuma dam

The Fujinuma dam was an earth-fill embankment dam near Sukagawa, Fukushima prefecture, Japan. It was established on the Ebana River, a tributary of the Abukuma River, 16 km west of the city office of Sukagawa (37°18'07"N, 140°11'41"E). The dam construction began in 1937 and it was completed in 1949 after construction was halted during World War II. The primary purpose of the dam was water supply for irrigation. The cross section of the main dam and its layout is shown in Figs. 2 and 3. The dam was an embankment type, 18.5 m high and 133 m long with a structural volume of 99,000 m³ and a crest width of 6 m. On the upstre

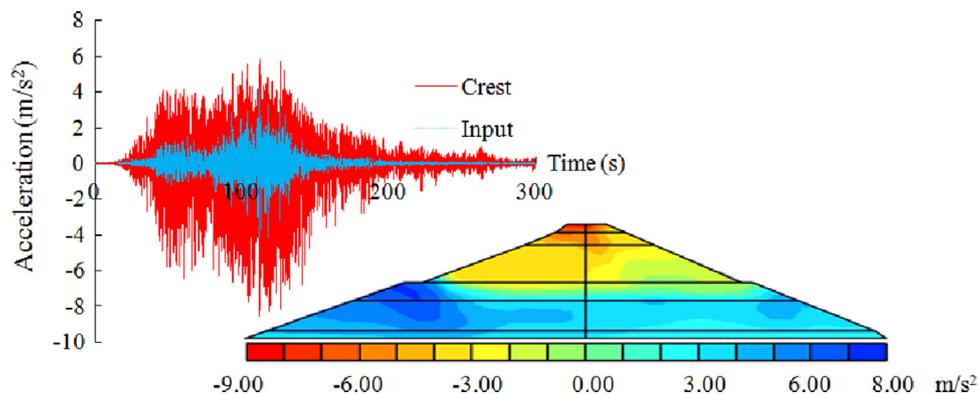
Fig. 12. Acceleration contours (inverse phase of observed motion).

Results show that larger maximum crest acceleration can be obtained using inverse phase of the observed and simulated motions. Therefore, the acceleration contours at the time when the maximum acceleration reached the dam crest are shown in Figs. 12 and 13 for inverse phase of the observed and simulated motions, respectively. By using the observed motion, the maximum crest acceleration is determined to be 7.42 m/s² and 8.56 m/s² accelerating towards the upstream direction at the time of 104.45 s and 111.60 s for normal and inverse phase motion (Fig. 12), respectively. For the simulated earthquake, the maximum crest acceleration is 7.60 m/s² acting towards the upstream direction at the time of 72.78 s. Similarly, for its inverse phase, the crest experienced the maximum acceleration moving towards the upstream side with a magnitude of about 7.65 m/s² at 71.24 s (Fig. 13).

The observed motion contains high-amplitude waves for a longer duration than does the simulated motion. This generates a great response throughout the dam body resulting from significant inertial force acting on the dam. This causes a great amount of plastic deformation and eventually the dam failure owing to the loss of freeboard. In addition, regarding to the spectrum of the observed motion, it can be seen that this motion is characterized by a wide band. Therefore, it might possible induced resonance in the dam and caused a higher response. In contrast, the simulated motion contains high-amplitude waves only for a comparatively short period; thus, this does not contribute a sufficient effect to cause large movement and settlement of the dam.

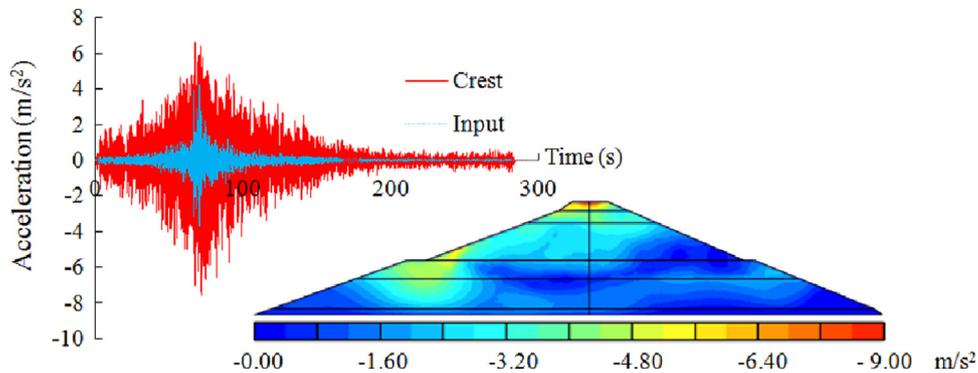
Fig. 13. Acceleration contours (inverse phase of simulated motion).

For both motions, it can be seen that the acceleration at the dam crest is amplified significantly. The maximum amplification ratio taken from the crest to the base is 1.76 and 1.79 for the observed and simulated motions, respectively. To verify the effects of the phase of ground motion, the opposite waveforms were used as input motions and amplification ratios of 2.03 and 1.80 were obtained for the observed and simulated ground motions, respectively. This indicates that the response is very sensitive to input ground motion.

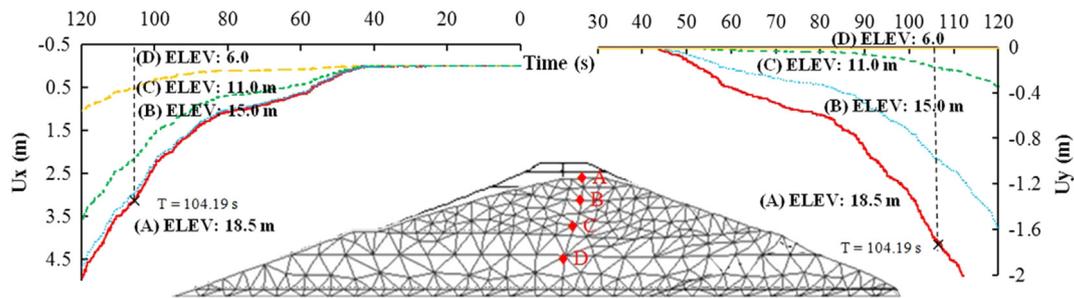
Fig. 14. Deformed mesh at 104.19 s using observed motion.

Fig. 14 shows the deformed mesh at 104.19 s and its corresponding displacement curves when subjected to the observed

motion. It can be seen that the entire dam body was moved in the downstream direction. As time increases, plastic deformations were accumulated. This caused the permanent horizontal displacement U_x of 2.95 m, and crest settlement U_y reached 1.80 m at 104.19 s; this is considered as the point of dam failure due to the loss of freeboard. Settlements at other observation points yield a similar tendency, but the settlements were less with decreasing dam height.

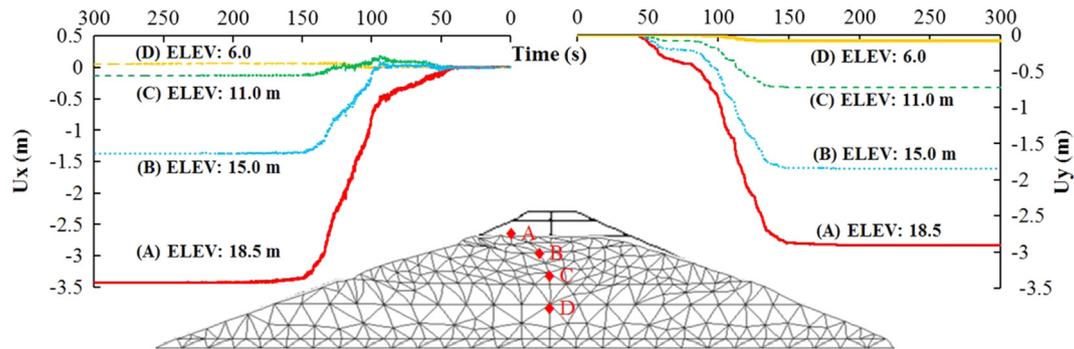
Fig. 15. Deformed mesh at end of the analysis using inverse phase of observed motion.

In addition, the deformed meshes and deformation curves in both directions, at the end of the shaking using the inverse phase of simulated and simulated ground motion, are shown in Figs. 15 and 16. These indicate that both horizontal and vertical displacements fluctuated during the earthquake and settled continuously at a rapid rate, and then remained constant until the end of the excitation. The permanent horizontal displacement of the dam was 3.40 m (upstream side), 0.30 m, and 0.42 m for the inverse phase of the observed, simulated, and inverse phase of simulated motion, respectively. The vertical displacement at the dam crest reached 2.90 m, 0.63 m, and 0.60 m for the inverse phase of the observed, simulated, and inverse phase of simulated

motion, respectively. As a result, by considering overtopping failure, the dam was able to withstand safely the simulated input motion except for the case of using the inverse phase of the observed motion, for which overflow is expected to occur.

According to the facts, the dam experienced overflow and subsequent breach. The one possible cause is that the significant settlement of the dam body led to the loss of freeboard. Thus, the observed motion does reflect the actual failure mechanism of the dam, whereas the simulated motion does not. However, all cases show that settlement is high, especially in the upper portion of the dam owing to its softness. For the changed phase, the observed motions show the significant effect of creating the displacement obtained from the normal and inverse phase, to be in opposite directions.

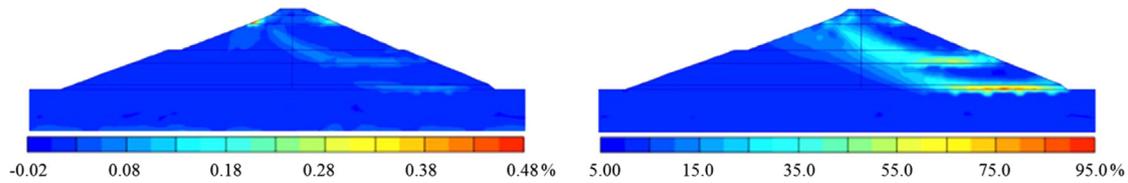
Fig. 17. Shear strain contours at 40 s and at 104.19 s using observed motion.

Shear strain contours for various times obtained using the observed motion are shown in Fig. 17. Most of the dam body experienced an insignificant rate of shear strain. It can be seen that initially, large shear strains occurred in the upper portion, especially on the upstream side. Thereafter, the occurrences of large shear strain can be observed clearly on both sides of the dam in the middle and bottom portions of the downstream slope. This excessive level of shear strain may indicate a possible cause for the dam failure. Similarly, shear strain contours obtained from the remaining motions yield almost the same pattern as the previous motion (Figs. 18 and 19). However, the exception is when using an inverse phase of the observed motion, for which large shear strains can be seen on the upstream slope instead of on the downstream slope.

The sequence of dam failure has been reported by previous researchers. Initially, the dam experienced excessive deformation or a slide on the upper portion of the upstream slope. This, together with a subsequent large slide that occurred on the downstream face, yielded a loss of freeboard and triggered the overflow that resulted in the breaching of the dam. Most numerical results show good agreement with this scenario, except for the case of using the inverse of the observed motion, which exhibited large strain appearing mainly on the upstream slope. The simulated

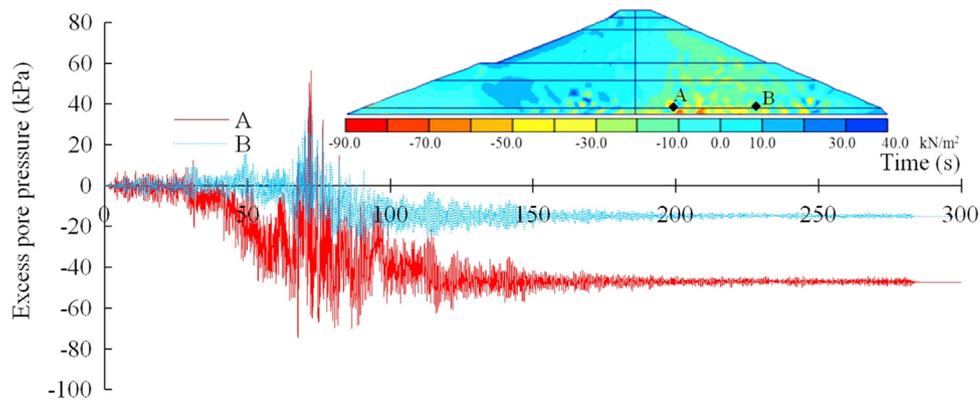
Fig. 20. Excess pore pressure.

The distribution of the excess pore pressure within the dam body and the records of the observation points A and B at 104.19 s using the observed motion are shown in Fig. 20. It can be seen that the excess pore pressure developed mostly at the downstream side. The maximum excess pore pressure was about 90 kPa and it can be found near the dam's base close to the dam center line. Besides, the suction or the positive excess pore pressure can be found on the upstream face and within dam's body on the upstream side. It can be seen that from the time history curves of the excess pore pressure at the observation points A and B that the build-up pore pressure was fluctuated at the early period of the shaking and then kept constant until the end of the excitation. The maximum excess pore pressure obtained from the observation points A and B was about 48 kPa and 18 kPa, respectively.

In case of using inversed phase of the observed motion, the distribution of the excess pore pressure shows that the build-up pore pressure was mostly concentrated on the upstream side. The maximum excess pore pressure was about 90 kPa which can

be found at the lower portion of the dam. On the other hand, on the downstream side, the excess pore pressure found to be in a range of 10–30 kPa and also the suction can be found at the downstream face.

The results show that most of the dam body experienced the build-up pore pressure that was not high enough to equal the effective stress and trigger the total loss of the soil strength. However, in particular locations such as on the downstream side where the effective stress found to be small, the reduction of shear strength can be fairly high and led to significant permanent deformation on those areas. However, it must be noted that the Mohr–Coulomb model can only capture the excess pore pressure due to volumetric stress. Although the excess pore pressure due to earthquake excitation was presented here, the actual phenomenon of cyclic mobility and liquefaction cannot be modeled and captured in this study.

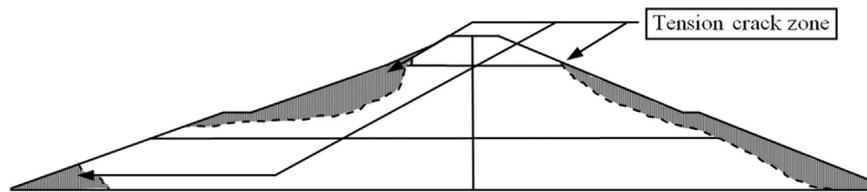
Fig. 21. Tension crack zone.

A tension crack is an extension fracture caused by tensile stress. Soil material normally has low tensile strength, and therefore it is possible for any small tensile stress, which might be a product of stretching deformation or positive pore pressure, to cause a tension crack in the soil structure. Besides, the materials used in this study, the middle and bottom, showed fairly high cohesion values which are prone to cracking. Therefore, this phenomenon is important and should be taken into account in this study. This crack provides information that might be useful for understanding the failure mechanism of the failed dam. The occurrence of tension cracks could initiate sliding or internal erosion of the dam structure.

tensile stress does exceed the tensile strength. Fig. 21 summarizes the zone of the tension crack that occurred throughout the time of the analysis for both the observed and the simulated motions. It can be seen from both cases that the tension crack occurred similarly within the same location. This crack appeared clearly in the middle portion and at the toe for both sides. However, the tension crack on the upstream slope seems to penetrate deeper into the dam body. From this evidence, it would appear that sliding and internal erosion could be triggered, thereafter causing the failure of the dam.
