Alleviation of rolling contact fatigue on Sweden's heavy haul railway

Abstract

A test has been undertaken on Sweden's Malmbanan, or iron ore railway, to reduce rolling contact fatigue (RCF) damage by developing a preventative maintenance regime involving routine grinding of the rails. In just the first 2 years of the test, the total cost of grinding plus rail replacements was reduced by almost 40%, while both the rail and track quality generally improved immensely. Although it may not be possible to reproduce such savings everywhere that RCF damage occurs, some lessons from the test are of general relevance. In particular, the development of even existing surface-initiated defects can effectively be halted by grinding and thereafter regularly reinstating, a profile which substantially removes loading from those cracks. In this test, the rate of metal removal by grinding was about 0.2 mm per 25 MGT. Methods were also developed for objectively monitoring the transverse and longitudinal profiles of the ground rail, and the depth of metal removed from the rail, i.e. the overall grinding "quality". It would appear that the desired benefits of grinding can be obtained even if deviation

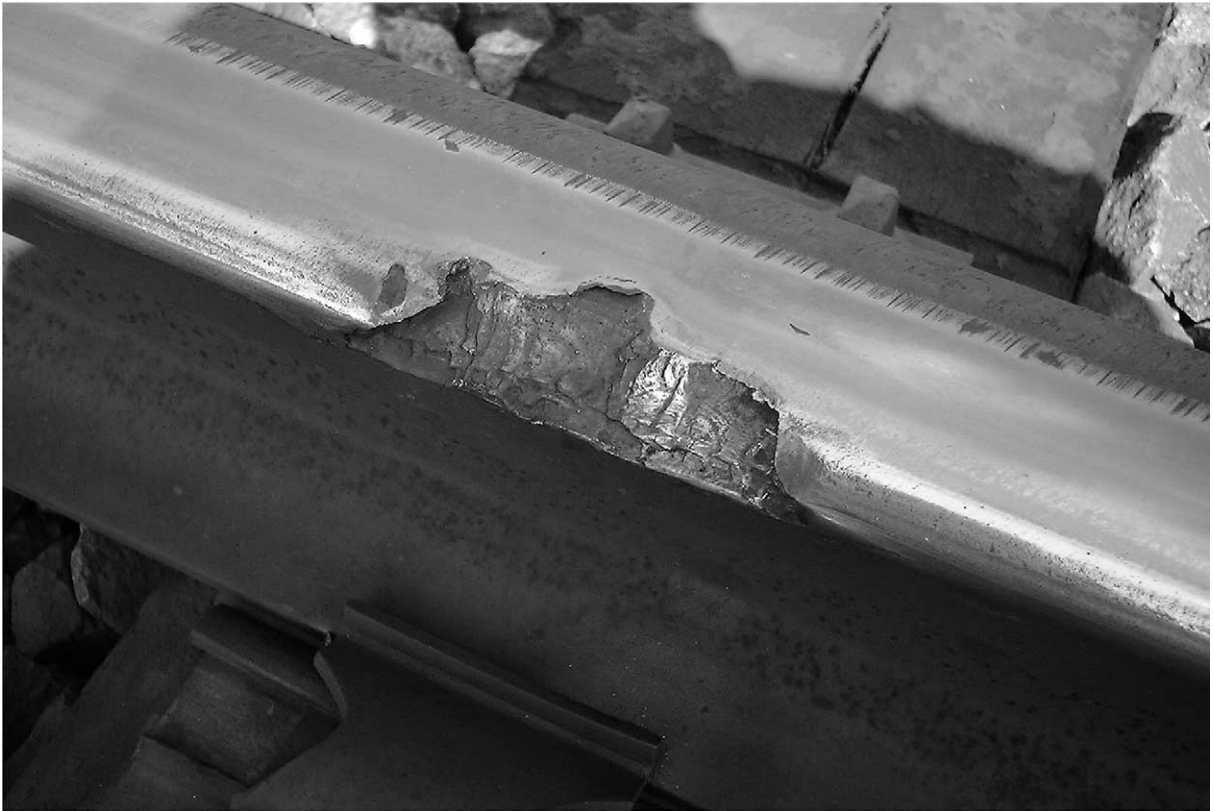
For many years, the Malmbanan has suffered from problems of severe rolling contact fatigue (RCF): spalling, shelling and head checking (Figs. 1 and 2). RCF damage occurred primarily in switches and on the high rail in curves. South of Kiruna the rail was ground infrequently. This line suffered from corrugation and severe gauge-face wear, as well as RCF. The rail damage and rail breaks (which were more frequent on the line north of Kiruna) were a cause of considerable concern, not least because the line was ground every year or two (i.e. at an interval of about 23–46 MGT) and the received wisdom was that grinding should alleviate such problems. Yet, despite this relatively frequent grinding (by European standards) almost 10% of rail on the line plus several switches were renewed every year.

Fig. 1. Example of severe localised spalling on Malmbanan.

- Even if the crack depth were known, it was clear from the existing spalling on the line that it would have been necessary either to remove several millimetres of metal in the gauge corner and shoulder areas of the rail (Figs. 1 and 2), or to rerail much of the track. In either case, a great deal of grinding would have been required (if only, in the latter case, to establish the desired profiles).

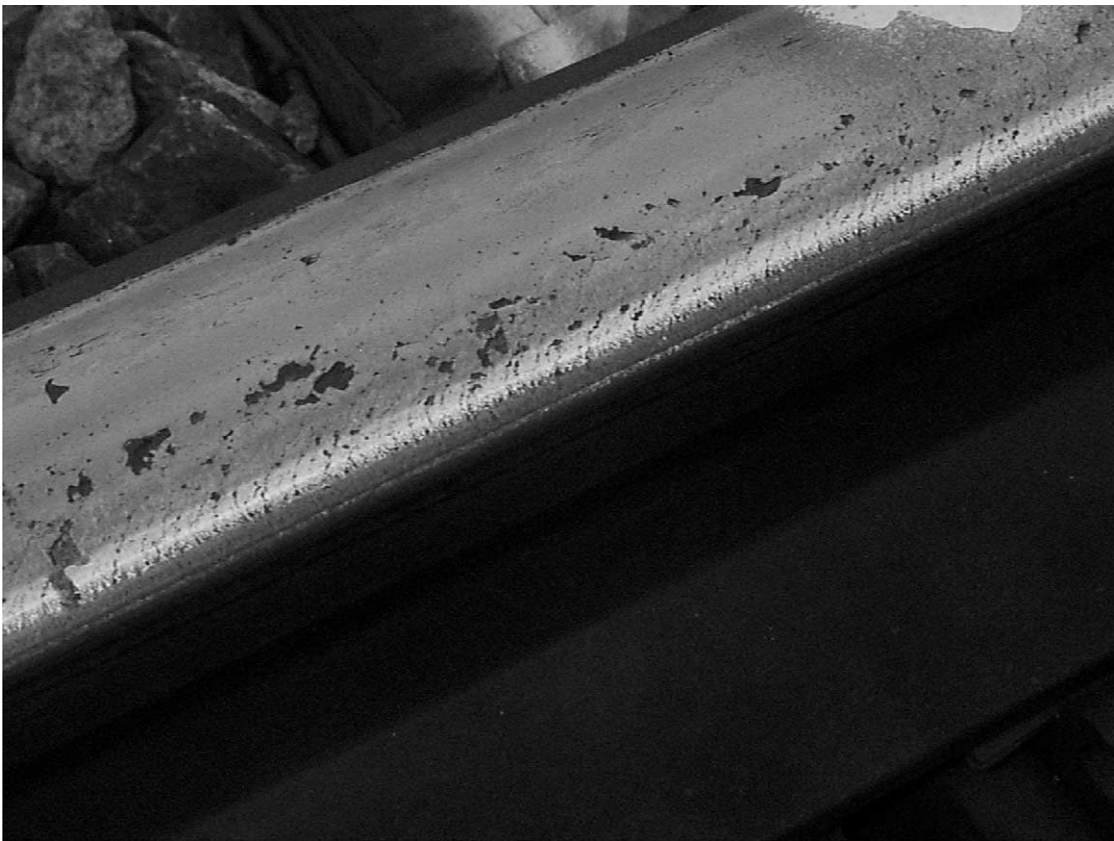
Fig. 2. Distributed spalling and headchecks.
