Permeation grouting for remediation of dam cores

DongSoon Park^{a,b,*}, Jeheon Oh^a

^a K-water Research Institute, 1689 Beon-gil 125, Yuseong-daero, Yuseong-gu, Daejeon 34045, Republic of Korea

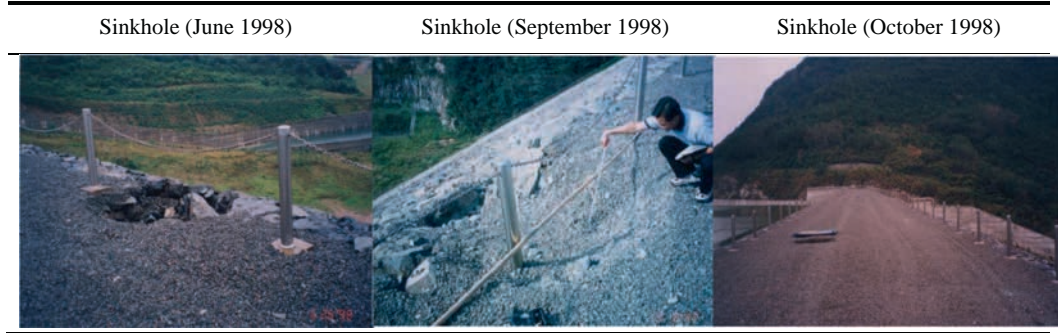
The WM dam is a 55-m-high earth-cored rockfill dam that exhibited distinct deterioration in the form of three sinkholes near the dam crest, which were observed over six months during normal dam operation (Fig. 3). Before any remediation, the dam seepage measured at the downstream toe increased up to approximately 2340 m³/day at normal high water level (NHWL) (EL: 150.0 m). After an in-depth diagnosis, an initial remediation measure was applied by compaction grouting on 80 m out of the dam crest's total 407 m (Chun et al., 2006; Lim et al., 2004; Yea et al., 2012). After compaction grouting, the total seepage was reduced to 860 m³/day near NHWL. However, two and a half years later, seepage had increased to up to 1007 m³/day and another in-depth diagnosis revealed diversified flow paths within the embankment, which required remediation to be applied over the whole length of the dam. The final remediation was conducted using low-pressure

Fig. 3. WM dam sinkhole incidents.

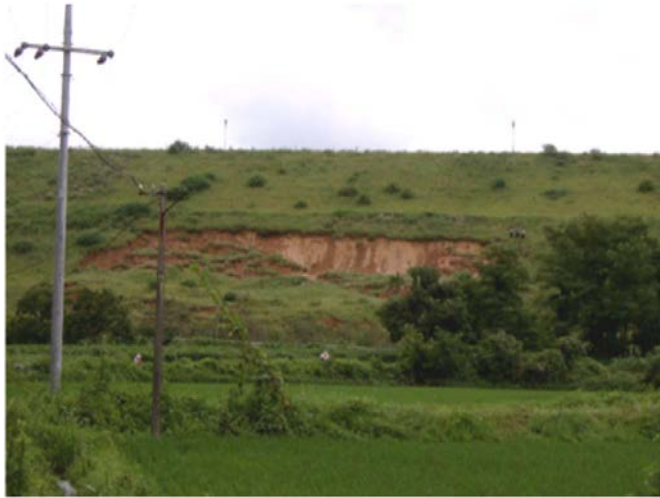
embankment's state. As a result, heavy rainfall in 2003 induced significant downstream slope failure (Fig. 4). After implementing immediate emergency measures to rehabilitate the slope, permanent remediation was undertaken with permeation grouting.

Fig. 4. AG dam incident: downstream slope failure (2003).

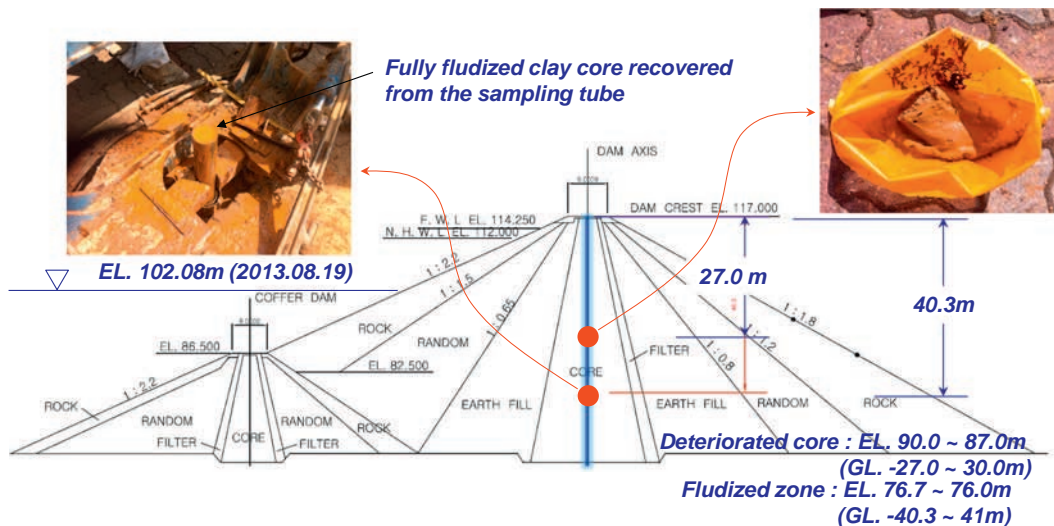
Fig. 5. DB dam: deteriorated core samples discovered during geotechnical investigation (2013).

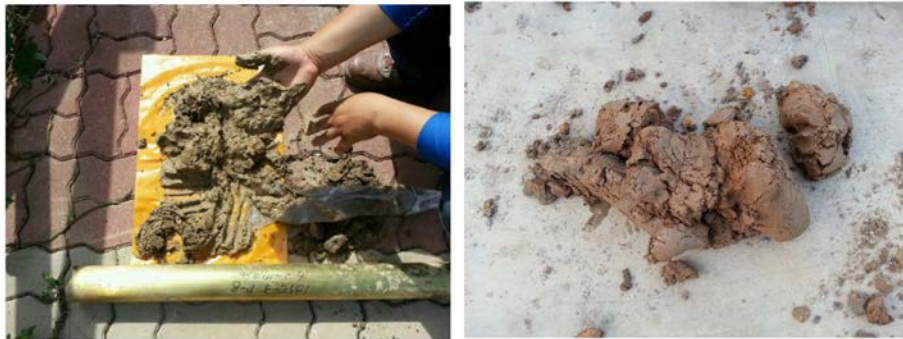
Fig. 6. YC dam: locally deteriorated core samples discovered during geotechnical investigation (2013).

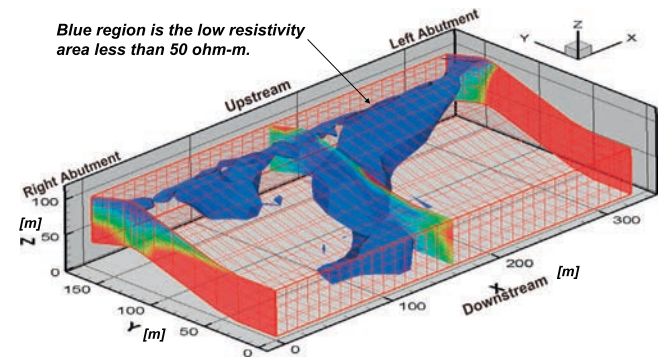
Fig. 7. Results of 3D electrical resistivity survey of DB dam, showing the low resistivity area of < 50 Ω-m.

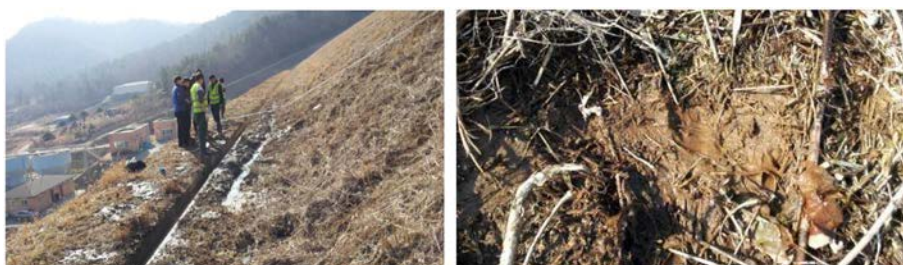
The HD dam also exhibited extensive wet zones on the downstream surface. Leakage water was distinctively observed on the downstream berm near one-third of the dam height from the crest (Fig. 8). The clay core material was in poor condition, and the reservoir water level was operated near NHWL. After an in-depth geotechnical investigation and diagnosis, to remediate the core layer permeability, permeation grouting and bentonite injection were performed at the upper crest area.

Fig. 8. HD dam: leakage and wet zones observed on the downstream surface.

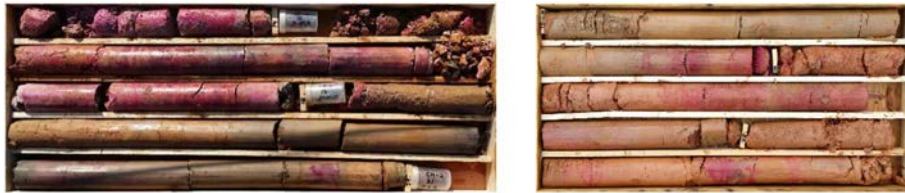
wet surface soils. For all five dams, chemical indicator reaction tests were performed on checkhole core samples using Phenolphthalein spray. It was observed that the area penetrated by the grout milk turned red after application of the Phenolphthalein spray, indicating a good filling of soil voids (Fig. 15).

Fig. 15. Chemical indicator reaction for HD dam checkhole core samples after remedial grouting.
