International Journal of Mining Science and Technology

Coal bursts that occur during development: A rock mechanics enigma

Christopher Mark

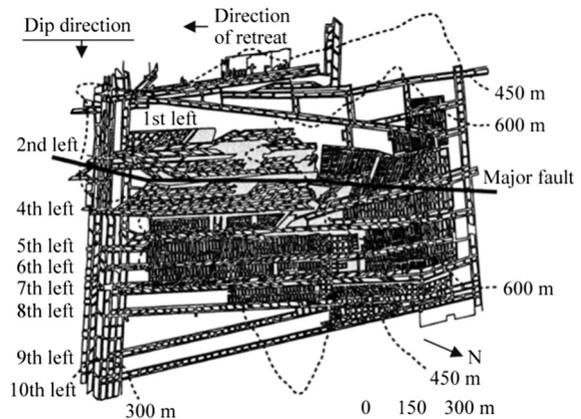
The overburden at Sunnyside was predominantly strong sandstone, with some beds more than a hundred meters thick. The immediate roof above the coal was generally poor, however, consisting of shales, sandy shales, thin laminations of sandstone and shale, and rider seams. The floor was a strong sandstone 6–15 m thick. The depth of cover at Sunnyside was severe even in the early days, with the 600 m cover line just 800 m from the coal outcrop due to the cliff-forming sandstones [3]. Numerous faults are present, most prominently the Sunnyside fault system which parallels the outcrop (Fig. 4).

Fig. 4. A portion of the Sunnyside Mine that was mined in the 1950s, showing the Sunnyside Fault (labeled “Major fault” on the right) [2].

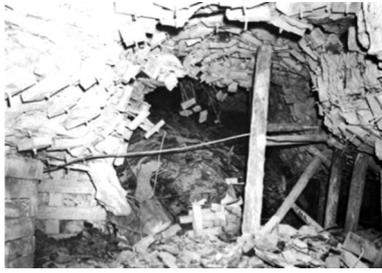
In January of 1957, a series of events caused great damage to the main slope area near the fault. A heavily bolted section of roof in the track slope settled on the bolts throughout 150 m of track entry, and the railroad on the same slope was heaved and thrown out of line for a distance of 400 m. This same area had been damaged in bursts in 1944 and 1952.

In December of 1957, a pillar in the same area burst again, filling the manway with rock for a distance of 70 m. The entry had caved previously, and the cave had been used as fill and graded over, so the event was actually rock burst rather than a coal failure (Fig. 5). The tremor was felt at the Sunnyside Town site and was

Fig. 5. 1957 burst site in the main slope at the Sunnyside Mine [7].

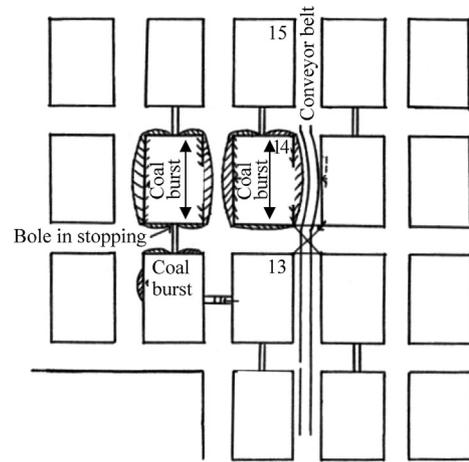
In January of 1991, however, an extremely unusual event occurred. Miners developing a set of main entries felt a sudden blast of air and the conveyor belt stopped. They walked 240 m outby to investigate and found that a large coal burst had occurred. Two coal pillars had blown out and an overcast had collapsed (Fig. 6). The report on the event noted that the depth of cover was approximately 480 m, the overburden consisted predominantly of massive sandstone, and there was a major fault located approximately 60 m from the outburst area. No retreat mining or multiple seam interactions were located anywhere near the burst [8].

Fig. 6. Burst pillars along the belt line, 240 m outby the development faces at the Deer Creek Mine [8].

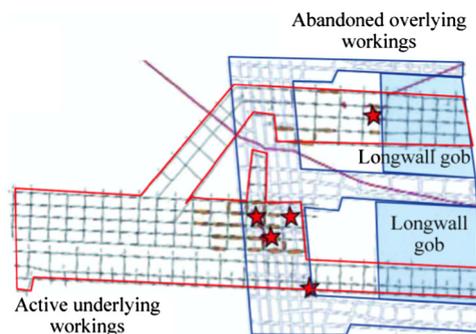
In late 2007, a series of three bursts occurred at Bowie while developing a five entry mains in the B seam. In this area, the overburden was approximately 530 m, and the base of the 30 m thick C Sandstone was 27 m above the B seam. The development was crossing beneath a D Seam mains located 100 m above when the first event occurred, causing 1 m of rib failure and 1 m of floor heave around three pillars. It also caused an air blast and damaged ventilation stoppings for 7 breaks outby the face and registered $M = 2.1$ on the local seismic monitoring system.

In response to this first event, the mine ramped up to leave more coal in the floor and rock in the pillar for reinforcement. A second event occurred that required significant cleanup though it only measured just $M = 1.1$. The third event was the largest of the three, registering $M = 2.9$. It reactivated the earlier floor heave and also caused extensive new floor heave, as much as 1.5 m in some places. The development headings were abandoned at this point.

All of these events occurred beneath developed D-seam pillars which, if they had any effect at all, should have reduced the vertical stress and transferred it to the solid coal on either side (Fig. 7). All the events also occurred well outby the B seam development faces and were not triggered directly by coal cutting activities. It seems likely that the most significant factor was the presence of a zone of steeply dipping northwest trending joints, interpreted as remnants of a fault zone that had been mined through without difficulty in the D seam [13]. Another hypothesis is that the D seam pillars might have themselves failed, providing a dynamic trigger to the events encountered in the B Seam [12].

Fig. 7. Location of four development bursts and one headgate burst at the Bowie Mine.

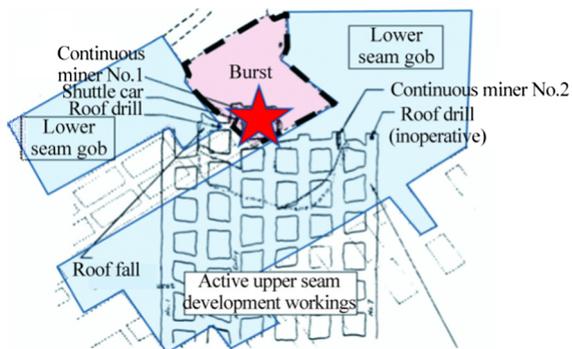
Nearly all Central Appalachian coal bursts have occurred during or in close proximity to pillar recovery, or at a least multiple seam interactions involving pillar recovery. For example, USBM describes a burst that occurred at an International Harvester Mine in Harlan County [20]. The burst occurred when the development workings crossed over an island remnant barrier pillar located between gob areas the underlying coal seam 23 m below (Fig. 8).

Fig. 8. Development burst in upper seam workings above an island lower seam barrier pillar (outlined with thick dashed line) in a Harlan County, KY mine (after USBM, 1970).

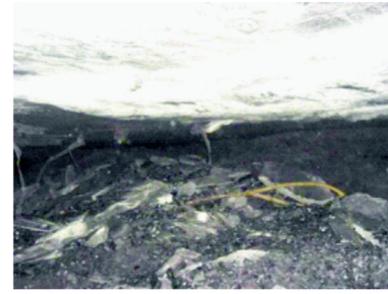
Newman examined the 2001 burst area and observed that the bump impacted six pillars, with the greatest damage centered in the belt entry, two breaks outby the active face. Roughly 3–4 m of the pillar ribs on either side of the belt entry failed, and, the belt entry two breaks outby the face was filled with fine coal in the center of the entry. The coal in the remaining portion of the pillar was separated from the roof creating a void space, approximately 3 m deep into the pillar. The height of the void space was roughly 0.3–0.5 m at the edge of the remaining portion of the pillar, grading back to contact with the roof. Although no roof falls were visible, wide spans in excess of 12 m resulted from the void space that formed between the top of the bumped pillars and the immediate roof [21].

No unusual geologic features were noted in the vicinity of the burst. Fig. 9 shows the conditions after the burst.

Fig. 9. Conditions after the burst in the Manalapan No. 17 Mine.

After the 2001 event, no further mining was allowed in areas where the depth exceeded 460 m and where underlying barriers were present. The subsequent development burst in 2002, which occurred at a traditional gob-solid crossing at 425 m depth of cover, led to further mining restrictions for depths greater than 300 m. Yet another coal outburst occurred during development mining in 2006, which knocked an employee into a roof bolting machine.

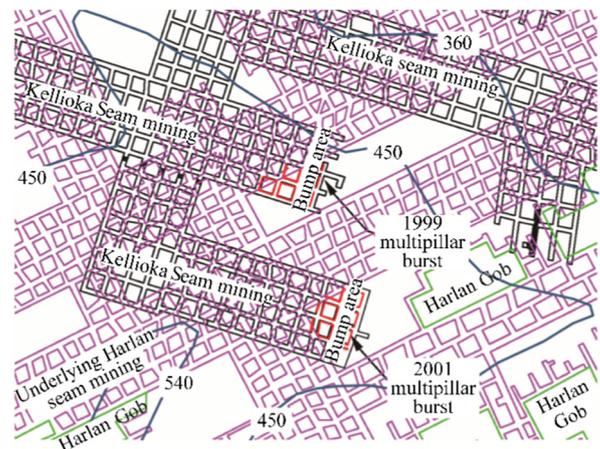
Both burst events were underlain by first workings in the Harlan seam (Fig. 10). An ARMPs version 6 evaluation of the Harlan Seam pillars showed that the stability factor (SF) of the Harlan seam pillars exceeded 2.0, which would normally suggest a stable pillar system. Nonetheless, investigators at the time of the events inferred that the Harlan Seam pillar systems created a pseudo gob that transferred stress onto the adjacent barriers [23]. Even more surprisingly, other Manalapan workings were underlain by

Fig. 10. Locations of burst events in the Manalapan No. 17 Mine (black) relative to underlying Harlan seam workings (magenta and green).

full extraction in the Harlan seam (see areas noted as “Harlan Gob” in Fig. 10), yet no bursts had occurred when mining above them.

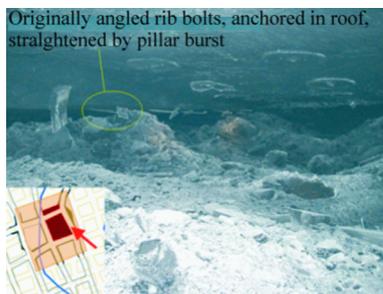
Rivers Edge was extracting the Powellton seam. In 2006, while advancing an eight entry main, a burst occurred in a pillar located two crosscuts outby the faces. At the bumped pillar, Gauna and Phillipson observed the following: ...a deep cavity of indeterminate depth above the bumped pillar where coal had been blown into the entry. Mounds of coal were deposited in a wavy, undulating expanse that almost filled the entry. The exposed sandstone

Fig. 11. Conditions in the entry adjacent to the pillar that burst at the Rivers Edge mine [25].

roof above the former location of the pillar was characterized by a rusty red, powdered coloration. Installed pillar rib bolts, angled upward and anchored to the roof, had been bent parallel to the roof horizon by the force of the bump. The roof horizon remained undisturbed and unbroken above the bumped pillar (Fig. 11) [25].

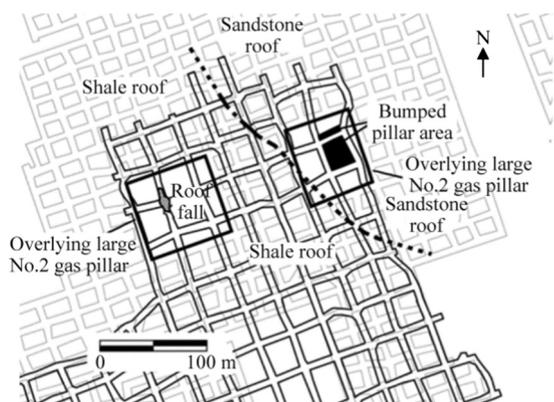
Fig. 12. Powellton seam burst region.

The Powellton seam burst region (Fig. 12) was situated approximately 18 m beneath a large pillar, 73 m × 69 m, which had been left in the overlying No. 2 Gas Seam. The large pillar in the No. 2 Gas Seam was surrounded by much smaller pillars, measuring 12 m × 15 m. The No. 2 Gas Seam small pillars immediately surrounding the remnant barriers had an ARMPS SF over 1.9. SF of these magnitudes normally suggests a relatively stable pillar system. However, it was believed that long-term flooding in the No. 2 Gas seam in a region above the active mining may have softened the overlying pillar system and degraded the load-bearing capacity of the smaller pillars, creating a “pseudo gob” [23]. It was also noted that above the burst pillar, the roof had transitioned to a sandstone channel.

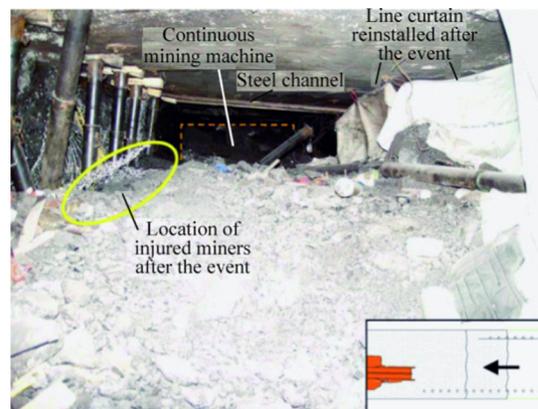
Fig. 13. Entry No. 1 filled with broken coal at the Crandall Mine after the burst on August 16, 2007 [26].

Rescue efforts recommenced in the No. 1 entry. It was completely filled with burst coal and had the appearance of a previously unmined face. The barrier side rib was observed to have shifted horizontally up to 3 m into the entry. At least eleven bursts occurred during the cleanup, but, before August 16, they were either at the continuous mining machine in by the miners, or they were contained by the standing support.

The rescue efforts were interrupted on the morning of August 16 when a burst occurred in the coal pillar between the No. 1 and No. 2 entries. The burst, which registered as a $M = 1.5$ seismic event, displaced approximately 1.2 m of the pillar rib, filling the entry on the right side of the continuous mining machine to a depth of approximately 0.8 m.

The burst that terminated the rescue operation occurred that same evening. Coal was thrown violently across the No. 1 entry during the magnitude 1.9 seismic event. The burst created a void up to 6 m deep into the right side pillar at the roof line. The dislodged coal threw posts, steel cables, chain-link fence, and a steel channel toward the left side of the entry, striking the rescue workers and filling the entry with approximately 1.2 m of debris (see Fig. 13). Three rescuers were killed and six more were severely injured.
