Study on application of fiber-reinforced concrete in sluice gates

Yu Wen Liu^{a,*}, Shih Wei Cho^b

^a Department of Civil and Water Resources Engineering, National Chiayi University, Chiayi City, Taiwan, ROC

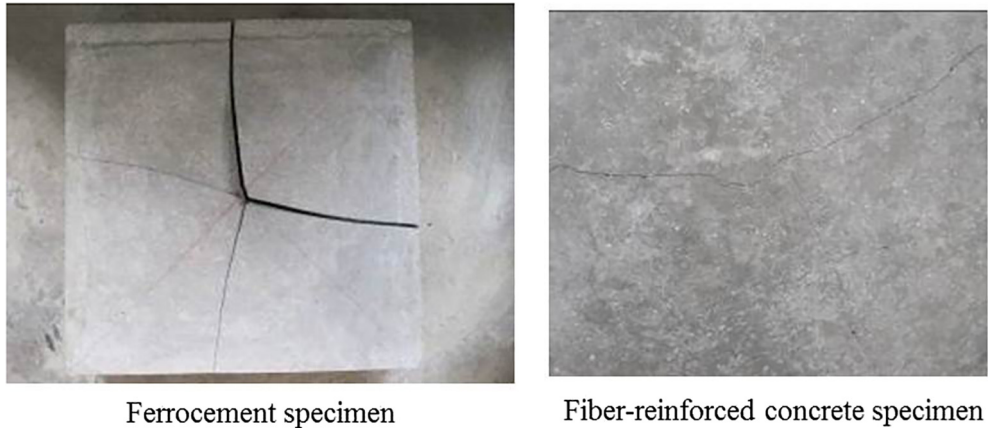
Both had dimensions of $500 \times 500 \times 60 \text{ mm}^3$ and contained double-layered galvanized wire meshes. Small cracks formed on the ferrocement specimen after 8 impacts and on the fiber-reinforced concrete specimen after 28 impacts, as shown in Fig. 10. Thus, brittle fracture was less likely to occur on the surface of fiber-reinforced concrete sluice gates containing double-layered galvanized wire meshes when they were impacted by driftwood or other drifting objects.

Fig. 10. Concrete specimens produced cracks after the impact test.

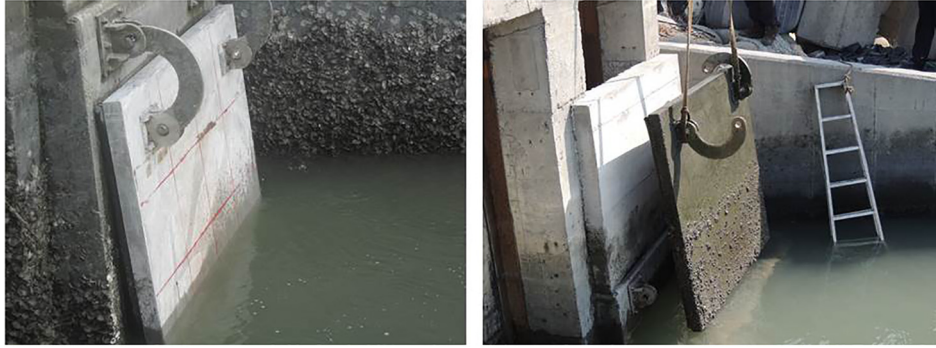
Fig. 13. The appearance of the Houanliao sluice gate (after 12 months of field testing).

The visual inspection revealed no damage to the surface of the FRC sluice gates after 1 year, during which time the temperature had been 15–29 °C, the total rainfall 789.5 mm, and the relative humidity 72%–86%. One flood (which occurred on June 12, 2012) and a few tropical cyclones occurred during this period. Notably, although the Houanliao sluice gate was constantly struck by flood and ebb tides, with more than one-third of its body constantly under seawater, its lifting lugs and surface exhibited no corrosion or rust stains. Similarly, despite having been soaked in wastewater from local pickling factories for a long period of time, the Tanduliao sluice gate showed no corrosion, had no cracks, was still functioning normally, and no damage or rust stains were present on its surface or lifting lugs after the high riverbank outside the embankment had been flooded on June 12, 2012.

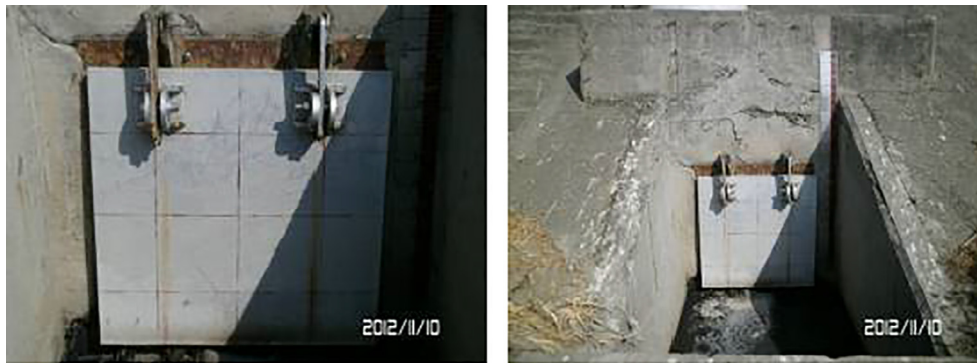
Fig. 14. The appearance of the Tanduliao sluice gate (after 12 months of field testing).

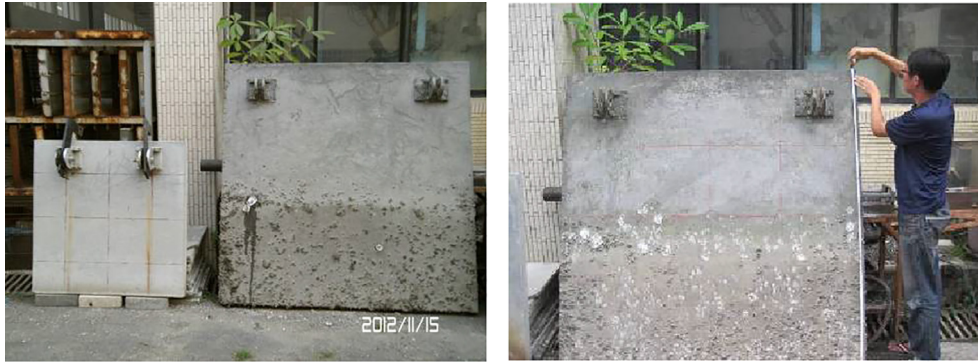
in use for one year. Specifically, the inspection focused on whether the cutting and welding of the lifting lugs and their bases met specifications; whether the edges on the lifting lugs and their bases were deburred; whether the gate surface was even; and whether any scars or cracks existed on the surface. Fig. 15 presents photographs of the sluice gates after they were removed for inspection. The Houanliao sluice gate had no cracks or rust stains, and its lifting lugs and water seals had not rusted or sustained any damage. However, the sluice gate was covered with barnacles and oyster shells up to 1200 mm from its bottom. Water-table measurements made by the supervisor of the Houanliao sea embankment suggested that the area of the sluice gate to which the marine creatures were attached had been frequently under seawater, indicating a high-tide level of 570–1200 mm. After the creatures were removed from the gate surface using manually operable tools such as shovels, the surface was found to be smooth. The surface of sluice gates at the Houanliao location should thus be cleaned annually, lest barnacles and oyster shells grow excessively on them, inhibiting their operation. Table 4 presents the results of the appearance inspection of the sluice gate in question.

Fig. 15. Appearance of FRC sluice gates after they were removed from their embankments.

No.	Item	Outcome
1	The cutting and welding of lifting lugs and their bases meet specifications.	Yes
2	Edges on lifting lugs and their bases are deburred.	Yes
3	There is no damage of any sort to the lifting lugs and their bases.	No
4	There are no uneven areas on the surface.	No
5	There are no scars or cracks on the surface.	No
6	The surface is free from deformation.	Yes

- After one year of use, both the Houanliao and Tanduliao sluice gates were removed from their respective embankments and returned to our laboratory for comprehensive inspection. The Houanliao sluice gates had barnacles and oyster shells attached at the bottom but exhibited no noticeable deformation, wear, or cracks. Both sluice gates were concluded to have been highly resistant to the impact of water flow.

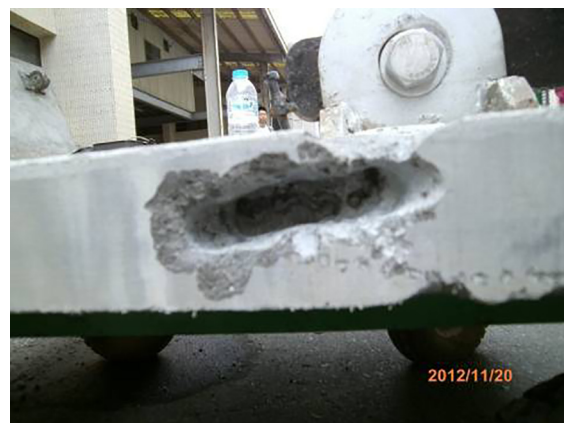
The corrosion found in the Houanliao and Tanduliao sluice gates is displayed in Figs. 17 and 18, respectively. No corrosion or rust was discovered on the rebars or wire meshes of the sluice gates after 1 year. Corrosion in the sluice gates was assessed using drill holes as working electrode contacts (Fig. 19). The assessment of corrosion current and potential at nine assessment points on each sluice gate indicated no corrosion of rebars or wire meshes. The corrosion current approached $0 \mu\text{A cm}^{-2}$ or was lower than $0.1 \mu\text{A cm}^{-2}$; the corrosion potential exceeded -200 mV . Thus, the probability of corrosion in the sluice gates was $<10\%$.

Fig. 18. Corrosion in Tanduliao sluice gate.

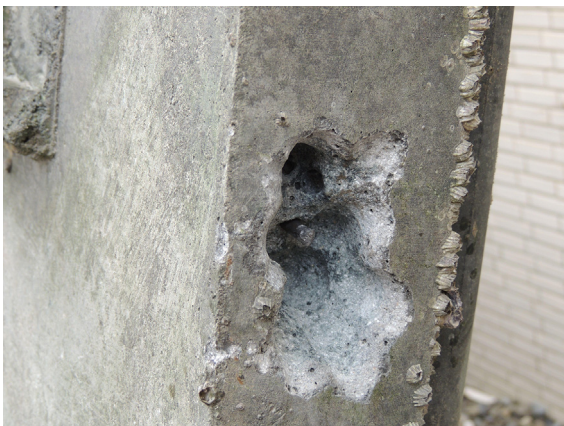
Fig. 17. Corrosion in Houanliao sluice gate.

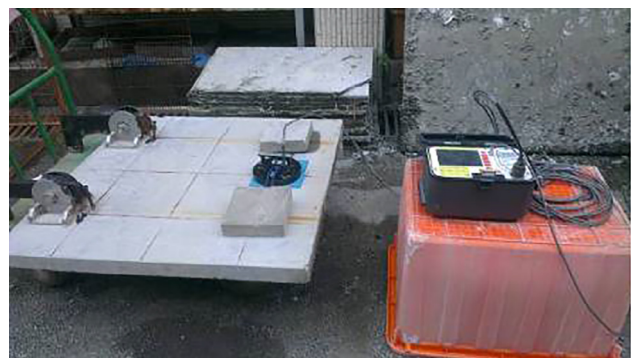
Fig. 19. Assessing corrosion in FRC sluice gates.
