## Soil Dynamics and Earthquake Engineering

## Liquefaction-induced settlement and tilting of buildings with shallow foundations based on field and laboratory observation

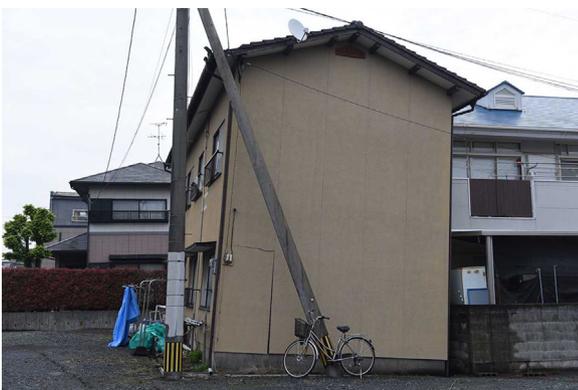
The 2016 Kumamoto Earthquakes, consisting of two major events on April 14th and 16th ( $M_w$ 5.8 and  $M_w$ 7.0), induced catastrophic damage to infrastructures and buildings in the source region as well as the Kumamoto plain. The quakes also caused soil liquefaction and related damage, particularly following the second event. Fig. 2 shows typical damage to a 2-story wooden house.

Fig. 2. Liquefaction-induced tilt of a 2-story wooden house in Karikusa town.

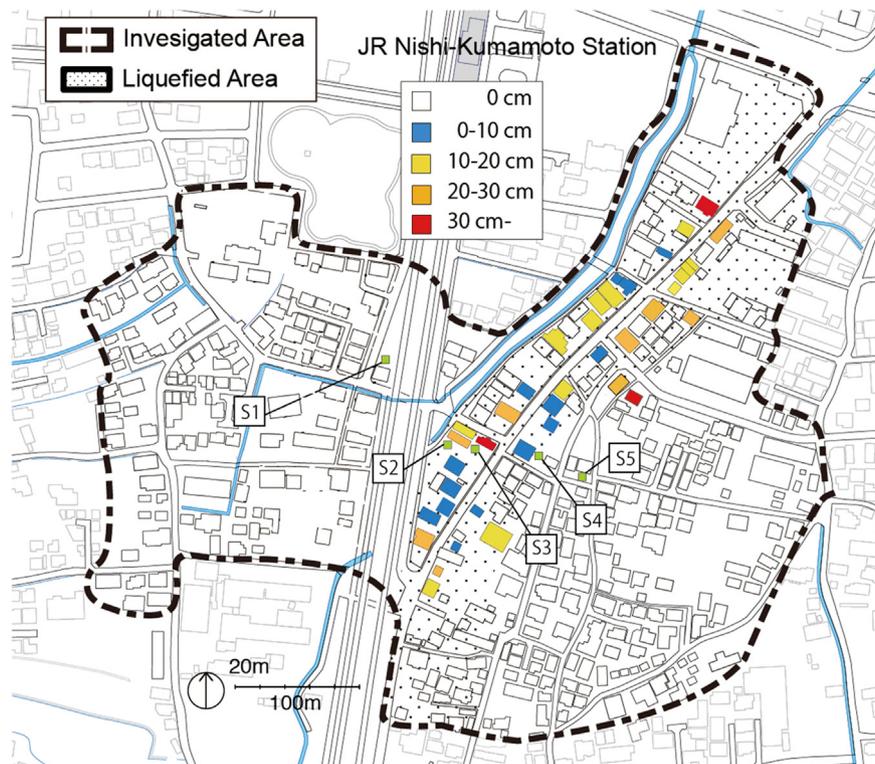
(West)-Kumamoto station. According to a geomorphological map, most of the area were classified as natural levees presumably consisting of predominantly sandy soil. A total of 307 buildings on spread foundation were examined. Table 1 summarizes the structural type and the number of story of these buildings with occurrence or non-occurrence of soil liquefaction. About 70% are lightweight two story wooden houses. Fig. 3 illustrates the distribution of relative settlement of buildings in the district.

Fig. 3. Distribution of liquefaction-induced settlement of buildings in Karikusa town.

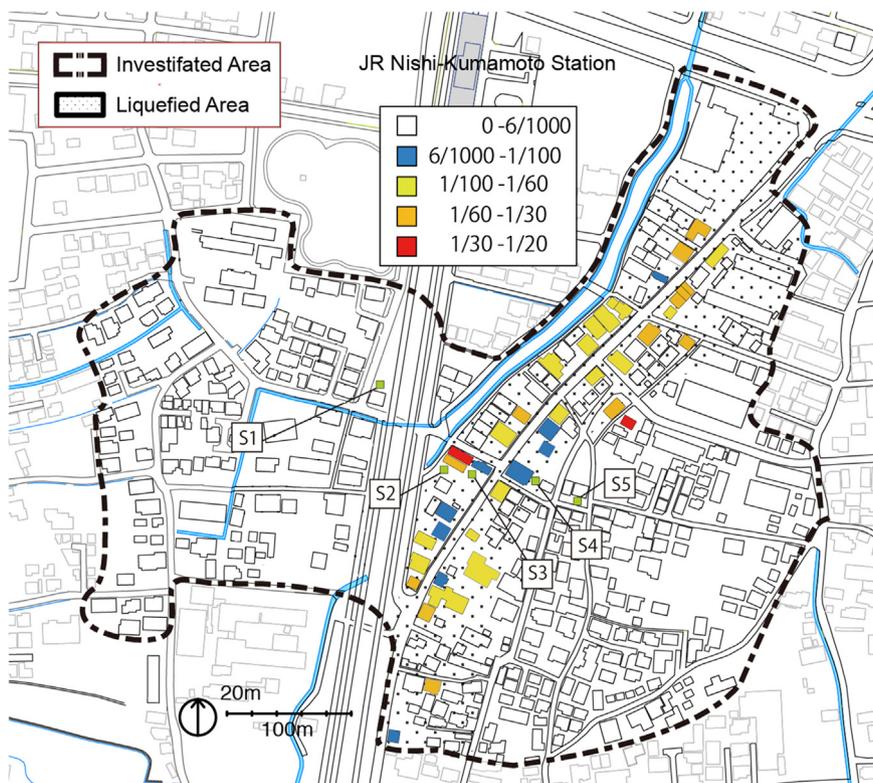
Figs. 4 and 5 show similar distribution of tilt angle and damage level of superstructure of buildings, which have been classified according to Tables 2 and 3. Note that any house inclined more than  $6/1000$ , even without any structural damage, generally requires re-leveling for subsequent usage. From Figs. 3 and 4, it is evident that liquefaction-induced settlement and tilting of buildings were concentrated within a narrow band along the road running from the northeast to the south, which was reportedly an old river channel about 400 years ago and artificially reclaimed sometime in the Edo era (1603–1868). Fig. 4 also indicates that liquefaction-induced settlement of buildings was relatively minor, probably attributed to the fact that most of those buildings were lightweight wooden houses.

Fig. 4. Distribution of liquefaction-induced tilt of buildings in Karikusa town.

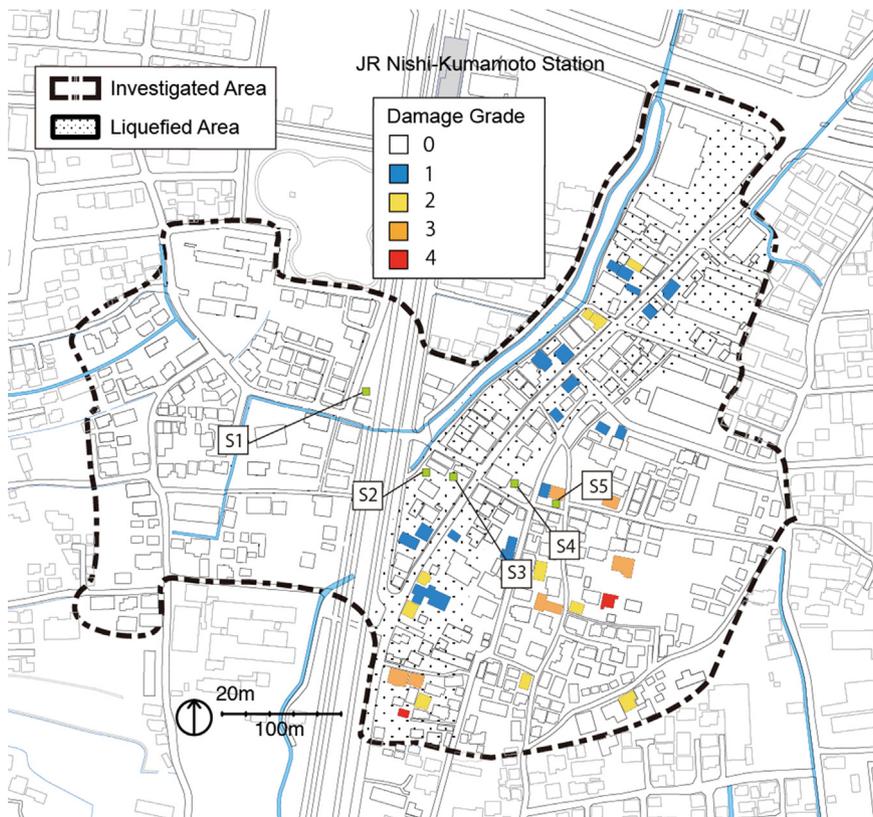
Fig. 5 suggests that significant damage to superstructure of buildings were largely distributed on the southeastern part of the investigated area outside of the liquefied belt, indicating significant effects of strong ground shaking amplified through the non-liquefied soil near the ground surface. A few buildings also experienced damage to their superstructures in the southern part of the liquefied belt. During the survey, it was observed that all these buildings were very old wooden houses with unreinforced weak foundations. Therefore, it is expected that the occurrence of soil liquefaction would result in unacceptable deformation to their superstructures. This reflects the historical changes in design specification of continuous foundation of wooden houses, in which more reinforcements were stipulated over time, following important lessons learned from performances of geotechnical structures in the last half century [12].

Fig. 5. Distribution of damage to superstructure of buildings in Karikusa town.

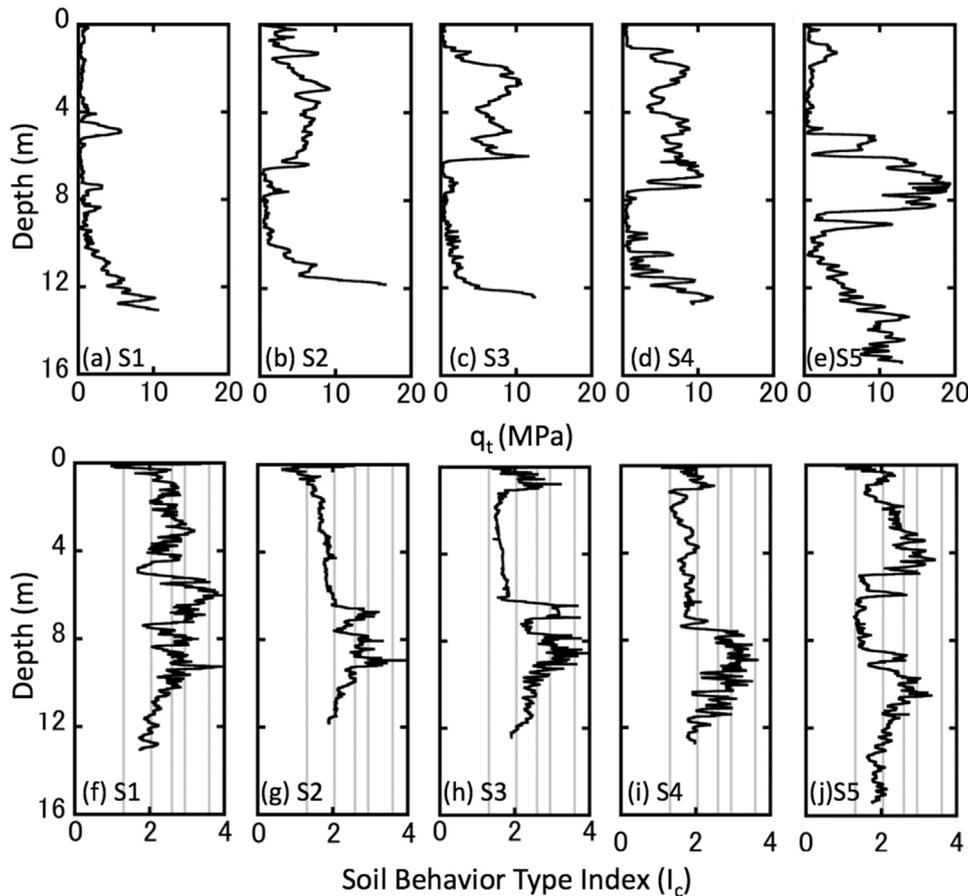
Cone penetration tests were conducted at five locations (S1 to S5) across the old river channel, along with standard penetration tests at two sites (S3 and S5). Sites S2–S4 were located inside the liquefied belt, while Sites S1 and S5 were outside as shown in Figs. 4–6. Fig. 6 shows the distribution of cone tip resistance and normalized soil behavior type index ( $I_c$ ) with depth of the five sites. Although all sites are located within the natural levees classified in the geomorphological chart of the region, sandy soils with  $I_c < 2$  dominate from the ground surface to a depth of about 6 m at liquefied sites S2 to S4, while silty and clayey soils with  $I_c > 2$  prevail within the same depth at non-liquefied sites S1 and S5. This suggests that the difference in liquefaction-induced damage in the region could be attributed to the differences in near surface soil type.

Fig. 6. CPT tip resistance and soil behavior type index ( $I_c$ ) at Sites 1-5.
