## Traditional techniques for the rehabilitation and protection of historic earthen structures: The seismic retrofitting project

Paulo B. Lourenço, Maria Pia Ciocci, Federica Greco, Georgios Karanikoloudis, Claudia Cancino, Daniel Torrealva & Kelly Wong

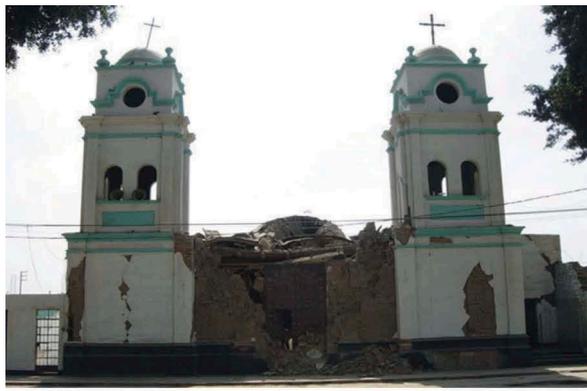
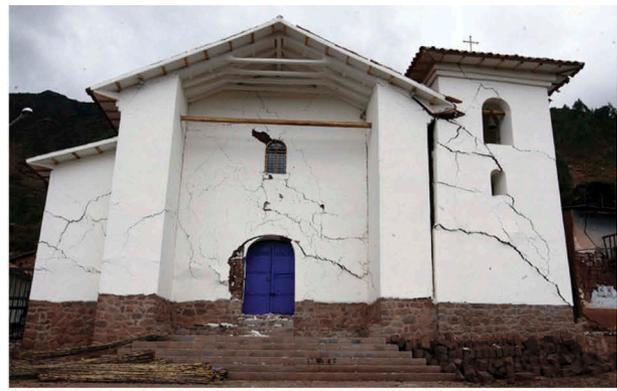
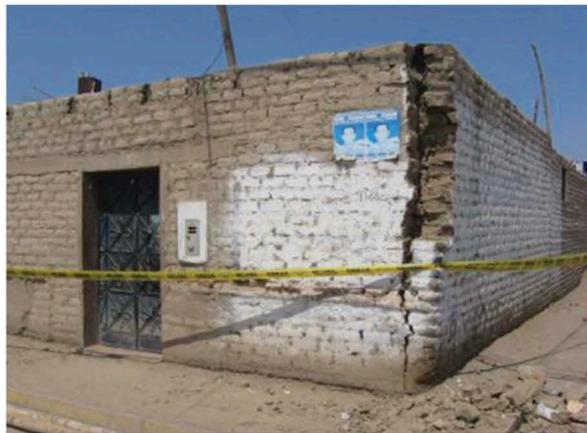
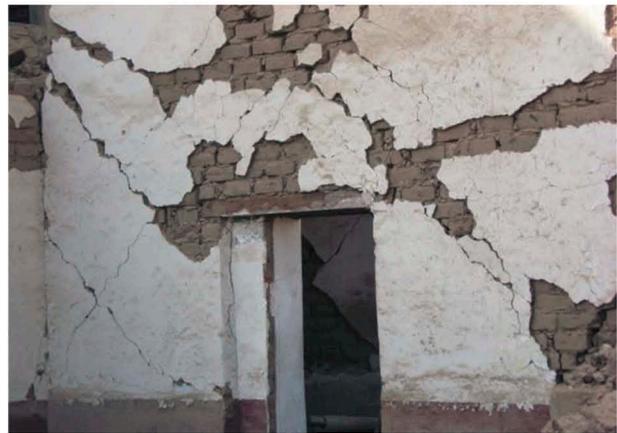
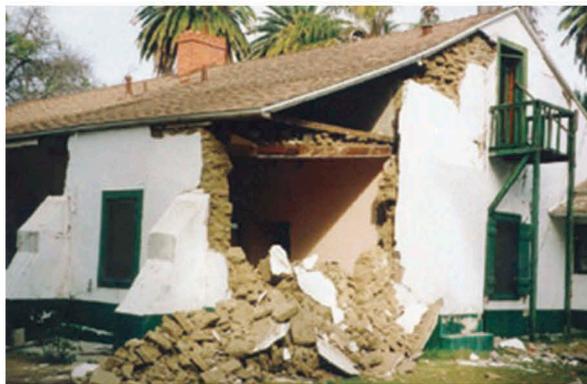
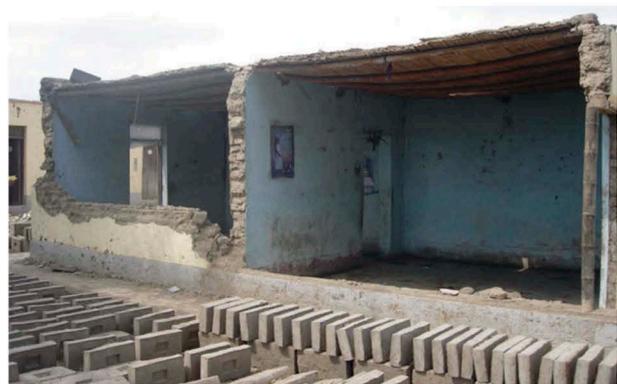
**Figure 4.** Failure mechanisms in earthen structures, induced by earthquakes: (a) collapse of the main façade due to rocking in the Church of Guadalupe, Ica 2007 (Cancino et al. 2011); (b) horizontal and diagonal shear cracks induced by rocking motion of independent structural parts in the church of Santísima Trinidad, Cusco 2014; (c) corner separation (Tarque 2008); (d) shear cracks near openings (Tarque 2008); (e) overturning failure of the corner of a lateral wall (Tolles 2006); and (f) out-of-plane overturning of entire adobe walls (Cancino et al. 2011).

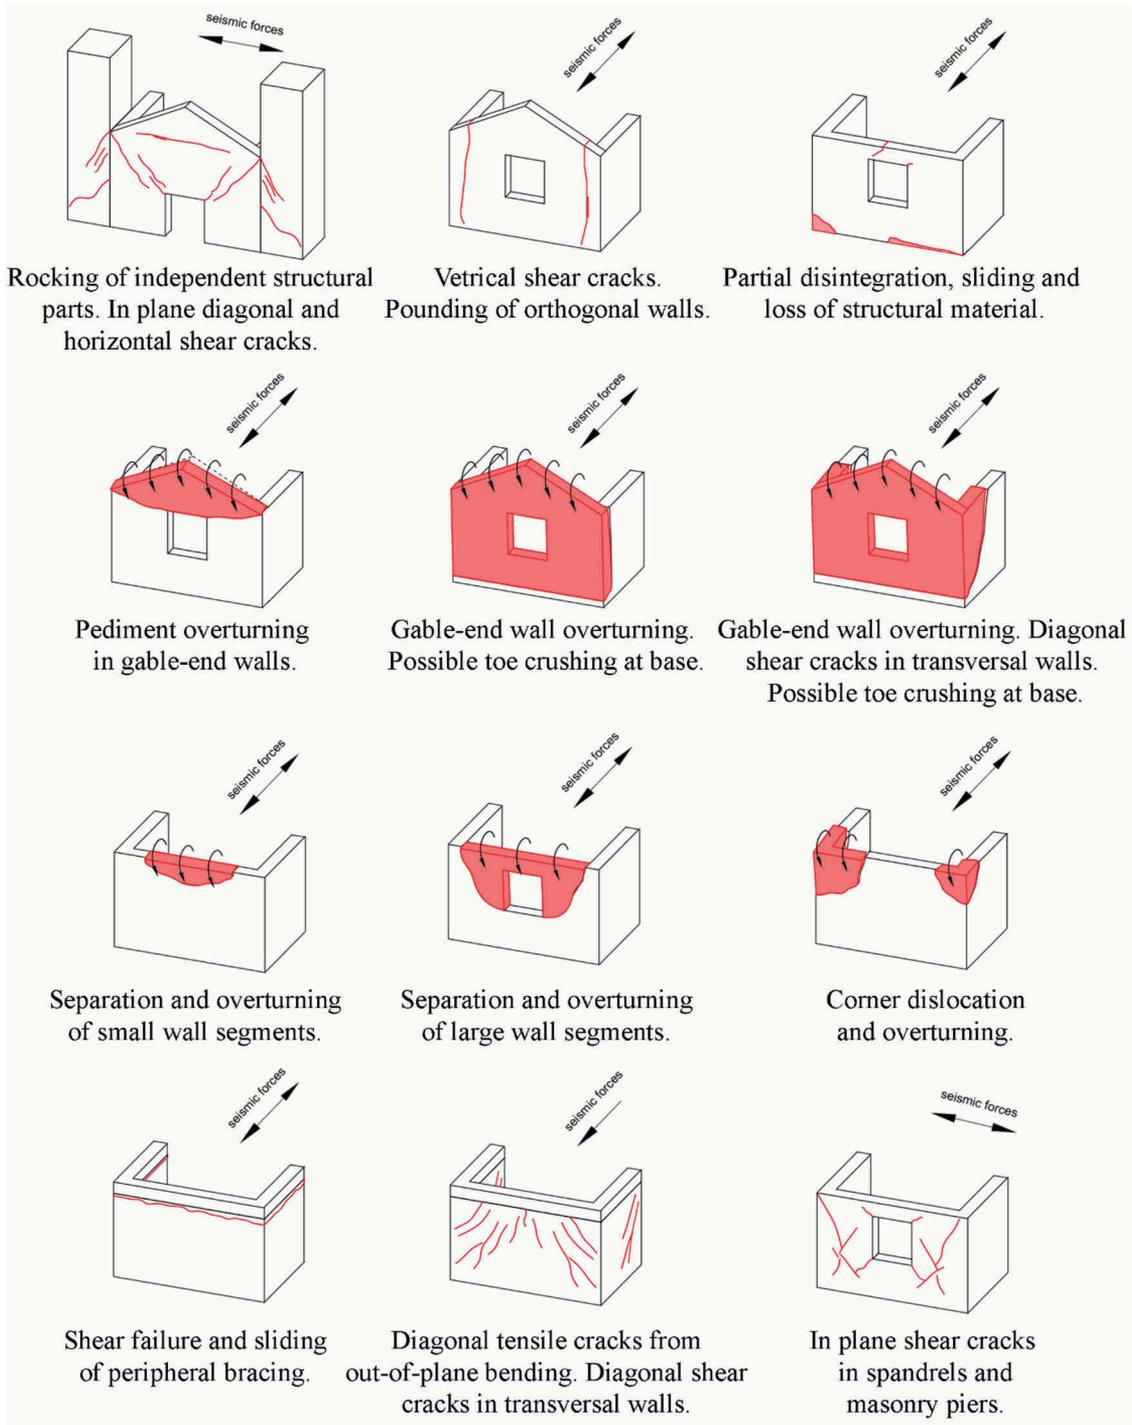
Figure 5. Typical failure mechanisms in earthen structures.

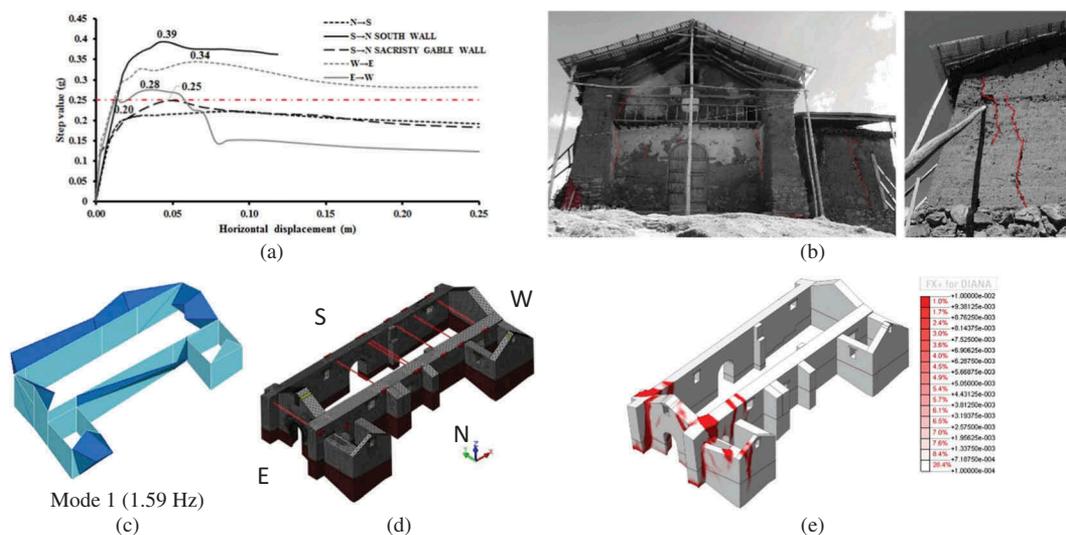
The present damage appears to be inflicted partly by earthquakes and settlements, amplified by erosion due to improper drainage, lack of use and inadequate maintenance, and consequently abandonment. The system of six existing timber ties, along the span of the nave and altar, at eave level, is discontinuous and the level of confinement is poor. In the east façade, damage consists of vertical cracks at the corners, along the entire thickness and elevation. The south wall exhibits outward displacements, small cracks, and loss of material in exterior areas. Also, the baptistery exhibits several vertical cracks, located in the sidewalls and at the northeast corner. The dynamic behavior of the church, as identified from ambient vibration tests, is characterized by out-of-plane and out-of-phase bending modes, for the lateral and gable walls of the nave, as shown in

Figure 6 (Lourenço, Karanikoloudis, and Greco 2016). These configurations demonstrate the low level of connectivity at the corners, which approximates true cracks, and the ineffectiveness of the existing tie beams.

**Figure 6.** The Church of Kuño Tambo: (a) selected capacity curves for the principal direction; (b) crack pattern of east facade (left) and gable-end wall of baptistery; (c) first mode shape from dynamic in-situ tests, with geometric interpolation; (d) FE model in 3D view; and (e) plot of maximum principal strain distribution at load step near collapse.

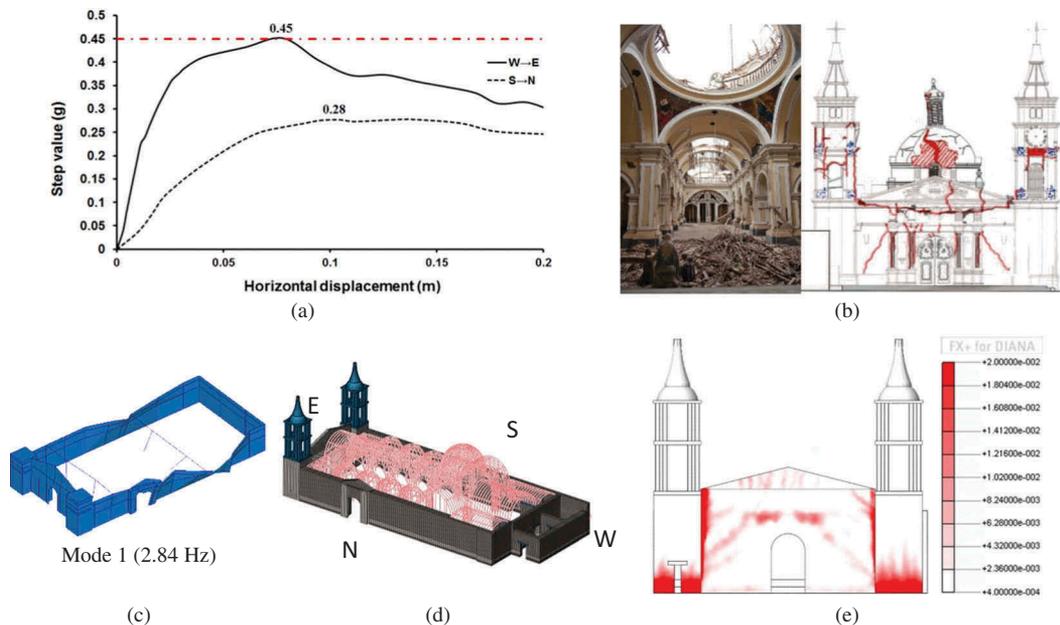
**Figure 7.** Ica Cathedral: (a) Selected capacity curves for two principal directions; (b) crack pattern of east facade (right) and collapsed main dome and barrel vault (left); (c) first mode shape from dynamic in-situ tests, with geometric interpolation; (d) FE model in 3D view; and (e) plot of maximum principal strain distribution at load step near collapse.

areas with the choir loft are well correlated with damage observed in-situ, as shown in Figure 7. The out-of-plane capacity of the north lateral wall is 0.28 g, much lower than the capacity demand of 0.45 g for the region. Several flexural cracks were observed along the transversal adobe wall at the interface with the rubble stone base course, together with vertical cracks at the connection with the transept, confirming again the existing damage (Ciocci, Sharma, and Lourenço 2017) (Lourenço et al., 2017).

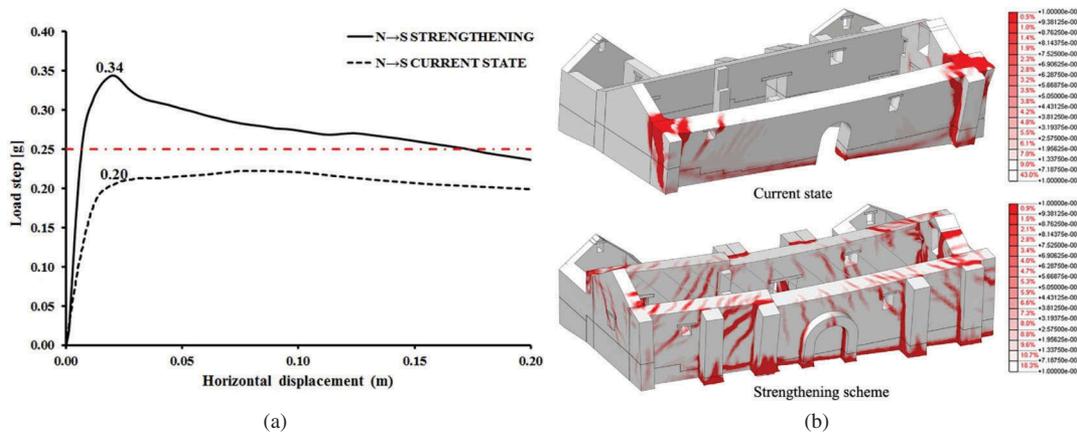
Due to the addition of new buttresses and timber frames, the structure presents a stiffer response, with a shift towards higher frequencies. The first out-of-plane mode for the lateral walls of the nave is now 4.41 Hz (eigenvalue analysis), vs. 1.59 Hz in the current state (dynamic tests). Nonlinear pushover analyses, under mass proportional lateral loading, were performed in all principal directions and the overall performance has greatly improved. The redistribution of seismic loads between transverse and longitudinal walls is now ensured, and the capacity reached is higher than the design requirement from the Peruvian seismic code, with a minimum safety margin of 1.5. In the direction of the weakest capacity (N→S), the strengthening scheme presents a substantial higher capacity of 0.34 g, increased by 70%, compared to that of the current state. As shown in Figure 13, an evident change on the failure mechanism occurs from the out-of-plane overturning of the entire south wall. The bond beams, corner keys and buttresses increase the stiffness and allow the lateral walls to deform in out-of-plane bending, while activating the transversal walls. Cracking at a load step near collapse, is more widely spread, with smaller crack widths, compared to the large cracks of almost 10 cm of the current state (Karanikoloudis and Lourenço 2016).

**Figure 13.** The Church of Kuño Tambo: (a) load-displacement diagram, at the top of the south wall. Note the seismic demand of 0.25 g (in red); and (b) distribution of maximum principal tensile strains for 20 cm of lateral displacement for the model at current and strengthening state. (Note that the results are from the numerical models with material properties updated by in-situ sonic tests.)

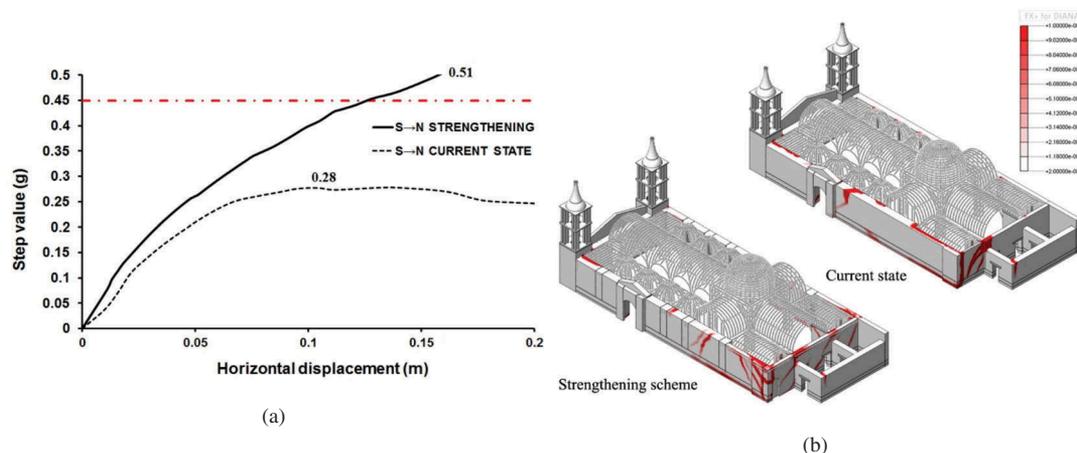
**Figure 14.** Ica Cathedral: (a) load-displacement diagram, at the top of the north wall. Note the seismic demand of 0.45 g (in red); and (b) distribution of maximum principal tensile strains for 20 cm of lateral displacement for the model at current and strengthening state.

The results obtained from the pushover analysis performed applying mass proportional loading in the N→S direction show a ductile progression of flexural cracks in the northwestern corner (Figure 14). The value of lateral load that could be applied to the model is higher than the seismic demand recommended for the region of Ica, with an increase of more than 60% when compared to the current state. In the other direction, the lateral capacity increases by 15% when compared to the current state, reaching a value equal to 0.45 g. The failure mechanism is identified in this direction is the out-of-plane overturning of only the southern bell tower, replacing the out-of-plane overturning of the whole front façade including the bell towers that was observed for the model without strengthening. As a result, the implemented strengthening techniques, which mostly improve the quality of the connections between the two sub-structures, reduce effectively the out-of-plane vulnerabilities and increase the capacity of the structure, higher than the seismic demand.
