Engineering Geology

Distribution and failure modes of the landslides in Heitai terrace, China

Dalei Peng^a, Qiang Xu^{a,*}, Fangzhou Liu^b, Yusen He^c, Shuai Zhang^d, Xing Qi^a, Kuanyao Zhao^a, Xianlin Zhang^a

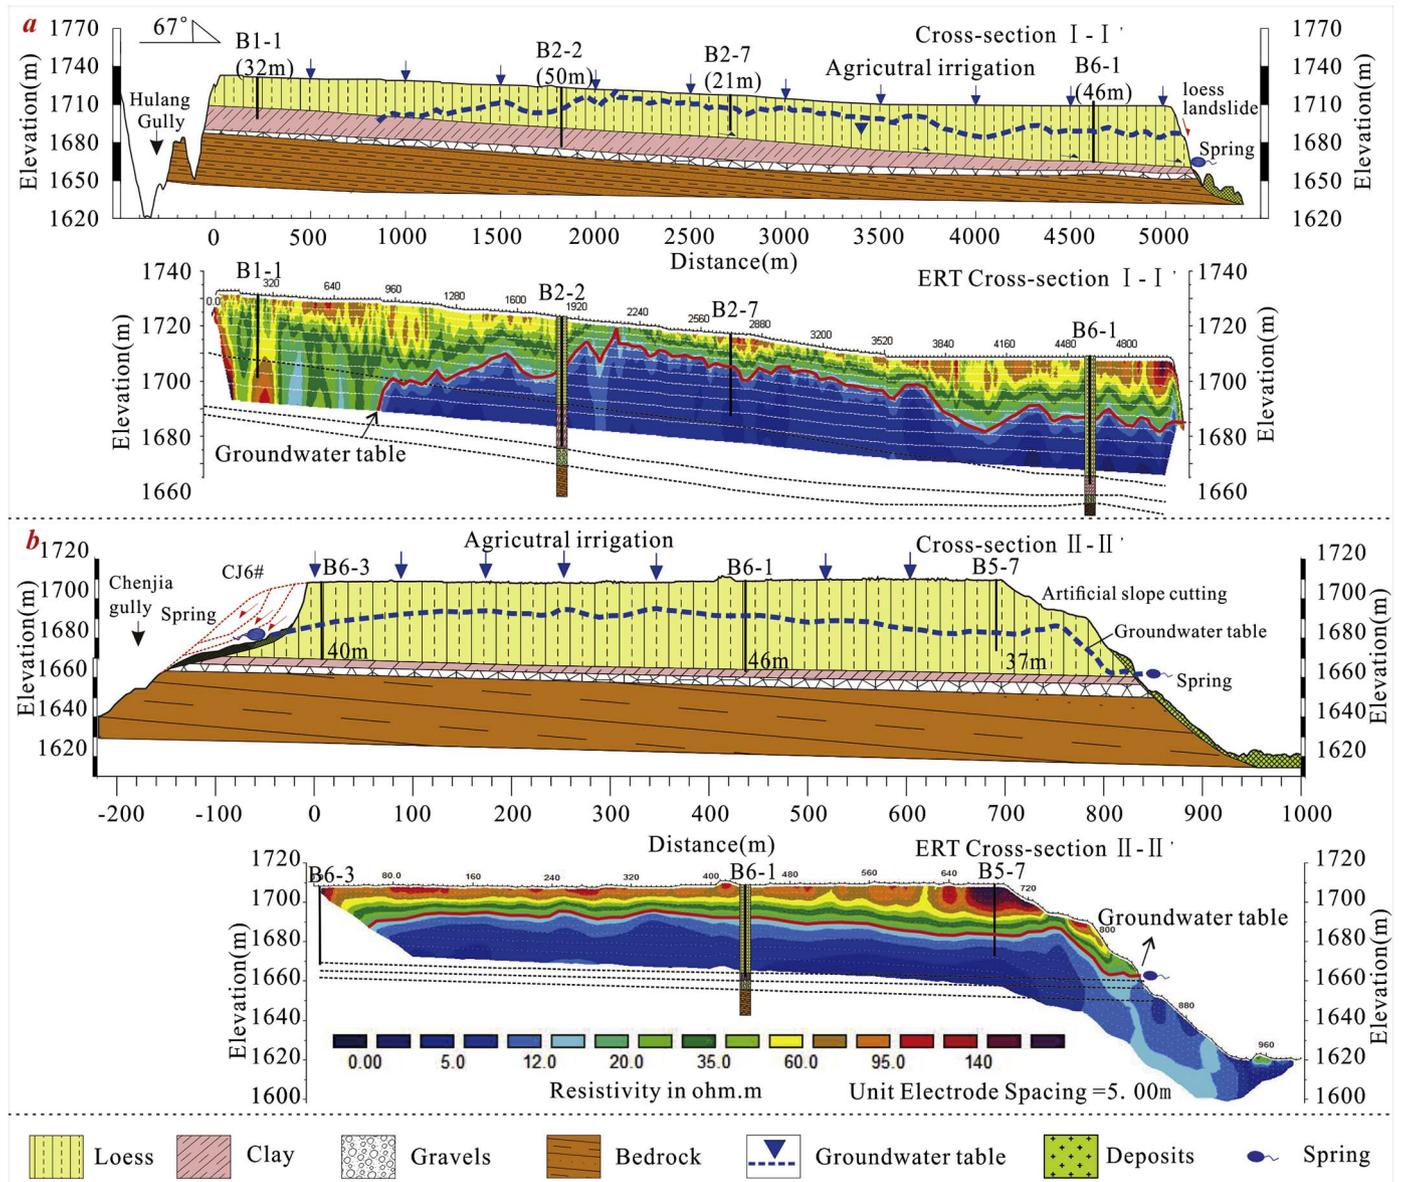
The distribution and dynamic groundwater is a key factor in understanding the distribution of landslides in Heitai. Groundwater level in the study site was mapped by using field data from 6 monitoring wells and 2 profile lines from the electrical resistivity tomography (ERT) survey across the east part as well as the longitudinal center of the terrace (Fig. 4). The 2-D resistivity images of the subsurface water content were produced from a detecting line (segment length 300 m) with 61 steel electrodes at 5 m spacing. In consideration of the overall length of the survey lines (> 1 km and 5 km, respectively), effective depth of detection, and accuracy of the results, each segment of the profile line has an overlap of 100 m. Each measurement takes about 90 min and was repeated three times. The coordinates of electrodes were calibrated by ground GPS to ensure a straight line on the same profile with precise elevation. Well data were used to validate the ERT survey, which indicated a margin of error of ± 0.5 m for the groundwater level variation, and the apparent spring lines on the slope surface confirmed the groundwater mapping results. The ERT survey shows that the groundwater level is higher on the west of the terrace with the maximum elevation difference of 30 m (Fig. 4a). In the profile line II-II', the groundwater level dropped along the slope geometry of the cut

slopes in S5 (Fig. 4b), of which the variations play a critical role in the landslide types in S5.

Fig. 4. Electrical resistivity map and geological cross-section across the east part and the longitudinal center of the terrace. (a) Variations of groundwater table in Heitai (from SW to NE); (b) Groundwater table next to JJ#4 showing significant drop after slope cutting in S5. Profile locations see Fig. 1d.

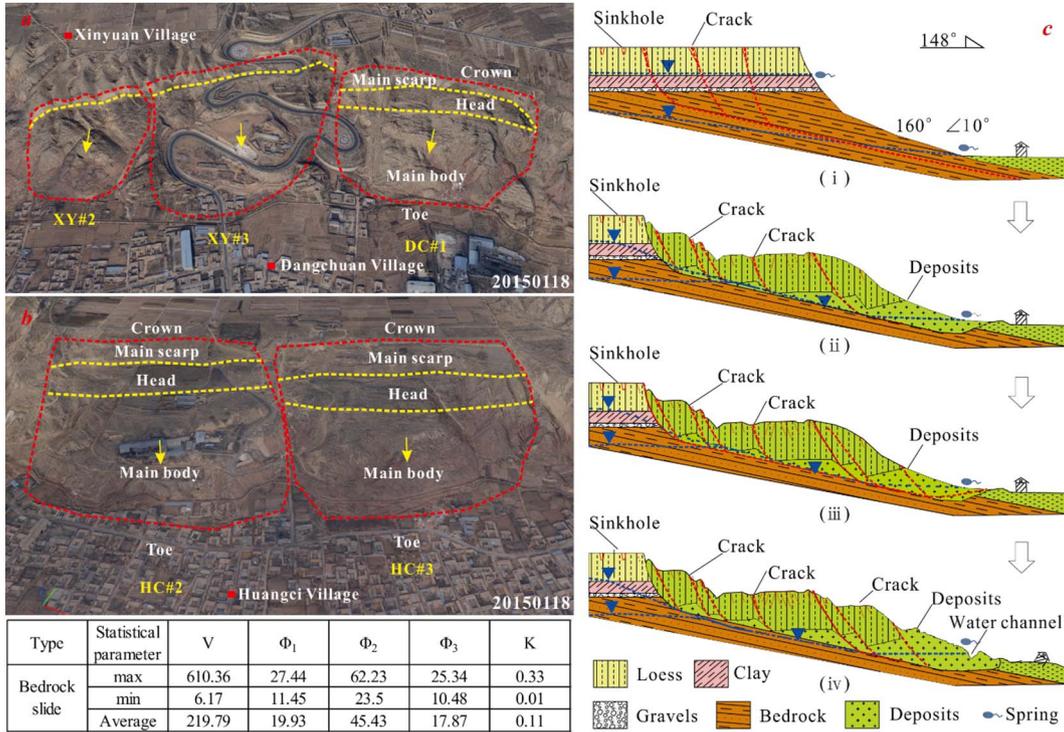
This landslide type and its failure mode is illustrated in Fig. 5 and an example is the HC#3 landslide in S3. The HC#3 loess-bedrock landslide occurred on Jan 30, 1995 (vol. 6×10^6 m³), and followed by another failure at the same location on May 14, 2006 (vol. 3×10^6 m³). The

entire failure process in 2006 spanned over 90 mins with an estimated travel velocity of 0.005 m/s and a runout of 30–60 m. The scarp of HC#3 retreated over 10 m as the second landslide developed at the previous site. A multi-level terrace was formed on the slope after the failures.

The seepage of groundwater on the slope surface results in the apparent spring line above the alluvial clay layer as well as on the bedrock slope, indicating a saturated basal zone in the overlaying loess layer and groundwater infiltrations along the bedding plane of the bedrock. Cracks are firstly formed at the surface of the terrace, and are likely to be caused by 1) the deformation of the saturated base of the loess layer and 2) unloading due to the preceding landslides. The cracks subsequently propagate from the overlaying loess layer to the bedrock forming the failure surface. Field evidence of the surface cracks is shown in Fig. 5. As deformation continues and cracks propagate into the bedrock, it provides flow passage for the ingress of groundwater along the bedding plane, which erodes the bedrock reducing resistances

Fig. 5. Loess-bedrock planar slide. (a) slides in S1; (b) slides in S3; (c) Failure model of loess-bedrock planar slide. Geometric characteristics of planar slides are tabulated. Landslide locations see Fig. 1b.

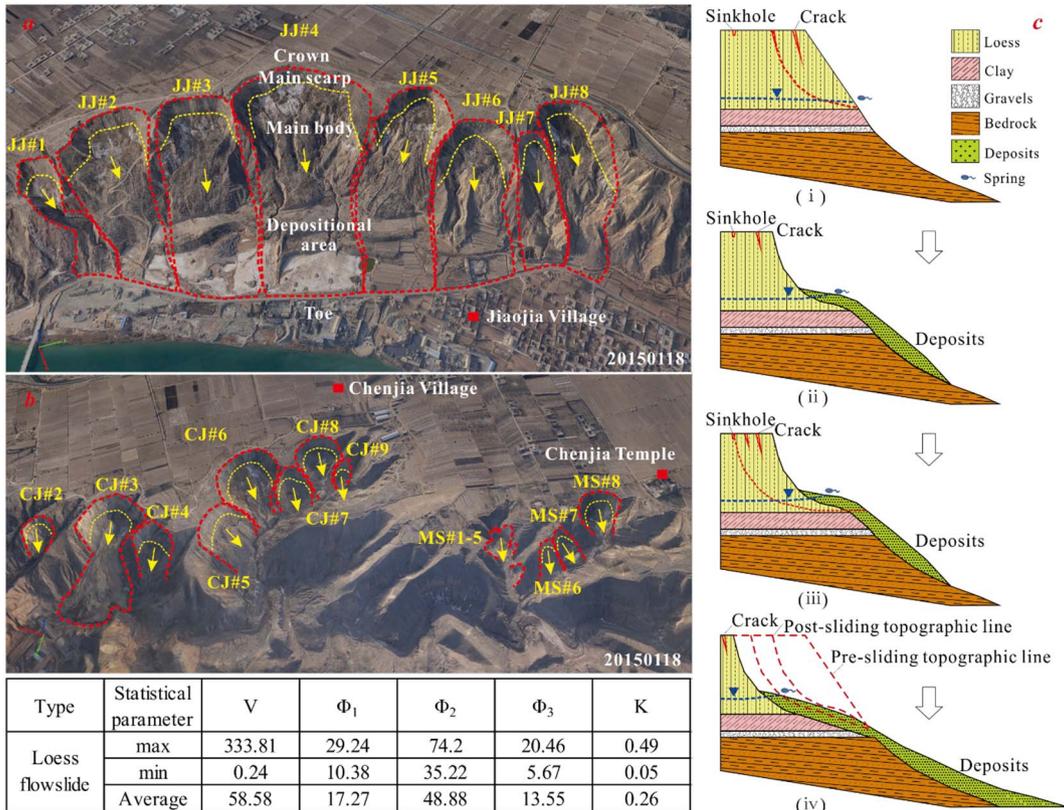
Fig. 6. Loess flowslide. (a) flowslides in S5; (b) flowslides in S7; (c) failure mode of loess flowslide showing retrogressive behavior resulted in significant slope retreat along the edge of Heitai. Geometric characteristics of flowslides are tabulated. Landslide locations see Fig. 1b.

The failure mechanism of loess flowslide is analyzed in detailed by Qi et al. (2017). As illustrated in Fig. 6, the failure surface was developed entirely within the loess layer. The retrogressive behavior typically involves a two-staged failure process associated with the groundwater flow in the terrace as well as behind the backwall of the preceding failure. At the 1st stage, as the location of the apparent spring line indicates, groundwater saturates the base of the loess layer and discharges at the edge of the terrace. This leads to the collapse of the loess structure, which in turn, results in a progression of strain development in the overlying loess deposits. Post-peak shear strength is thus mobilized over an increasingly small area along the potential slip surface until failure of the remaining loess occurs. At this stage, the failure is small in volume occurring at a drained condition, but it intensifies the localized groundwater convergence behind the scarp, which increases the thickness of the saturated base and the pore-water pressure behind the scarp. With the displaced material being deposited above the

apparent spring line, an undrained condition develops behind the scarp, where excess pore-water pressure may be induced by micro-shearing of collapsing void in the loess matrix (i.e. 2nd stage, defined by Qi et al., 2017), and it results in abrupt deformation and liquefied flow movement with long runout across a low-relief terrain. The retrogressive behavior of loess flowslide is likely to cause a new failure at the same location, and subsequently slope retreat by its very nature.

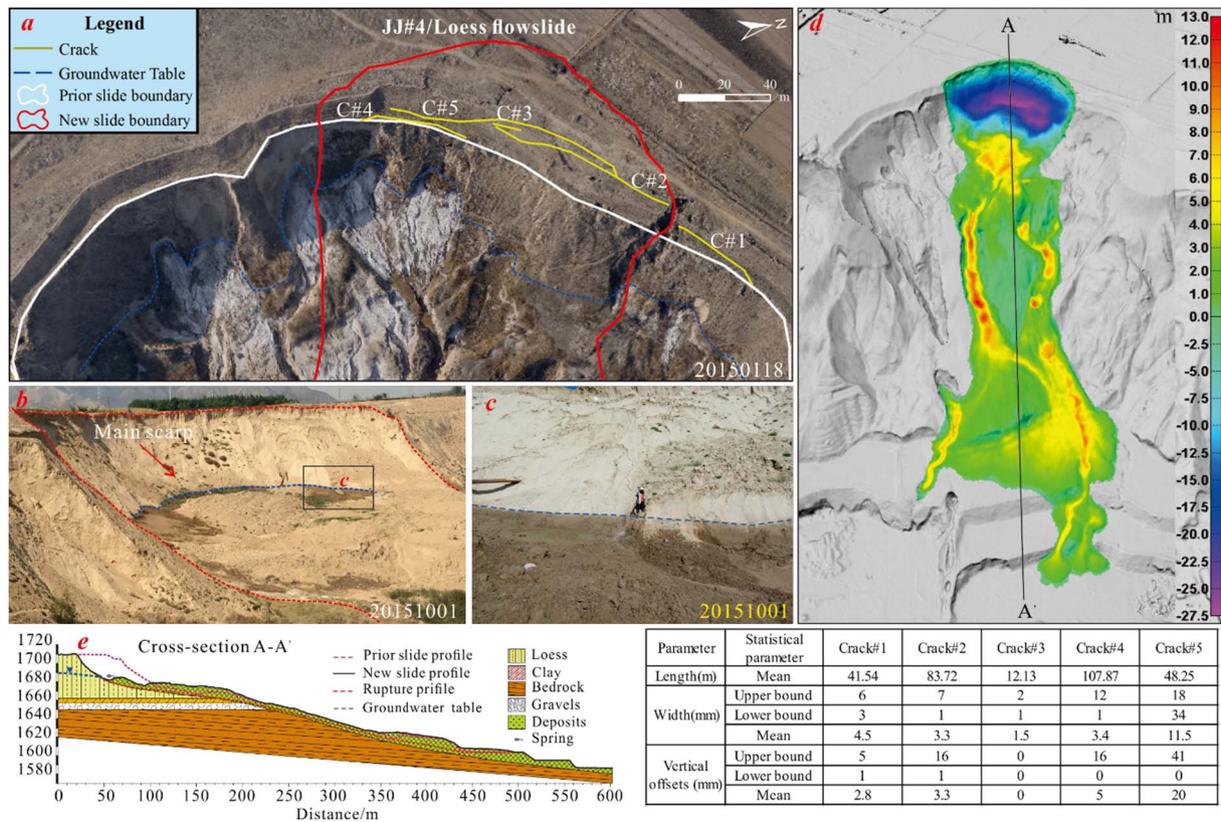
Fig. 7. JJ#4 loess flowslide in S5 (location see Fig. 1b). (a) Crown cracks, groundwater discharge, and landslide scarp boundaries (image taken on Jan 18, 2015); (b) A large amount of groundwater seepage ‘washes’ fine particulars in loess forming salt coating at the bottom of the main scarp (image taken on Oct 1, 2015). (c) Evident boundary between the landslide scarp and saturated deposit; (d) Surface elevation change of the loess flowslide estimated by using the pre- and post-failure DEMs; (e) geological profiles of JJ#4. Pre-sliding (occurred on Jan 26, 2015) crown cracks are summarized and tabulated.

A large amount of groundwater seepage and salt coating can be seen at the head of the displaced material before failure, indicating saturation and the removal of fine particles in the loess element. The failure is exemplified by the JJ#4 flowslide as shown in Fig. 7. Surface cracks with a width of 1–18 mm and vertical offsets of 1–41 mm are common at the crown due to unloading from the previous failures.

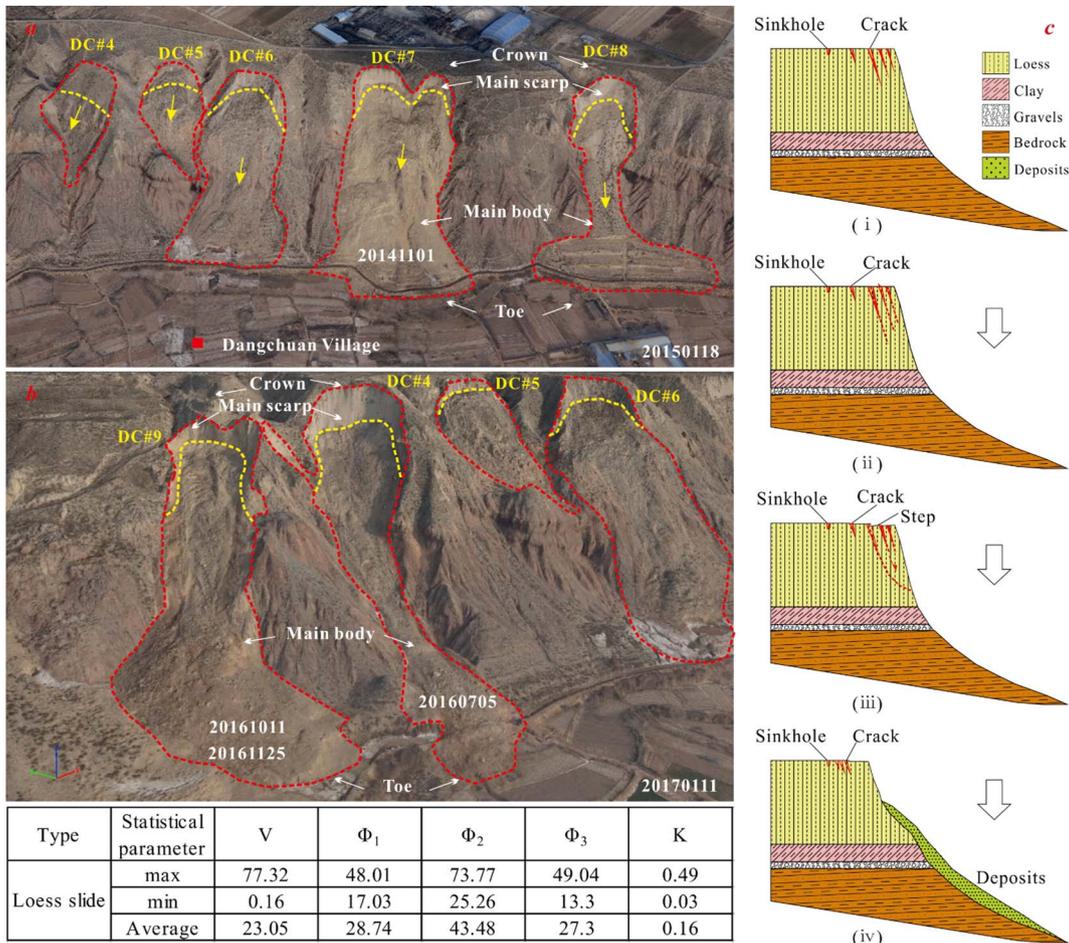
As shown in Fig. 8, similar to loess flowslide, saturation of the basal zone of the loess layer led to strain-softening and deformation. The unloading crown cracks are common prior to loess slide (Fig. 9), with width ranging from 5 to 420 mm and vertical offsets of 10–400 mm.

Fig. 8. Loess slide. (a) slides in S2; (b) slides in S2 showing new failure in DC#9; (c) Failure mode of loess slide showing the formation of crown cracks and failure. Geometric characteristics of slides are tabulated. Landslide locations see Fig. 1b.

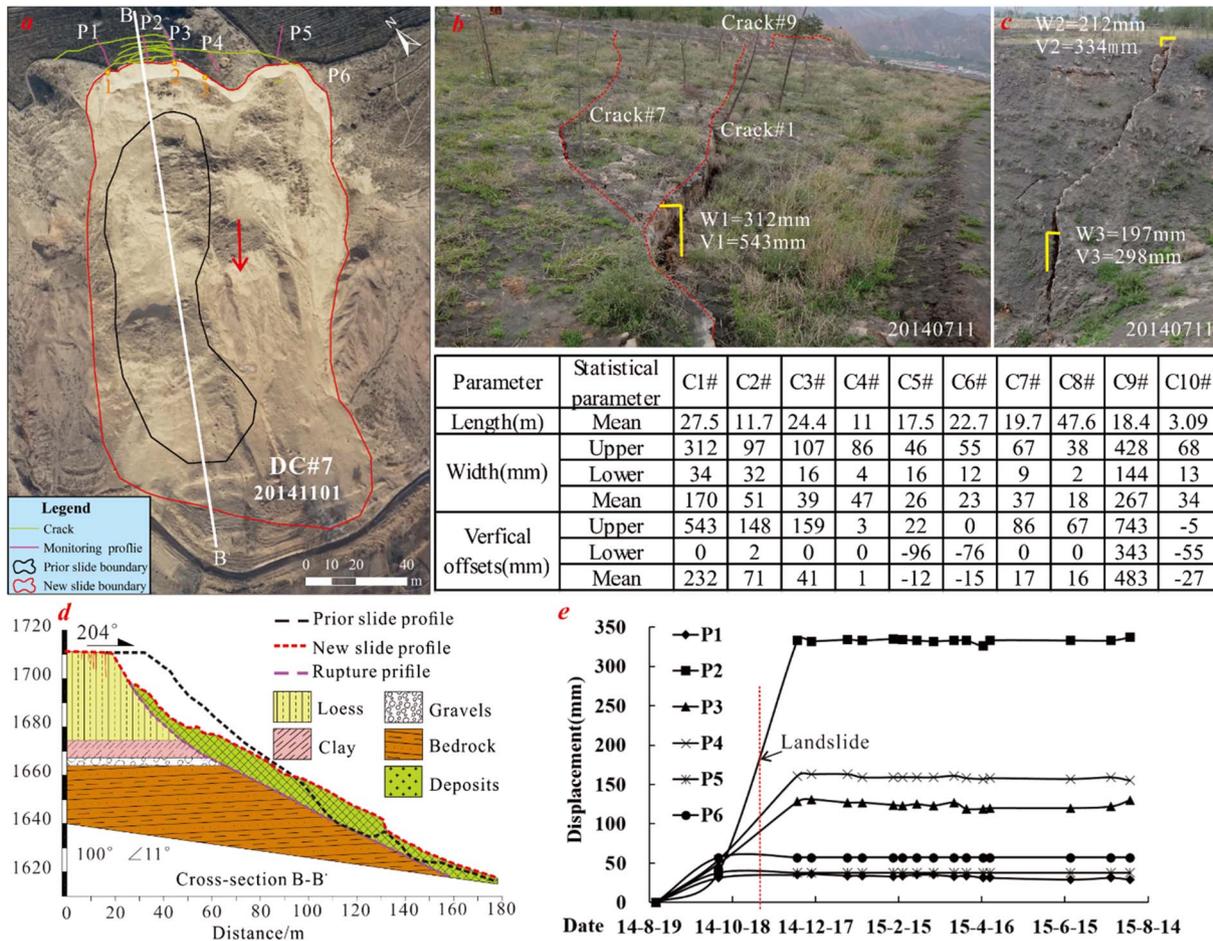
Fig. 9. DC#7 loess slide in S2 (location see Fig. 1b). (a) Crown cracks, groundwater discharge, and landslide scarp boundaries; (b) crown cracks; (c) cracks at the flank of the slide; (d) geological profiles of DC#7; (e) field monitoring on the crack deformation by measure relative changes of surface markers (Aug 24, 2014–Aug 1, 2015); Pre-sliding (occurred on July 19, 2014) crown cracks are summarized and tabulated.

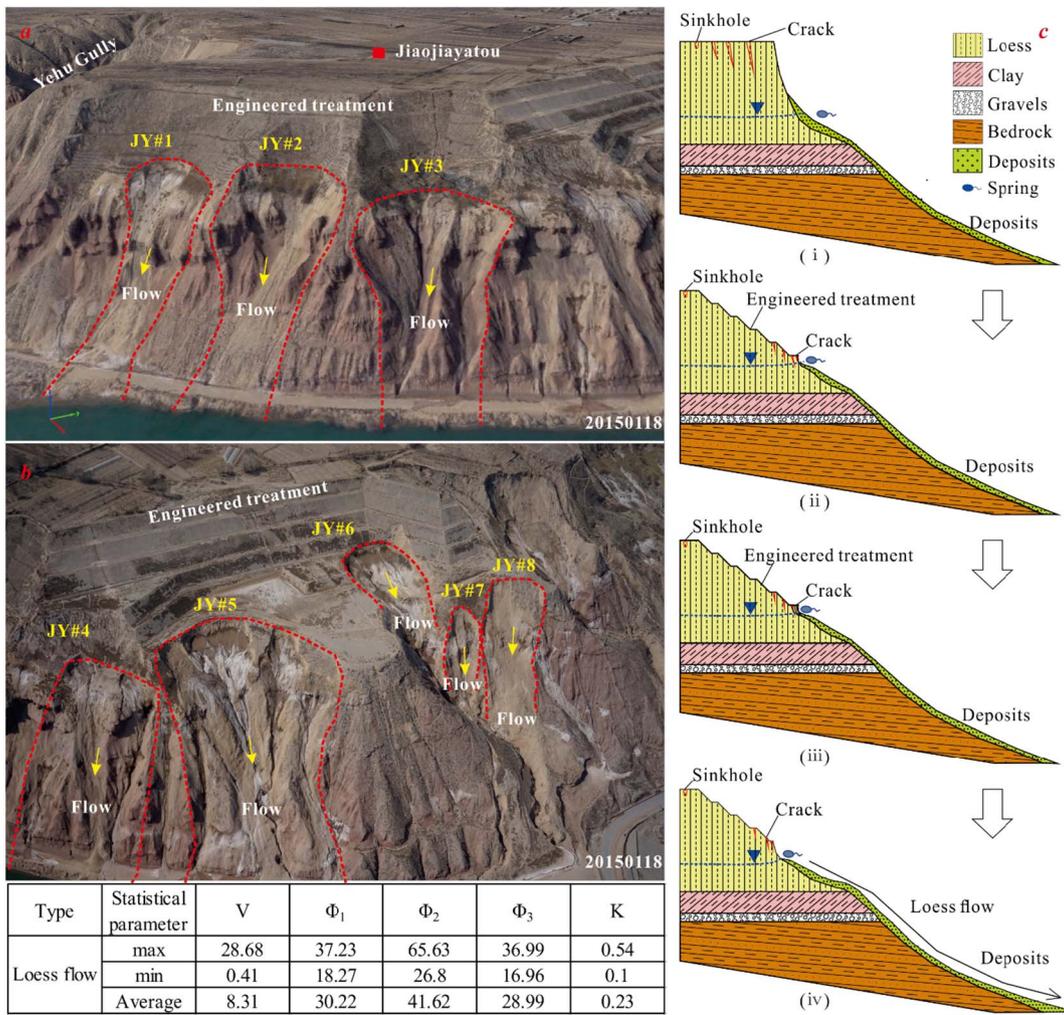
sults in a different type of loess landslide exhibiting a more flow-like failure. The loess flow exhibits slurry-like movement at a much smaller velocity and magnitude. Such type is observed only on the engineered loess slopes in S4 (Fig. 10). The volume of the loess flow ranges from 4×10^3 to $2.9 \times 10^5 \text{ m}^3$ with an average of $8.3 \times 10^4 \text{ m}^3$, which is typically smaller than other types of landslide in Heitai.

Man-made excavation reduces the surcharge imposed on the slope, resulting in a more localized failure with comparatively smaller size of deposit. The loess flow may be ascribed to the drastic drop of groundwater level at the edge of the terrace as shown in Fig. 4, which generated a smaller hydraulic gradient between the scarp and flanks of the landslide (Fig. 10). Based on the role of groundwater and landslide deposit interaction analyzed for loess flowslide and loess slide, the size and volume of loess flow deposit is not sufficient to impede groundwater seepage at the edge to create an undrained condition, and thus no excess pore-water pressure can be generated at the failure state.

Fig. 10. Loess flows. (a) and (b) flows in S4; (c) Failure mode of loess flow; Geometric characteristics of flows are tabulated. Landslide locations see Fig. 1b.

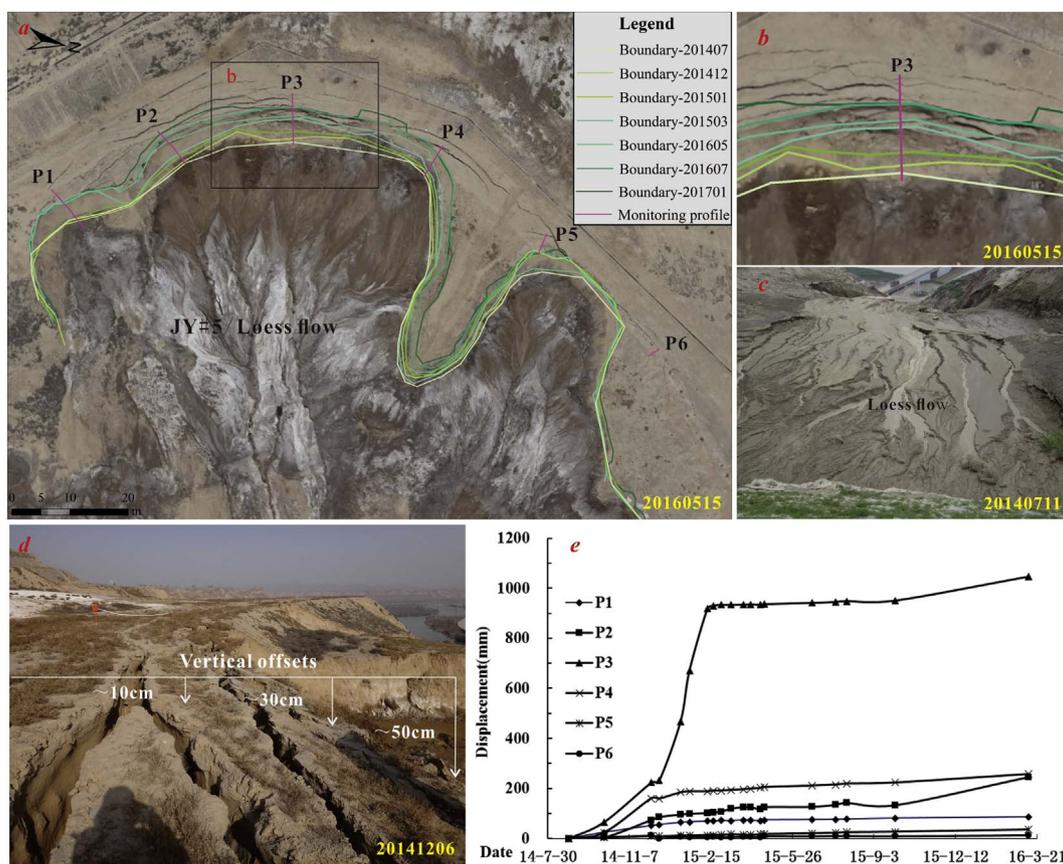
Loess flow typically occurs in the engineered slopes where the thickness of loess is 5–10 m. In the case of the JY#5 loess flow, field evidences in Fig. 11 shows a large amount of seepage and leaching of finer particles at the head of the deposit. Crown cracks have width of

20–600 mm with vertical offsets of 10–400 mm, which are accompanied by evident subsidence in the crown area and a slight bending motion that are similar to toppling failure. Loess flow in S4 is almost constant with no evident seasonal variation in the magnitude and velocity.

Fig. 11. JY#5 loess flow in S4 (location see Fig. 1b). (a) Boundaries of the most recent seven landslides (July 2014–Jan 2017), and cracks and monitoring profiles (image taken on May 5, 2016); (b) Enlarged monitoring profile P3; (c) A large amount of seepage and salt coating the bottom of the main scarp (photo taken on July 11, 2014); (d) Vertical offsets at the crown of loess flow varying 10–50 cm; (e) Field monitoring on the crack deformation by measure relative changes of surface markers (Aug 25, 2014–Mar 11, 2016).
