# Failures of masonry dwelling triggered by East Anatolian Fault earthquakes in Turkey

Burak Yön<sup>a,\*</sup>, Onur Onat<sup>a</sup>, Mehmet Emin Öncü<sup>b</sup>, Abdulhalim Karaşin<sup>b</sup>

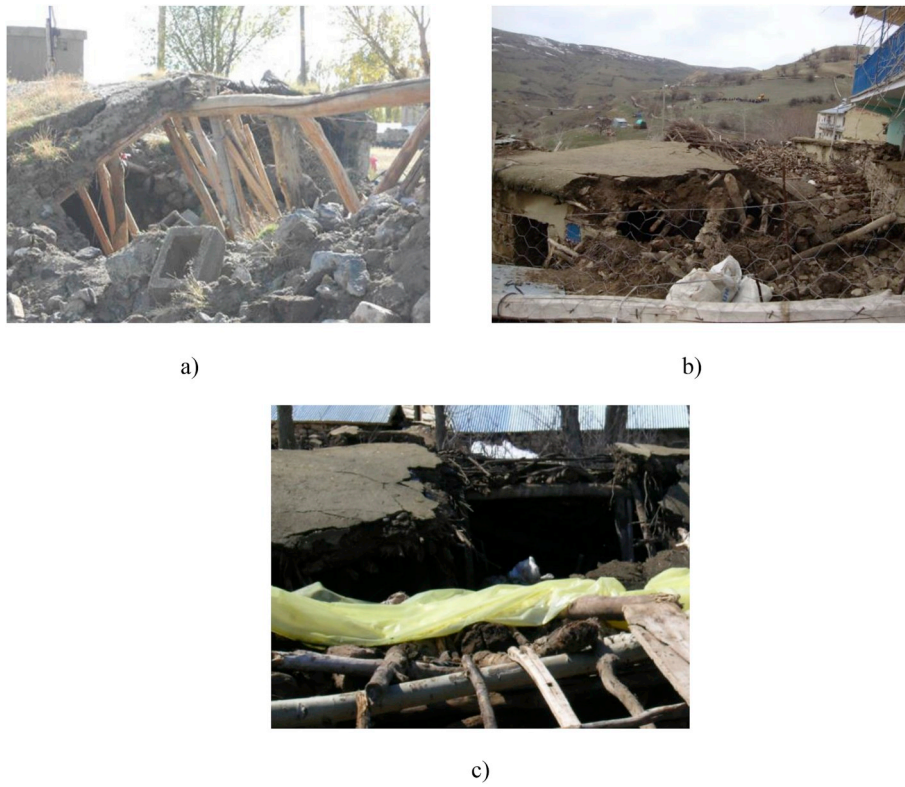
resistance of these type of structures is weak because they are designed to resist only vertical loads. Heavy earthen roofs increase the mass of the structures and cause large inertial forces during the ground motions. Field observations of the authors present that heavy earthen roof collapse occurs due to the combined effect of soil amplification, increasing lateral inertial forces causing heavy damages. Fig. 11 illustrates these failures.

Fig. 11. Heavy earthen roof damage: (a) Van (Photos by B. Yön, M. E. Öncü); (b) Kovancılar (Photos by B. Yön, M.E. Öncü, A. Karaşin); (c) Bingöl (Photos by A. Karaşin, M.E. Öncü).

From the observations, it is seen that the heavy earthen roofs caused heavy damages due to increasing the mass of the structures and caused large inertial forces during the earthquakes.

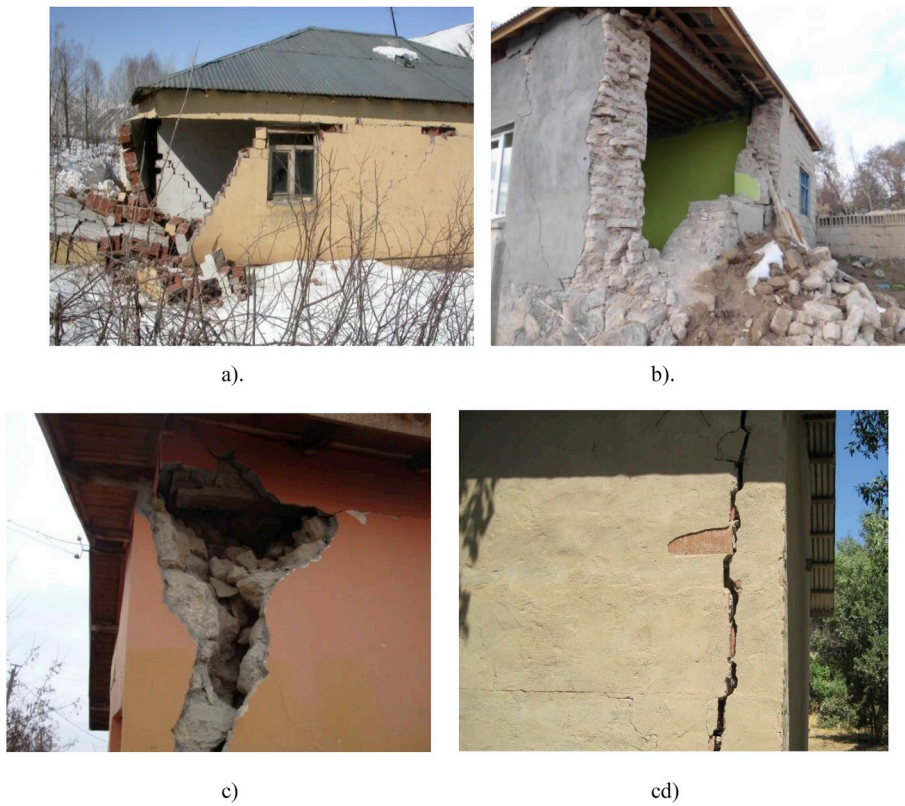
Corner damages occur at wall-to-wall connections when subjected to out-of-plane deformations due to the lack of connection between load-bearing walls. Bad workmanship (Fig. 12b,c) and low material quality (Fig. 12b,c) resulted in the failure of the masonry dwellings. Also, similar damages can occur at the intersection (Fig. 12a,d) of the wall and the floor or roof. To prevent these damages and increase the earthquake performance of masonry structures, the TSC requires reinforced concrete vertical bond beams. Corner damages were common in the masonry structures in the earthquake regions. Weak connections between walls and the absence of bond beams caused considerable damages. In addition, it should be emphasized that there were no suitable connections at the corners of the walls of damaged buildings. This type of damage for

Fig. 12. Corner damages in masonry structures, a) Bingöl (Photos by M.E. Öncü, A. Karaşin), b) Van (Photos by B. Yön, M. E. Öncü), c) Kovancılar (Photos by B. Yön, M.E. Öncü) and d) Maden (Photos by B. Yön).

masonry structures is presented in Fig. 12.

Corner damages were common in the masonry structures in the earthquake regions. Weak connections between walls and the absence of bond beams caused considerable damages. In addition, it must be emphasized that there were no appropriate connections at the corners of walls in the damaged buildings. The solution procedure for existing structures can be solved by applying anchorage wall-to-wall and wall-to-vertical-girder by using a steel plate and nail to fix.

To limit corner damage effects, reinforced concrete vertical bond beams, which increase the lateral stiffness of masonry buildings, should be used. Fig. 13 illustrates vertical bond beams at load-bearing walls required in the TSC. In these beams, the compressive strength of concrete should be at least 16 MPa, and Ø8 stirrups and a maximum spacing of 200 mm should be used together with longitudinal reinforcement.

These bond beams should be used for the entire height on the corners of the buildings, along the intersections of the load-bearing walls. The cross section of these beams should be equal to the thickness of the walls that intersect at the corners of the buildings. Furthermore, the other cross-sectional dimension should not be less than 200 mm.

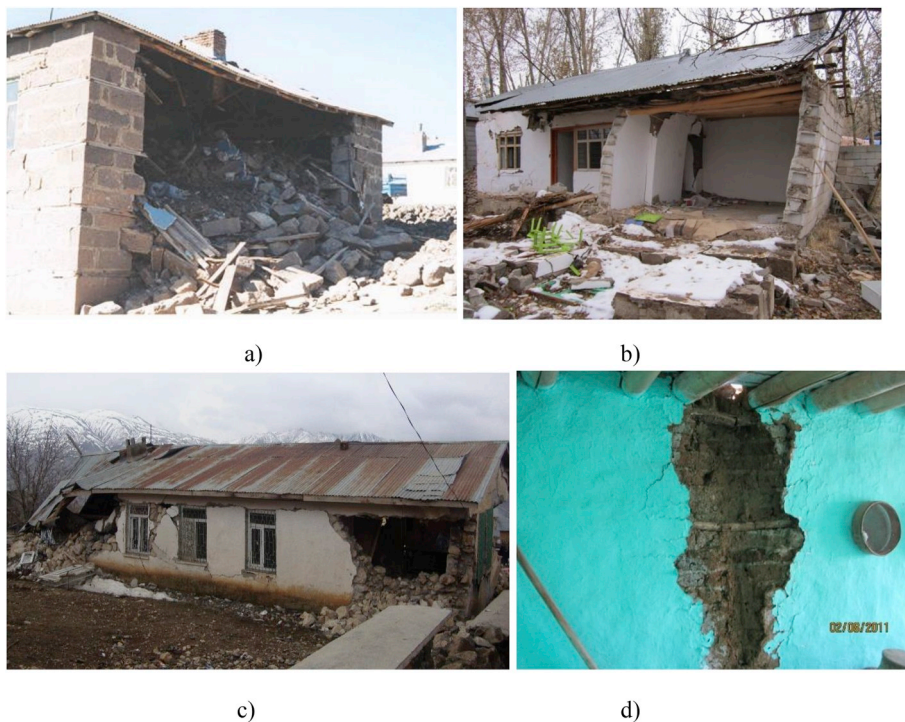
Fig. 15. Out-of-plane collapse of bearing walls in structures: (a) Bingöl (Photos by A.Karaşin, M.E. Öncü); (b) Van (Photos by B. Yön, M.E.Öncü); (c) Kovancılar (Photos by B. Yön, M.E.Öncü, A.Karaşin); (d) Maden (Photos by B. Yön).

mechanism represents especially brittle response compared to in-plane mechanism. Improper connections between two orthogonal walls, wall-to-floor connection or wall-to-roof connection, large unsupported wall lengths, absence of bond beams cause the out-of-plane failure mechanism. In addition, the stiff floor concept becomes important to prevent this type of failure mechanism. This floor creates a rigid diaphragm and provides unity of walls. Also, vertical and horizontal bond beams in the wall provide tensile and friction forces on the plane of the wall surface. If there is no girder on the wall, partial or complete overturning failure mechanism occurs. Fig. 14 shows various out-of-plane mechanisms. It was seen that the observed failure mechanism was commonly triggered by ignoring code requirements. Fig. 15 illustrates the out-of-plane mechanism of masonry structures.

There were many reasons of the out-of-plane failure mechanism such as improper connections between two orthogonal walls, walls and floors or roofs, large unsupported wall lengths, and absence of bond beams. This type of mechanism occurs when the entire wall or a significant part of it falls down during ground motions. This problem can be eliminated for existing masonry walls enclosed with a girder by reinforcement using polymer strips from corner to corner. Moreover, decreasing the useless dimensions of openings or closing the extra openings by bonding is another alternative solution to increase in-plane bearing capacity and prevent out-of-plane failure.

structures. The code requires that the maximum unsupported length of a wall should not exceed 5.5 m in the first seismic zone in the plan and 7.5 m in the second, third and fourth seismic zones in the plan. However, this unsupported length should not exceed 4.5 m in adobe buildings in all seismic zones (Fig. 16a). In addition, if these requirements are not provided, reinforced concrete vertical bond beams should be constructed along the full-storey height at the corners. Furthermore, these beams should be used every 4 m along the in-plane wall, and the unsupported wall length should not exceed 16 m (Fig. 16b).

The TSC requires that reinforced concrete horizontal bond beams should be used on the walls that support floors. These bond beams should be cast monolithically with the floors. The width of the horizontal bond beams and wall should be equal. The height of the horizontal bond beams should not be less than 200 mm. The concrete quality for the bond beams should be at least 16 MPa, and Ø8 stirrups and a maximum spacing of 250 mm should be constructed together with the longitudinal reinforcement. Figs. 17a,b illustrate the horizontal bond beams at the corner and intersection of the walls, respectively.

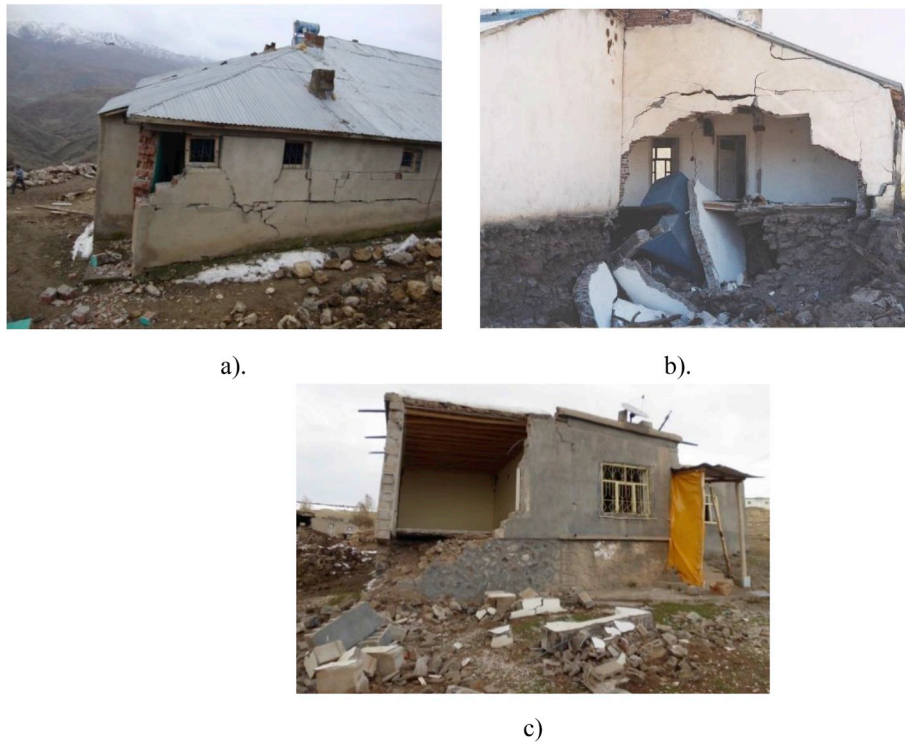
Fig. 22. Damages to structures located on sloping land a) Kovancılar (Photos by B. Yön, M. E. Öncü, A. Karaşin), b) Bingöl (Photos by M. E. Öncü, A. Karaşin) and c) Van (Photos by B. Yön, M. E. Öncü).

Structures located on sloping land or made-up ground can be damaged seriously. Foundation elevations of structures on slopes vary along the length of foundations in the plan. While one side of the structure can be on stiff soil, the other side can be on made-up ground. The side of the structure that with elevation lower than ground level is forced by lateral pressures arising from the soil. The increasing pressure during ground motion causes lateral movement of the structure. Fig. 22 shows damages arising from soil conditions.

The structures located on sloping or made-up ground were damaged

seriously due to the local soil features. The increased stress during the ground motion causes lateral movement of the structure. To prevent this movement, a retaining wall should be constructed.

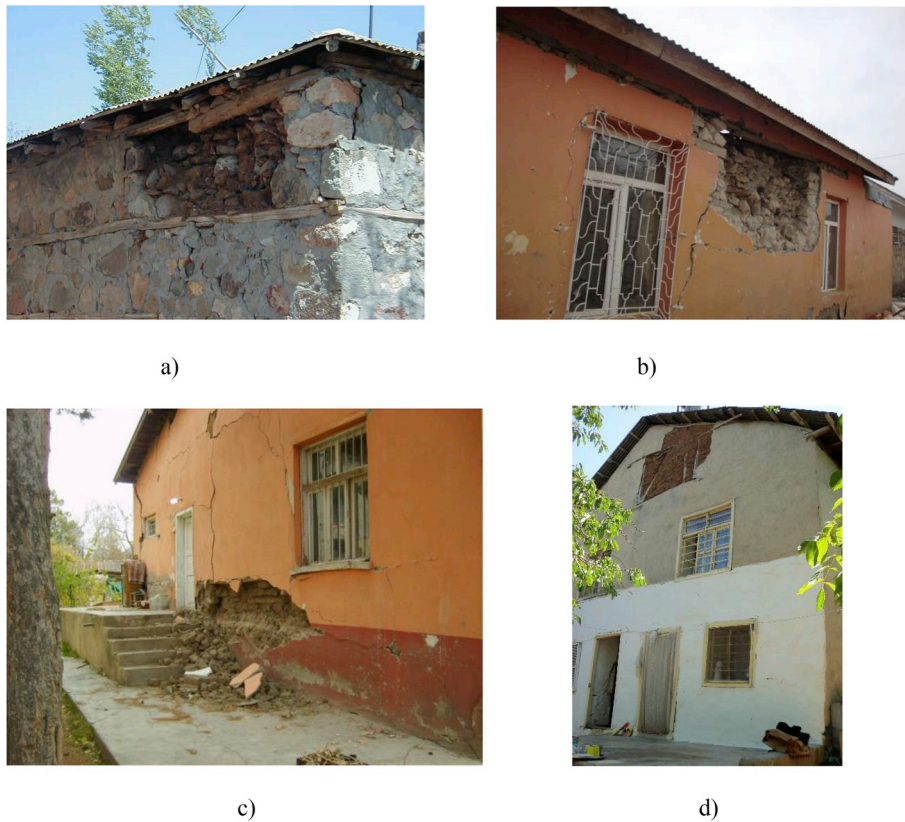
**Fig. 23.** Damages to masonry walls for various earthquakes, a) Bingöl (Photos by A. Karaşin, M.E.Öncü), b) Kovancılar (Photos by B. Yön, M. E. Öncü, A. Karaşin), c) Van (Photos by B. Yön, M. E. Öncü), d) Maden (Photos by B. Yön).

The in-plane mechanism was mainly observed as shear cracks. The earthquake resistance of masonry buildings is related to the shear strength of walls. Increased shear forces during earthquakes caused damages at walls and their connections. The suggested procedure for available structures propagating this type of damage on the masonry wall is to coat with steel mesh and anchor with nails and then to spray with shotcrete.

Many masonry buildings did not have sufficient and proper bond beams to enhance the lateral strength of the walls affected by earthquake. Furthermore, large openings that decrease the stiffness of the walls increased the shear effects. To limit this type of failure, the TSC

requires that reinforced concrete bond beams should be used (Figs. 13 and 17). Also, the requirements of the openings of load-bearing walls are illustrated in Fig. 21.
