Case Studies in Construction Materials

Case study

Corrosion assessment of reinforced concrete elements of Torre Velasca in Milan

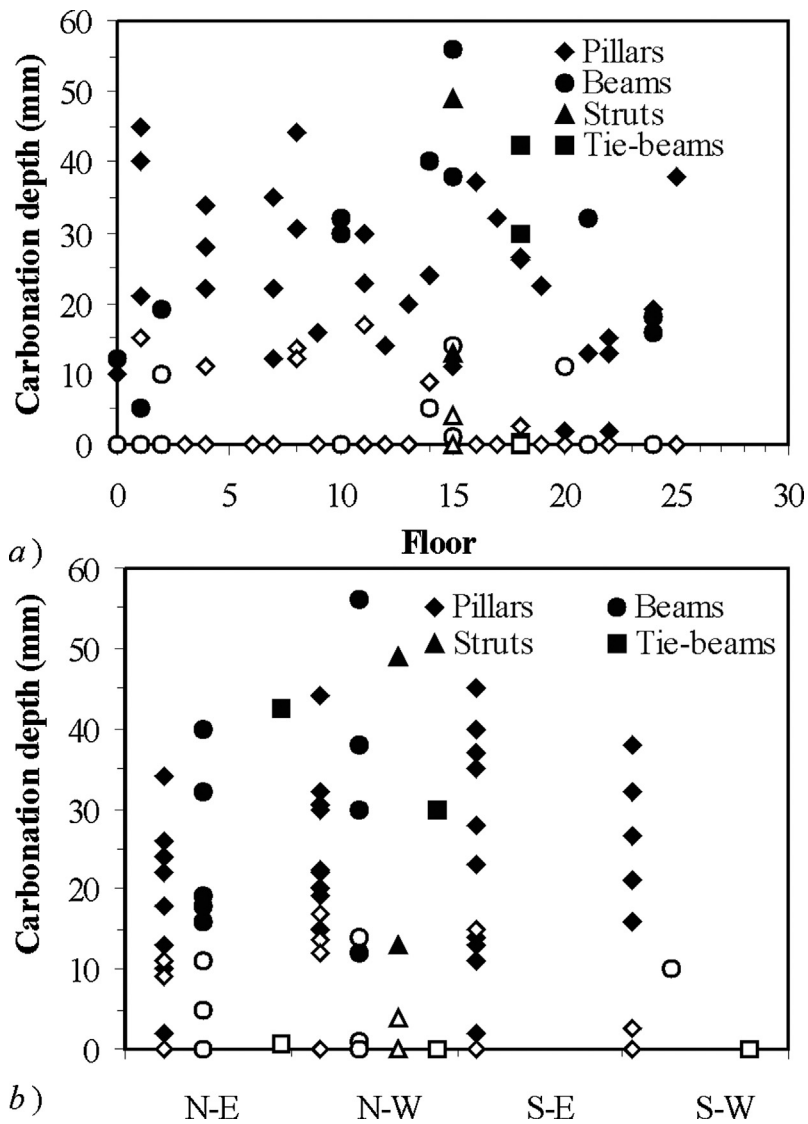
Regarding carbonation, in most of the samples the layer of render *R* was fully carbonated, while the carbonation depth of concrete was negligible. The total carbonation depth measured from the external surface ranged between 0 and 56 mm (Table 1). To investigate on possible factors influencing the carbonation depth, results of phenolphthalein tests were plotted versus the position of sampling. Fig. 4 shows, for each type of element, the carbonation depth as a function of the height (expressed as floor number) and orientation. Both the total carbonation depth (filled symbols) and the carbonation depth of the structural concrete (empty symbols) are shown. A systematic effect of either the type of structural element or the local exposure condition did not emerge. For instance, carbonation depths measured on cores taken from the intermediate part of the tower (from 16th to 18th floor), which is sheltered from the rain, were comparable with those measured on the lower and upper parts of the tower. This may be due to the variability of results, which is greater than the effect of local environmental parameters.

Fig. 4. Carbonation depth as a function of the floor (a) and orientation (b) where specimens were cored (filled symbols: total carbonation depth; empty symbols: concrete carbonation depth).

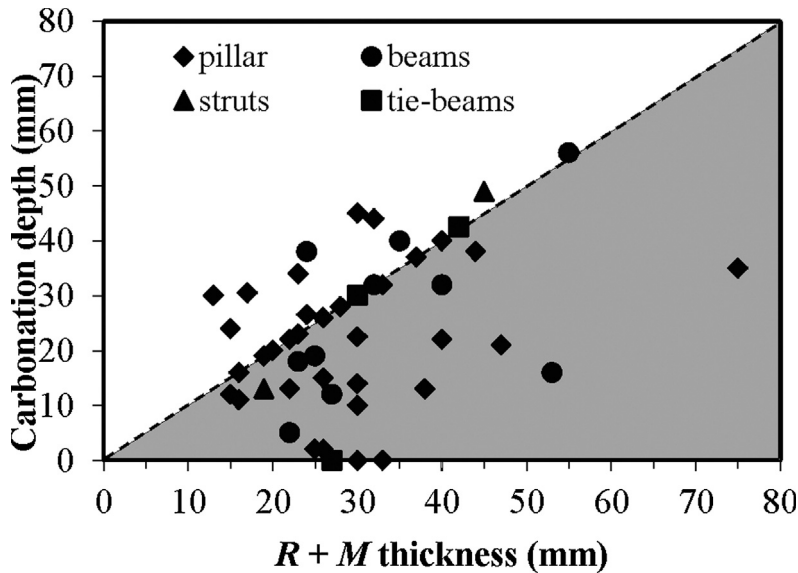
In order to investigate on the role of render and mortar layers on the penetration of carbonation, Fig. 5 shows the total carbonation depth as a function of the thickness of *R* + *M* layers: the grey area groups specimens with a carbonation depth that is lower than *R* + *M* thickness (i.e. concrete was alkaline), while the white area groups specimens where even concrete was carbonated to some extent. It can be clearly observed that in most specimens the carbonation front lays within *R* or *M* layers and, hence, the underlying concrete was barely carbonated. At the time of inspection, i.e. after about 50 years of exposure, even in the specimens with a *R* + *M* thickness of only 13 mm, the carbonation depth of concrete was lower than

20 mm. When R+M thickness was higher than 30–40 mm, carbonation of concrete was almost completely prevented, indicating that the render and mortar layers had an active role in hindering the penetration of carbonation.

Fig. 5. Relationship between $R+M$ thickness and total carbonation depth.

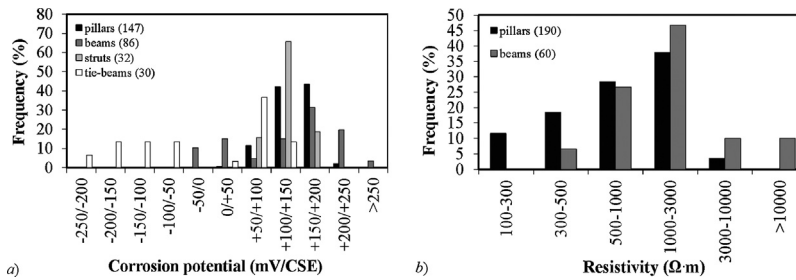
Potential values higher than 0 mV/CSE were measured on the rebars at floors below 15th and on some of the struts (Fig. 6a). The electrical resistivity, carried out on the external surfaces, without removing the render, was between 100 and 3000 $\Omega \times m$, with predominant values higher than 1000 Ωm (Fig. 6b). On the tie-beams the steel potential was measured on the surfaces more exposed to the rain and values between -200 and $+150$ mV/CSE were measured (Fig. 6a). The rather high values of electrical resistivity and corrosion potential, revealing that the elements below the 18th floor were relatively dry, even during rainy weather, suggested that the layers of render and mortar acted as a “barrier” and contributed to keep the humidity low in the inner concrete.

Fig. 6. Frequency distribution of steel potential of the reinforcement (a) and electrical resistivity (b) (number of data in brackets).
