Renovation of an alkali–aggregate reaction damaged swimming pool

Jukka Lahdensivu*, Jussi Aromaa

Ramboll Finland Oy, P.O. Box 718, FI-33101 Tampere, Finland

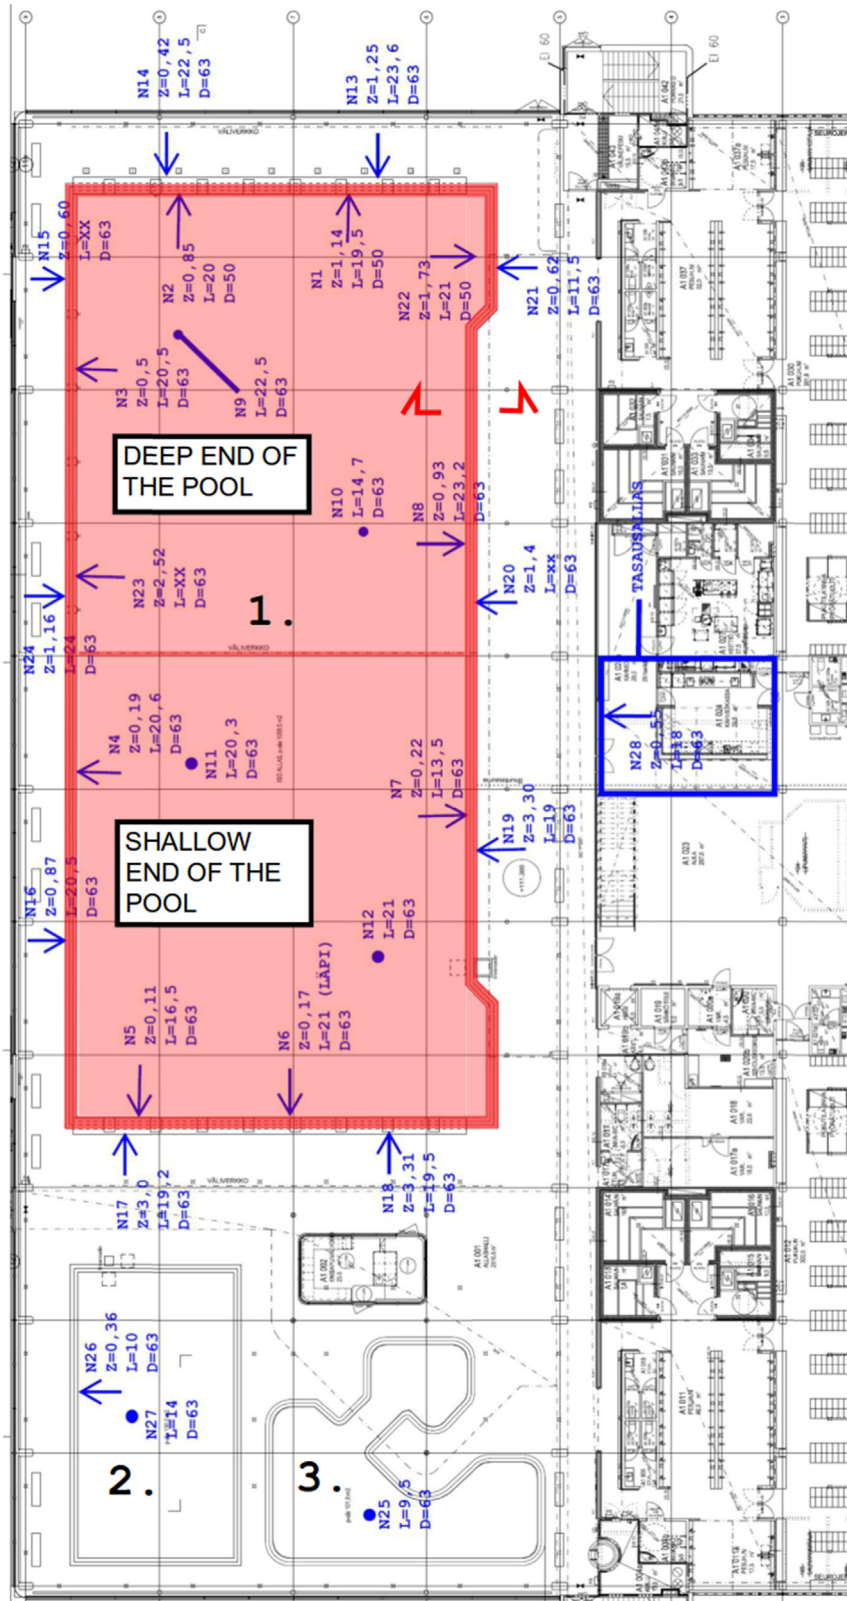
Fig. 1. Plan view of the pool complex and locations of taken concrete samples. The main pool is highlighted.

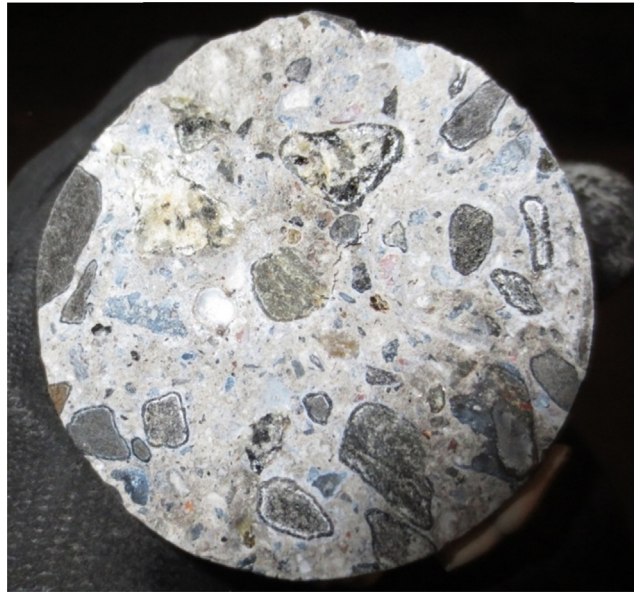
White void fillings were found in the sheared surfaces of concrete samples, see Fig. 2. SEM examination revealed that the white void filling material was alkali–silica gel. The white filling was typically discovered at a depth of 80–120 mm from the

Fig. 2. Alkali-silica gel in voids.

surface of a concrete sample. The cracking detected in 11 samples was considered to have been caused by drying shrinkage after casting. No cracks or disintegration were detected in any of the 17 samples.

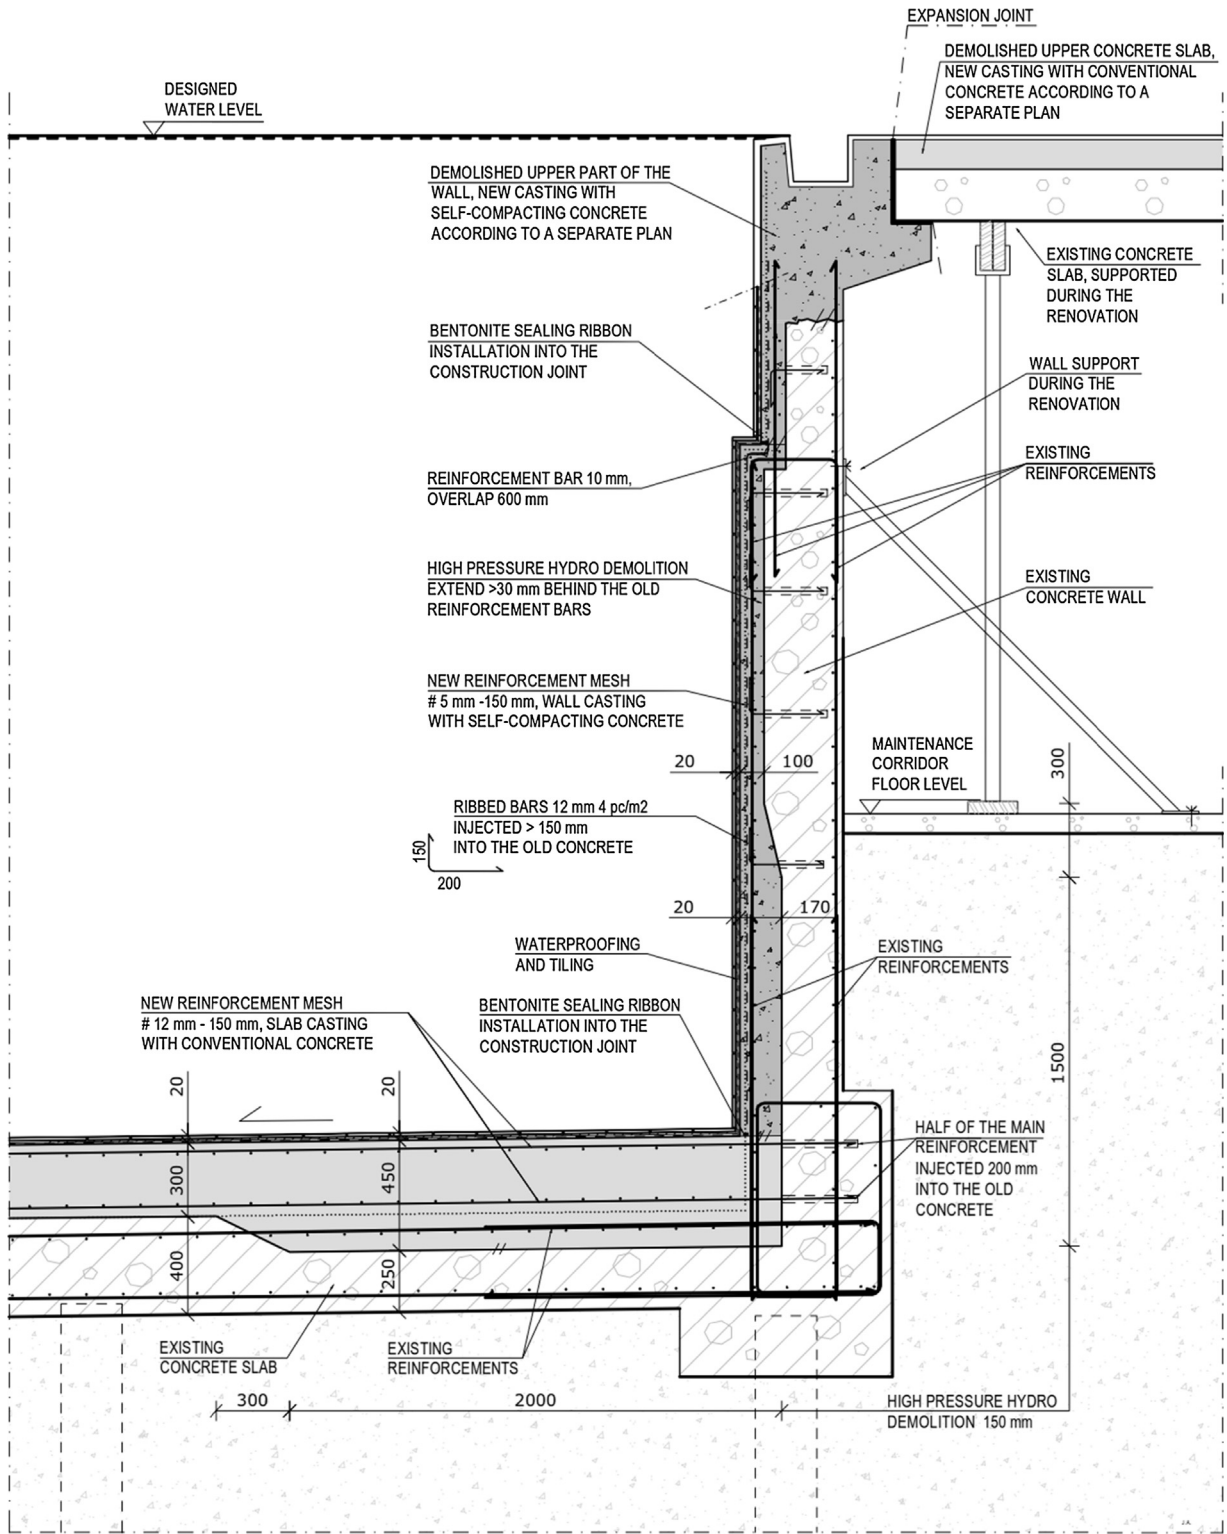
Fig. 3. Cross section of the pool. The grey parts are new concrete.

At the deep end of the pool, new water treatment pipes were installed on the old ground slab and a new reinforced slab 300 mm thick was cast on top of it, see Fig. 2. At the shallow end of the pool a new layer approx. 70 mm thick was cast of C32/40 concrete.

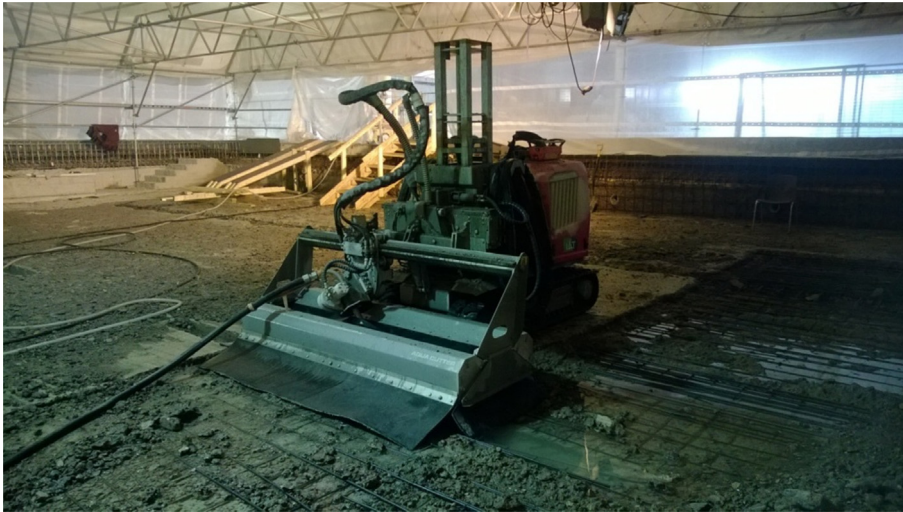
Fig. 4. The working width of the high-pressure water-jet cutter was 2 m. Concrete was removed under a temporary shield.

Approx. 70 mm of deteriorated concrete was removed from the upper parts of the walls using a high-pressure water-jet or a hydro-demolition robot, see Fig. 4. The aim was to penetrate 20–25 mm behind the existing vertical reinforcement and thereby ensure the durability of the old pool and the new concrete. Approx. 150 mm of deteriorated concrete was removed from the lower parts of the walls up to a height of 1500 mm from the ground slab. New and old concrete were joined with ribbed bars (\varnothing 12 mm, 4 pc/m²). At the deep end of the pool, a 2000 mm layer of the ground slab concrete was removed along the walls. At the shallow end of the pool, an approx. 70 mm layer of concrete was removed off the top of the entire ground slab to the level of the existing reinforcement.

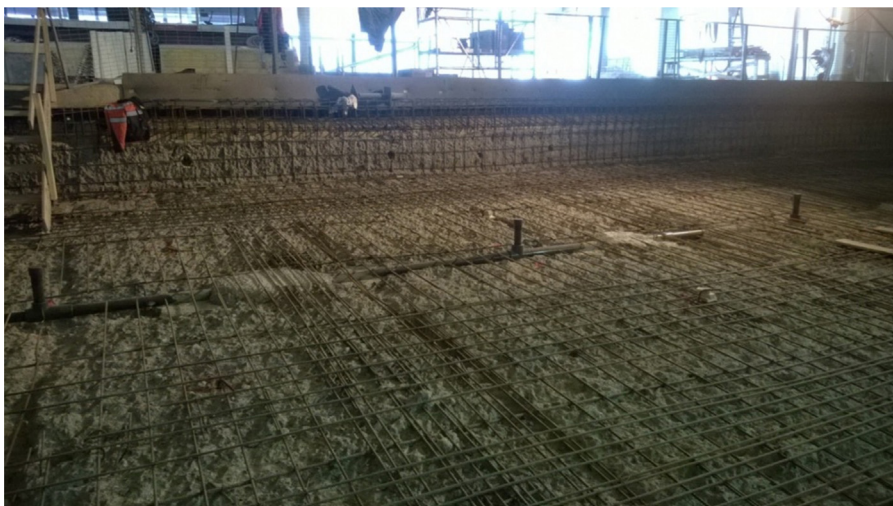
Fig. 5. Upper reinforcement of ground slab. New water treatment pipes were installed before reinforcement.

A temporary shield was built for using the high-pressure water jetting equipment and a hydro-demolition robot on the pool to keep splash water, moisture and removed pieces of concrete within a limited area. The working width of the hydro-demolition robot was 2000 mm both on the wall and the slab. In the corners which were inaccessible to the robot or spots demanding higher accuracy, concrete was removed with high-pressure water jetting equipment operated by a worker. When the concrete had been removed and washed out of all solutes, the condition and location of existing reinforcement was checked, and necessary auxiliary reinforcement was installed on top of new water treatment pipes, see Fig. 5.

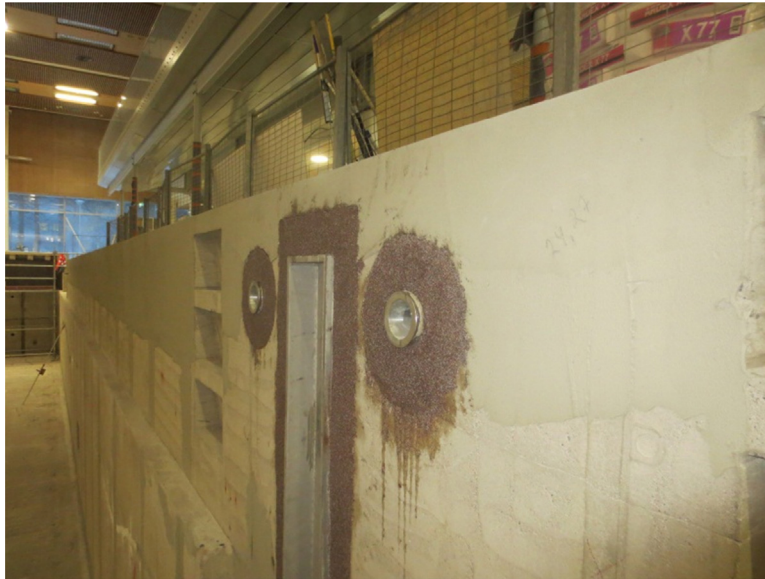
Fig. 6. Epoxy-based materials were used to seal all penetrations.

Waterproofing was installed on the concrete surface after the concrete had dried to RH 92% at a depth of 50 mm. The waterproofing was strengthened with buckram at the corners. Pipe penetrations, etc. were sealed with epoxy-based materials, see Fig. 6.
