Case study

A failure analysis study of a prestressed steel cable of a suspension bridge

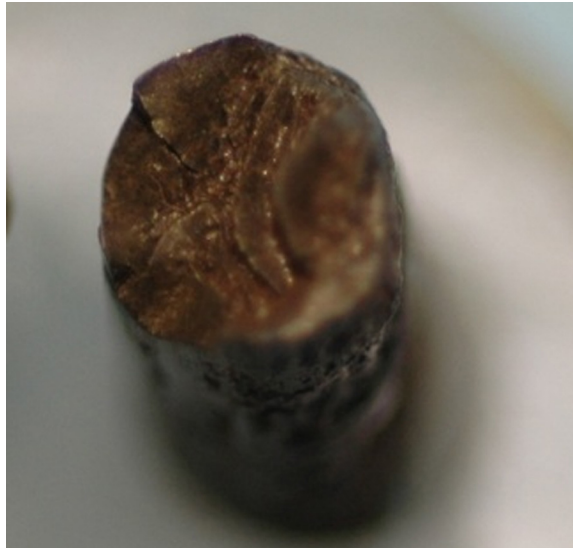
- 21 wires, corresponding to all three rods winding, exhibited ductile fracture surfaces, type “cup and cone” (Fig. 2), near the beginning of the anchor (between 100 and 250 mm).

Fig. 2. Ductile fracture surface, type "cup and cone".

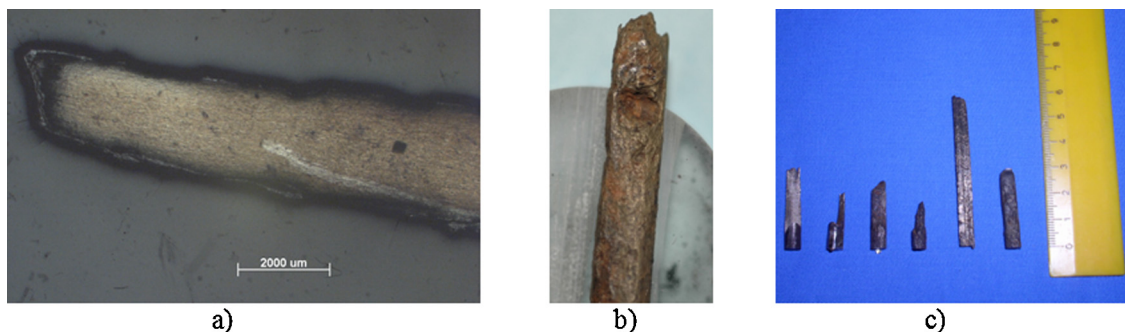
- 45 wires fractured the distance between 600 and 900 mm from the beginning of the anchor and showed high state of corrosion (Fig. 3a), brittle fracture type displayed some, of which end, in "arrow point" (Fig. 3b and c), developed along in various lengths, sometimes reaching 50 mm.
- The remaining wires have not undergone any fracture.

Fig. 3. Brittle fracture surface showing: (a) corrosion; (b) and (c) "arrow point".

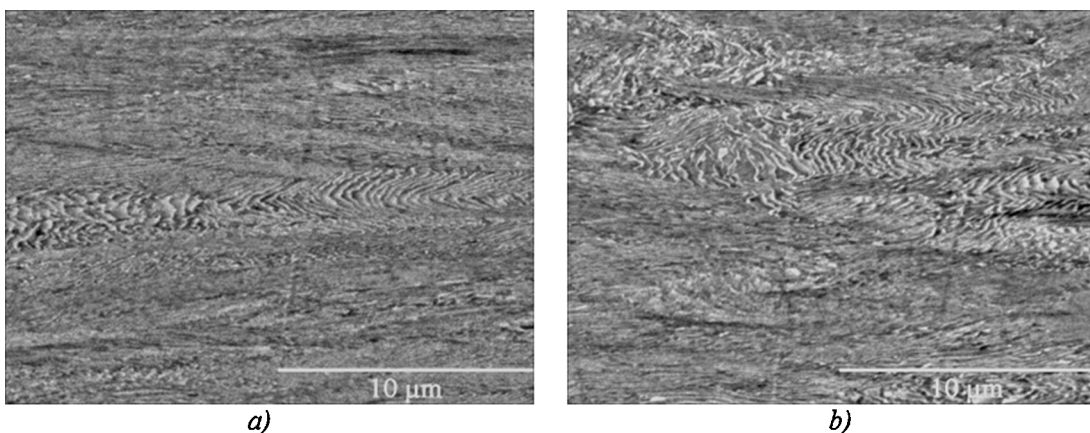
There were observed very fine microstructure, aligned in the longitudinal direction with non-metallic inclusions. Fine pearlite regions were visible by SEM ([Fig. 4a](#) and [b](#)).

Fig. 4. Zones of fine and aligned pearlite observed by SEM.

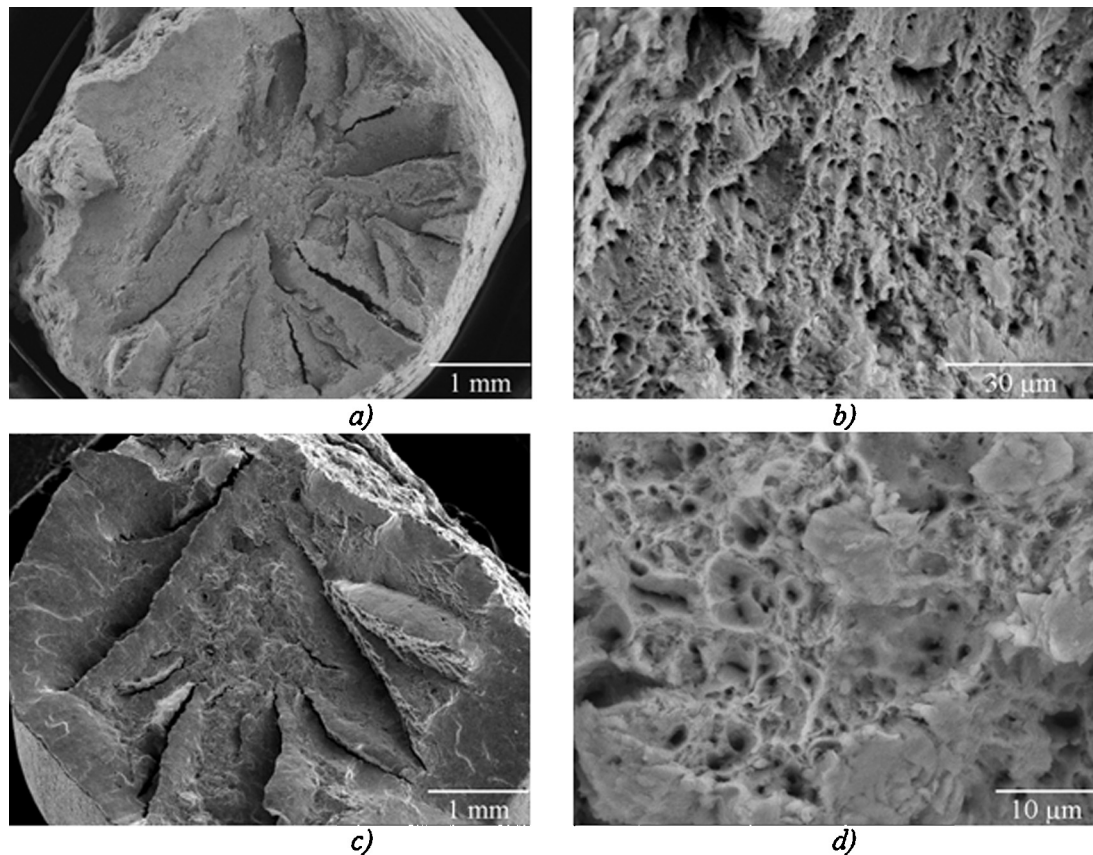
Specimens with ductile failures (cup and cone type) identified for small magnifications with secondary failures of the radical type starting from a central zone ([Fig. 5a](#) and [c](#)); larger magnifications of that central zones identified typical morphologies of this fracture mode, designated by “coalescence of cavities” ([Hull, 1999](#)) ([Fig. 5b](#) and [d](#)).

Fig. 5. SEM observation: (a) and (c) ductile type failure; (b) and (d) central zone of the specimen showing a morphology obtained by void coalescence.

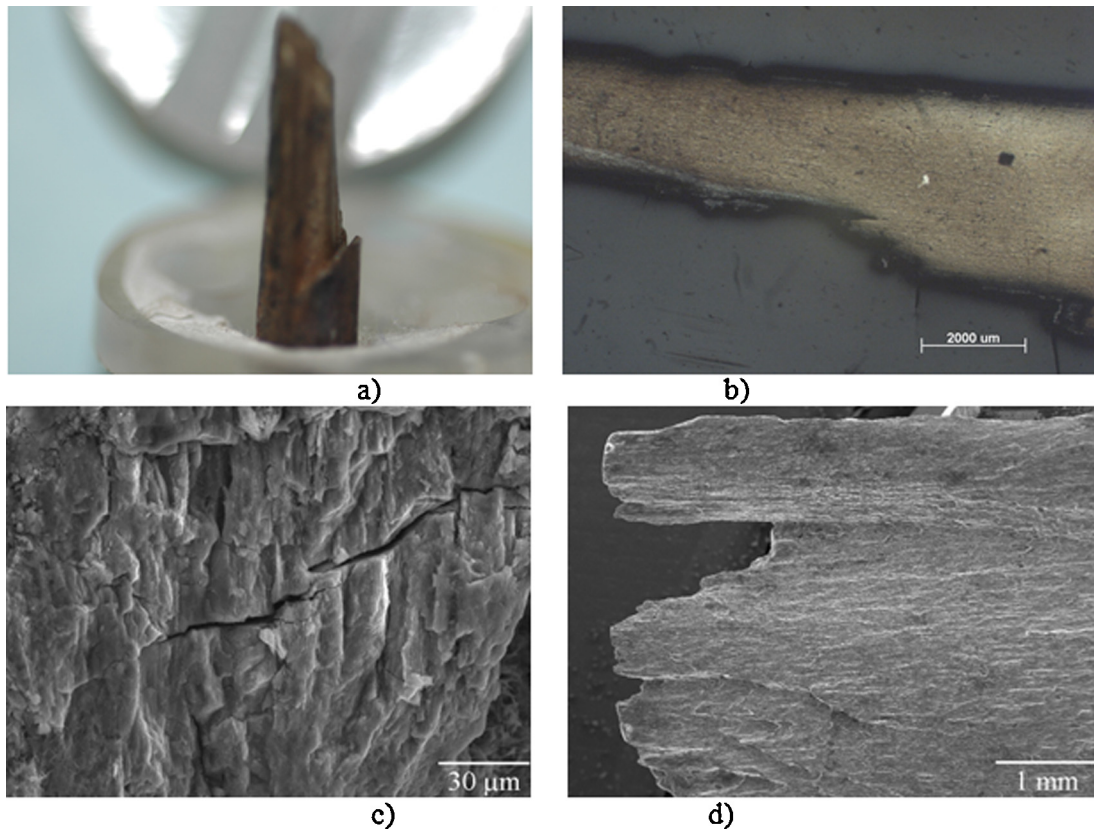
Specimens with failures of the arrow point type were observed along the longitudinal fracture surfaces (Fig. 6a and b). The intense corrosion (Fig. 6b) makes the observation difficult and it is not possible to make a perfect observation of the original fracture, but in some cases descohesion inside the material is visible (Fig. 6c) showing an eventual separation of fracture surfaces along longitudinal paths of lower strength: between the multiple factors that could enhance this failure mode, are the environmental factors that cause stress corrosion, the extremities of these arrow points also show an irregular shape confirming the referred above (Fig. 6d).

Fig. 6. Observations with several magnifications for specimens broken by arrow failure point type (a) longitudinal fracture surface; (b) intense corrosion; (c) descohesion inside the material and (d) irregular shape of extremities.

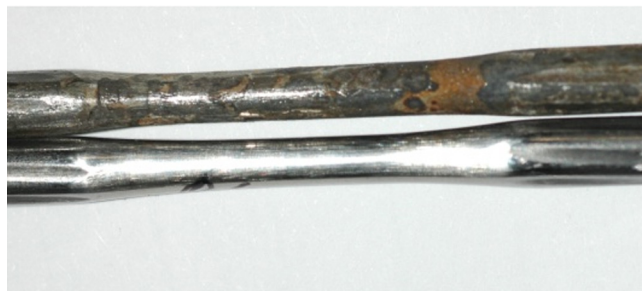
Fig. 7 shows the image of two specimens with and without the effect of corrosion in the tap water, where the significant effect of pitting, dissolution and oxidation caused by corrosion action can be noted.

Fig. 7. Two specimens with and without the effect of corrosion in the tap water.

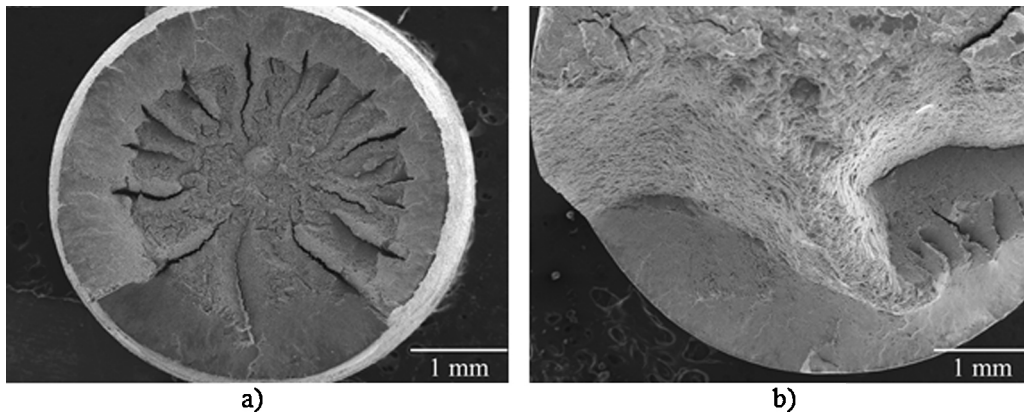
Fig. 8a and b shows with small magnification ($20\times$) the specimens fracture surface. It can be observed a radial cracking of the surface. In Fig. 8a the fracture surface is rougher and the steps of propagation are more visible because the crack growth rate is higher, giving a shorter life. The fracture surface showed in Fig. 8b is more uniform as a result of a small stress level and a longer life (lower crack propagation speed viewed as can be confirmed by the lower degrees or steps).

Fig. 8. Zone 1 specimens fractography (magnification 20 \times): (a) $N_r = 36,028$ cycles, $\sigma_{\max} = 1548$ MPa and (b) $N_r = 3,674,664$ cycles, $\sigma_{\max} = 1058$ MPa.

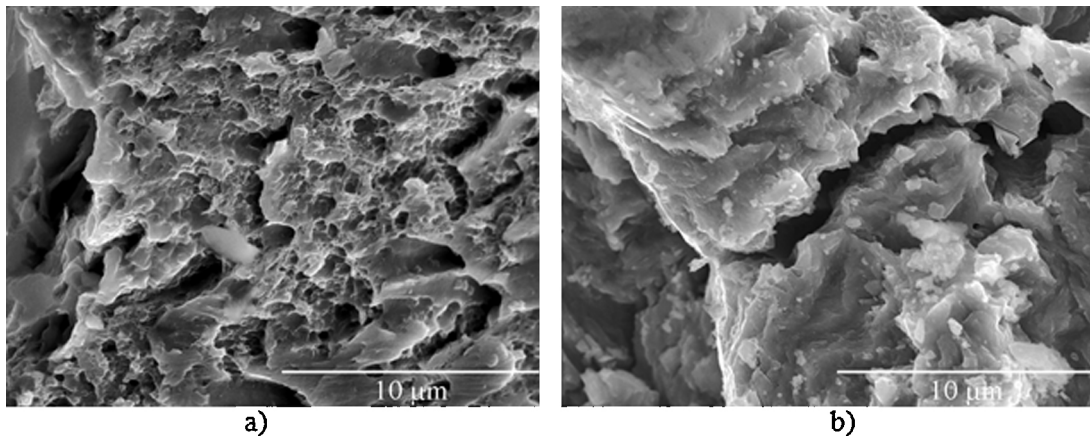
Fig. 9 is a fractographic image with magnification of $5000\times$ of the same specimen of Fig. 8. With this increased magnification it is possible to analyse some details like the fracture mode that is void coalescence and secondary cracking (Fig. 9a). Intergranular failure mode is observed in Fig. 9b which is one of the mechanism failures.

Fig. 9. Central zone specimens fractography (magnification 5000 \times): (a) $N_r = 36,028$ cycles, $\sigma_{\max} = 1548$ MPa and (b) $N_r = 3,674,664$ cycles, $\sigma_{\max} = 1058$ MPa.
