## Case study

## Root cause analysis (RCA) of fractured ASTM A53 carbon steel pipe at oil &amp; gas company

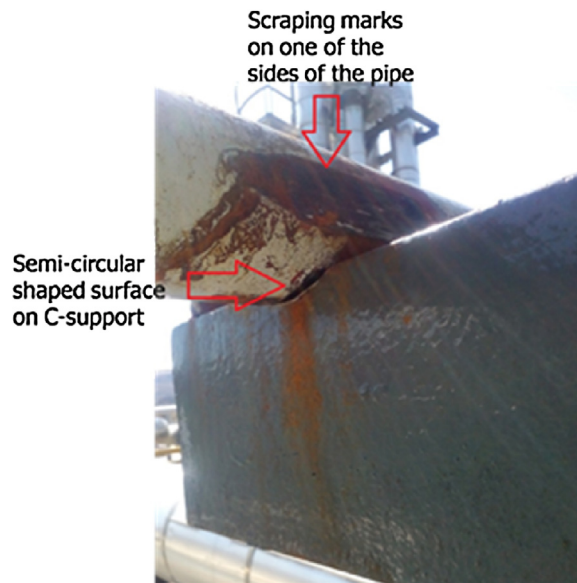
Fig. 4 shows actual location of the pipe portion that is resting on the C-support. The semi-circular shaped surface on this support is visible and indicates a material loss for both the pipe and the C-support.

In addition, minor corrosion and excessive scrapping marks on the sides of the pipe can also be seen. This situation further deteriorates the condition of the resting pipe.

Fig. 4. Actual pipe portion resting on C-support.

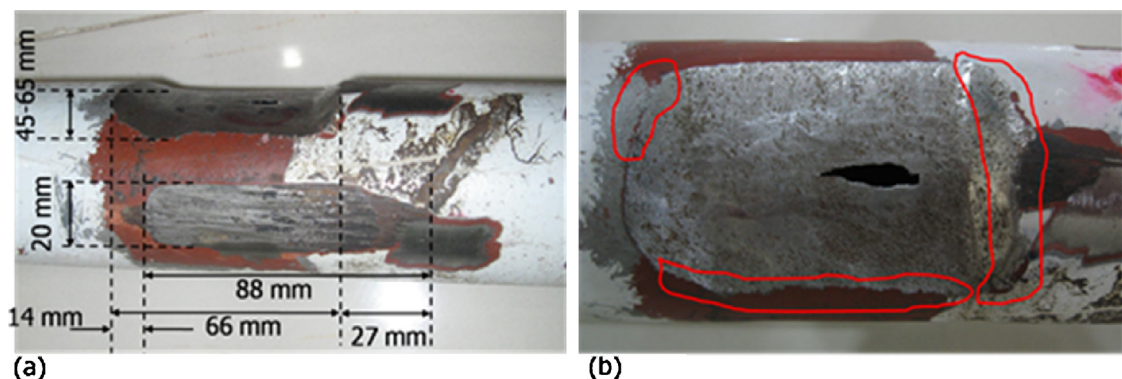
The carbon steel gas pipe was inspected externally and internally and photo-documented. Dimensional mapping was conducted and shown in Fig. 5a. The major failure area consists of approximately 45–50 mm in length of reduced section of pipe along with tapered edges on both sides of the cut. The depth of the reduced thickness portion varies from 3.1 mm to 4.3 mm on various locations, whereby, occurrence of the maximum thickness loss has led to the gas leakage from the opening. Moreover, it is also clear from Fig. 5a that the abrasion marks facing lower C-support and side support are not inline. Fig. 5b shows the presence of metal flakes around the boundary of the failure area. The direction of these flakes is towards outside with reference to the opening.

Fig. 5. (a) Approximate dimensions of the failure area resting on lower support and side abrasion region (Note: the smooth surface marks on right side are due to post failure lab work) and (b) metal flakes on boundary of the failure area.

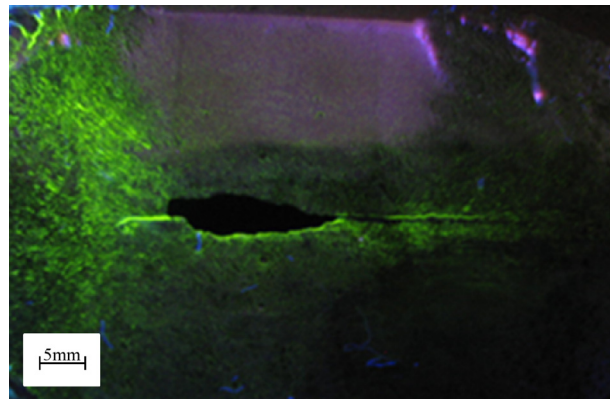
Fluorescent penetrant inspection (FPI) and magnetic particle testing (MPT) were performed on the fractured area of the pipe section. Fig. 6 shows the damaged pipe section under UV light during MPT. This proved that cracks have only initiated from the failed portion area due to the thickness loss and there are no further inherent defects.

Fig. 6. Fractured pipe area through UV light after magnetic particle testing (MT).

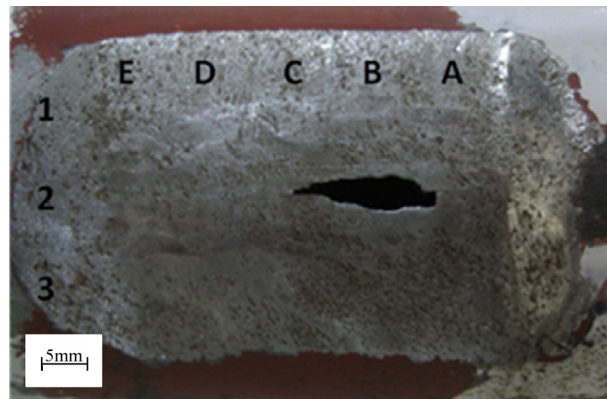
Ultrasonic thickness measurement (UTM) was performed for the fractured pipe section. The UTM results have shown marked variation in the thickness values at the vicinity of the fractured area. The thickness values vary from 1.48 mm to 2.91 mm. Marking plan and thickness variation are shown in Fig. 7 and Table 1 accordingly.

Hardness is affected by the levels of heat input and preheat used during welding. Table 2 shows hardness values (HRB) at selected locations of the failure region of the pipe. Apparently the unaffected portion has the highest hardness, 90 HRB, while it reduced to the minimum value of 64 HRB at failure location. Scatter of the measured hardness data is primarily attributed to the roughness of the eroded surface.

Fig. 7. Marking plan for UTM.

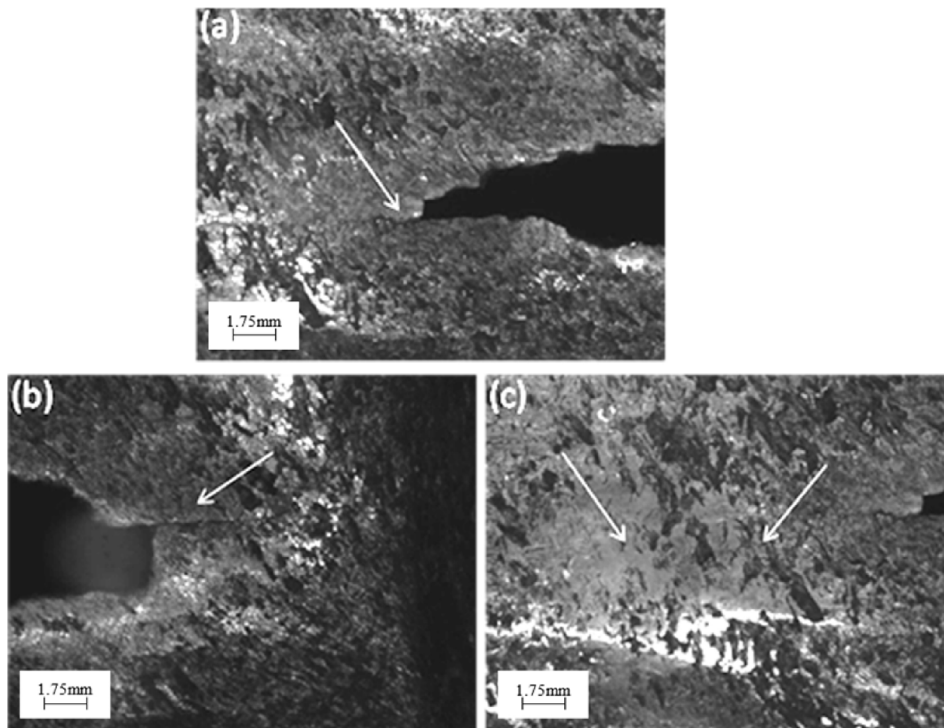
This task was carried out by examining the fractured area with stereo microscope. Fig. 8a and b shows that cracks nucleated from the edges of the opening due to post wall thinning nominal vibrations. Additionally, it can be seen that the surface texture of the failure area is a blend of shiny and uneven profile (Fig. 8c). Prepared specimen was also then examined with  $200\times$  magnification using Nikon optical metallographic microscope.

Fig. 8. Fracture surface analysis by stereo microscope.

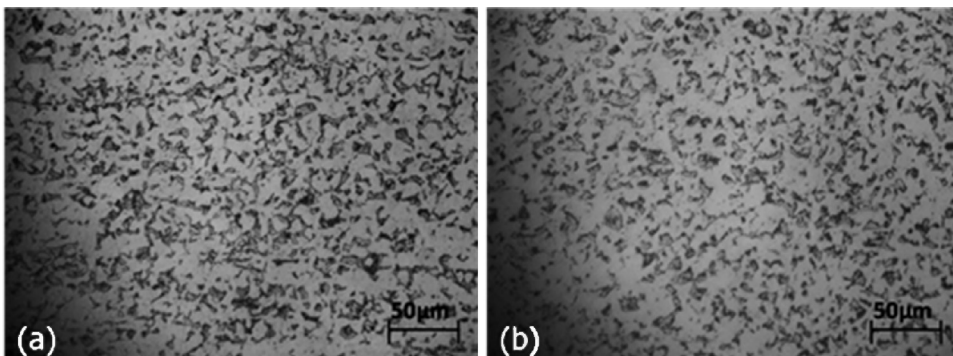
Examination of the microstructure at the failure region and the base metal location clearly indicate close similarity between both specimens that consist the typical ferrite and pearlite structure observed in carbon steels. There is also no evidence of micro fractures (Fig. 9a and b). These findings fully support the hypothesis that the pipe failed due to the increased turbulence caused by abrasive grindings and its adjacent regions and erosion-corrosion phenomenon was aggravated due to faulty workmanship erosion instead of corrosion.

Fig. 9. Optical micrograph of (a) fractured area and (b) base metal at  $200\times$ .

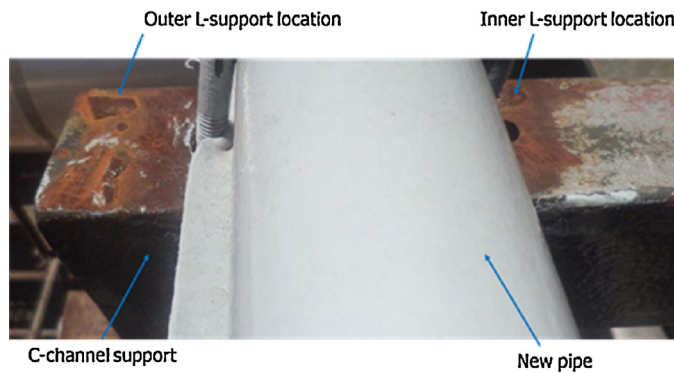
- i. In addition to pipe contact with the C-support, Figs. 10 and 11 show that the pipe was also in contact with inner L-support. This leads to a hypothesis that there may be significant amount of axial movement during the service. However, this theory was nullified by our earlier observed scrapping marks (Fig. 5a) on the pipe which indicates that the abrasion marks on lower and side facings on the pipe are not inline. This shows that any linear movement along the length of the piping during the service could not be the cause of failure. The reason is both motions should have been taken simultaneously.

Fig. 10. Actual location of the L-supports on C-support.

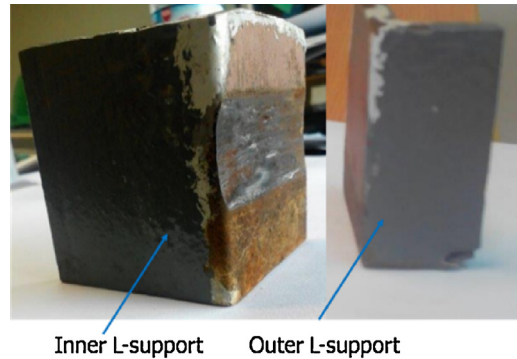
- ii. Based on the inspection results, it was observed that the failed surface does not indicate any metallurgical failure, and hence could be a foremost basis of failure. The surface texture on the main failure area shows grinding marks (Fig. 11). This leads to a conclusion that the main failure area on the piping could be due to manual grinding.

Fig. 11. Inner and outer L-supports.

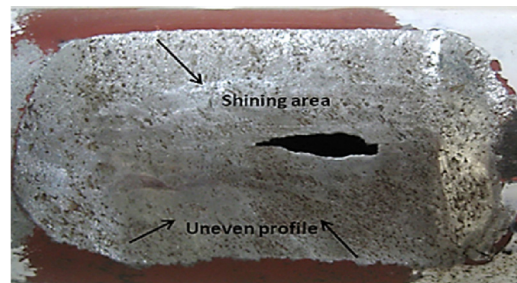
Fig. 12. Shining and uneven profile of failure area.

Shining and uneven profile of failure area can be seen in Fig. 12. It is also observed that pipe surface adjacent to the failure region was also excessively grinded, as shown in Fig. 13.

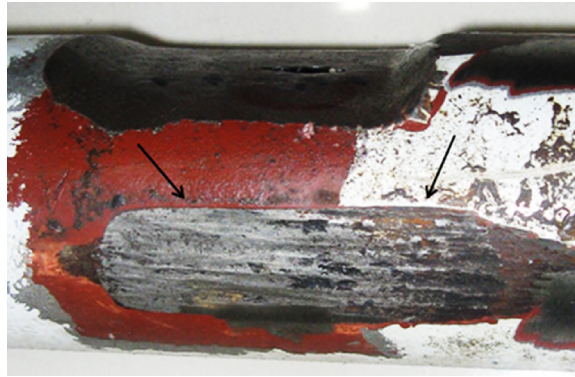
Fig. 13. Grinding marks on side surface of pipe.

- iv. The geometry and location of the excessive grinding at the failure and its adjacent regions of the pipe, base area of the C-channel and L-shaped side supports, clearly indicate that these grindings might have been performed to accommodate the pre-installed piping spool to avoid the alteration in pipe position to sit properly on support.

Based on the above, it is recommended that during installation/fabrication of piping system, proper procedures may be implemented, followed by visual inspection through qualified inspector(s) including pre-service and in-service inspection.
