# Case Studies in Engineering Failure Analysis

# Metallurgical failure analysis of a cracked aluminum 7075 wing internal angle

Internal angles are used to strengthen Aircrafts center box corners where the wing is attached to the airframe. There are 16 angles in Airbus A300s wing box. On the right side, rear spur, and lower flange area of the center wing box, one of these angles had been cracked with a length of 28 mm. This crack has decreased residual strength of the part under allowed values and resulted to a rupture in the rear spur lower cap. Several reports of the same occurrences in other Airbus A300 air crafts, highlight the importance of finding the causes of this failure. Detailed optical and SEM, plus 4 other metallurgical tests were conducted on the failed angle. Finally, it was concluded that corrosion fatigue was the main reason which itself comes from manufacturing, maintenance, metallurgical, and geometric reasons as were discussed in this study.

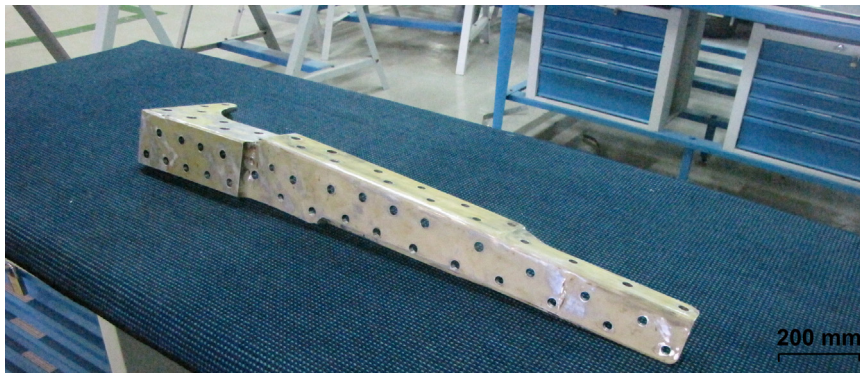
An internal angle fitting related to center box of Airbus A-300 submitted for failure investigation, which is shown in Fig. 1.

This component was a structural component of a 14-year-old commercial jetliner that had carried out approximately 19,000 flight cycles when the crack was detected through NDT implementation. This type of aircraft is mostly utilized by cargo airlines. The aircraft had been grounded for service, and specific NDT operation had been implemented according to manufacturer service bulletin which notifies all operators of A-300 to conduct this test for those aircrafts that their flight cycles exceeds 17,000 cycles [1]. NDT detected a crack between two fastener holes in a way that affect residual strength of the part. Airbus had issued a service bulletin to replace this component with a modified substitute. The location of the component in the airframe is illustrated in Fig. 2.

Fig. 1. Image of cracked internal angel after removing from A/C.

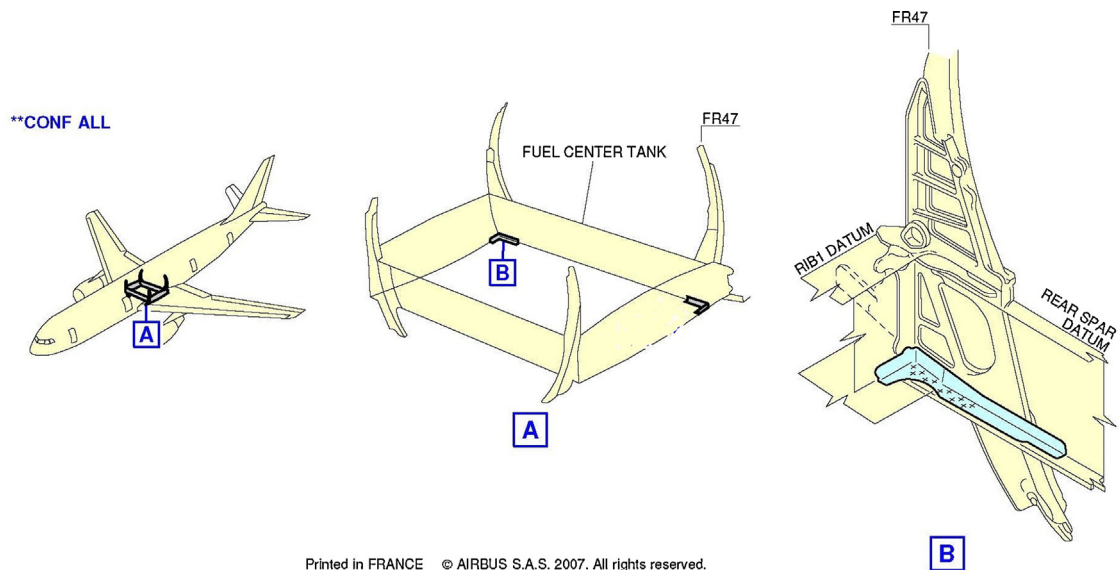
Fig. 2. Illustration of internal angles location [1].

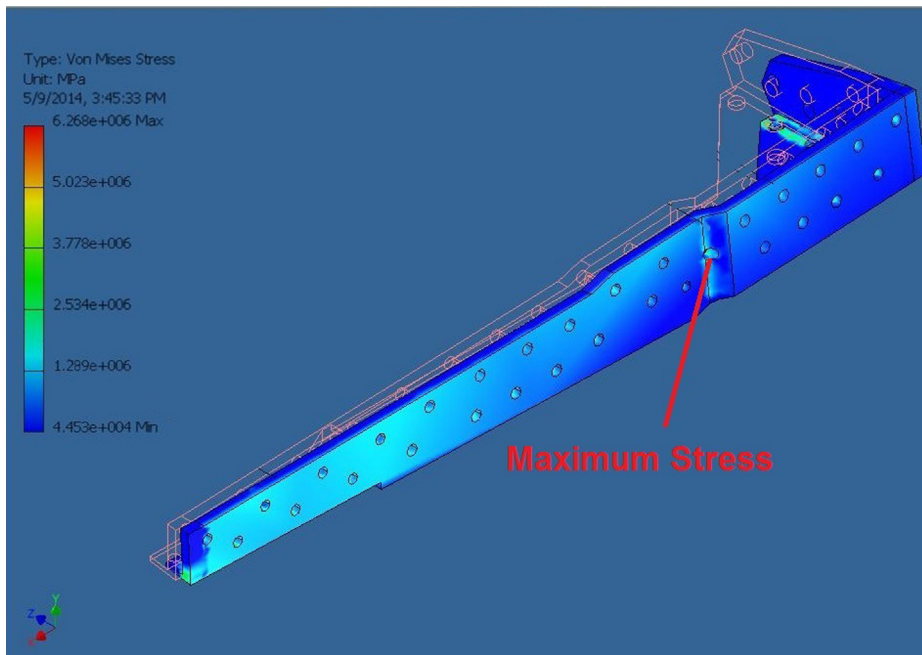
Contour plot of stress analysis over the angle is indicated in Fig. 3. Apparently, most severe stresses took place around a filet. It seems geometrical shape of angle's installing place had made designers to include this filet in the geometry of the angle. Changing in section area of the part resulted in some kind of stress concentration around the filet zone [3,11]. Meanwhile, crack path is along with filets axis. Therefore, stress concentration along the filet is able to be a cracking reason.

Fig. 3. von mises stress distribution analysis.

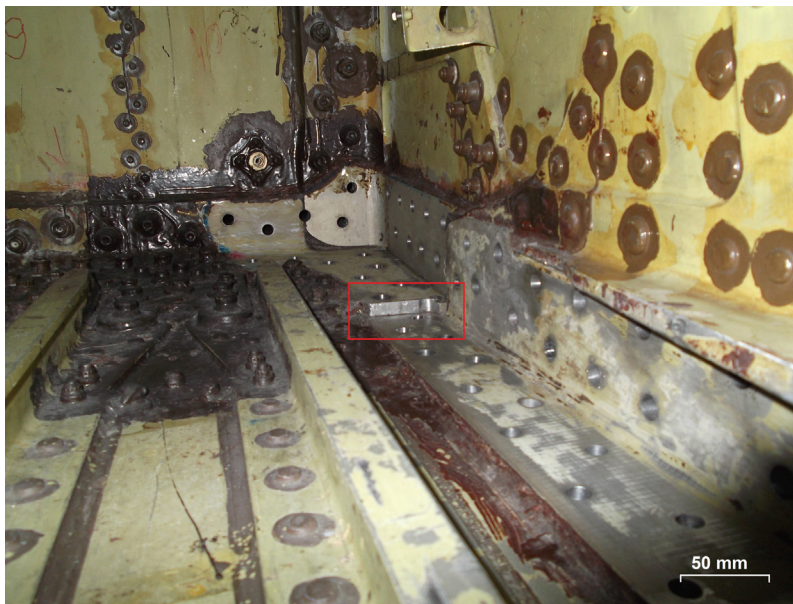
The place in which the angle is located has a step shaped geometry at its lower surface. Hence, geometry of the angle is shaped in consistent with that. Including this step results in a change in the parts section and creates stress concentration at this place. Fig. 4 shows the place in absence of angle to describe the condition effectively.

Fig. 4. Installation place of the angle at the corner of center box (step shaped geometry is highlighted in a red rectangular). (For interpretation of the references to color in this figure legend, the reader is referred to the web version of this article.)

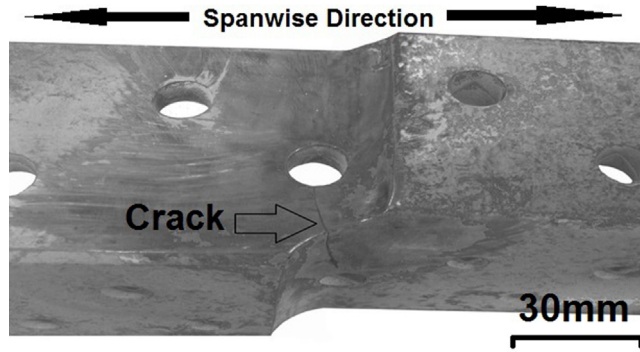
Fig. 5 illustrates condition of the part and the crack prior to performing tests. As is shown, crack had been grown between two holes. These holes are related to fasteners. Apparently, applying load under the wing triggers further stress concentration around the holes [2,3]. If we suppose the principal stress, which came from loads under wing surface it leads to a tensile stress would be happened under angles lower surface which comprises the crack. Obviously, crack path is normal to direction of tensile stress from wing lower surface. This cracking direction is to be expected because according to fracture mechanics principles crack path is normal to principle stress direction [3].

Fig. 5. Closer image of the crack and illustration of A/C Span wise direction (this direction is normal to cracking path as it is shown in the picture).

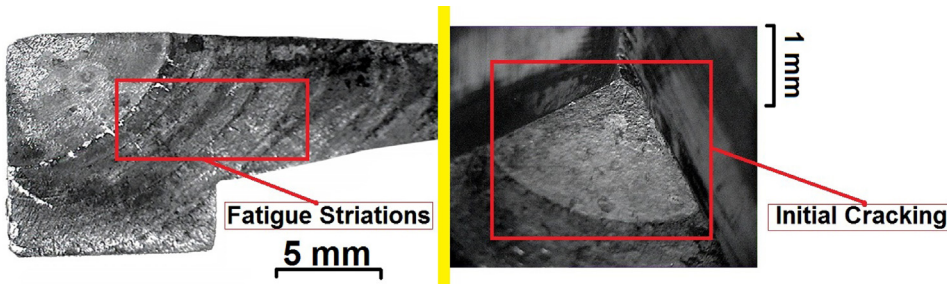
After performing SEM test, two important evidences were revealed. Firstly, as it is also discussed in [4], general appearance of fracture surface is consistent with fatigue as there are numerous beachlines and striations on surface that are illustrated in Fig. 6.

Secondly, a shiny crack origin was obvious. The reason of this initiation was not clear at this stage but this crack origin is located at the limb of a fastener hole. According to SEM test results, it is proved that some kind of damage or material defect resulted in creation of crack origin (which will be investigated at Section 7 of this paper). Meanwhile, a cyclic loading propagates the crack between two holes.

Fig. 6. SEM low magnitude images of fracture surface (at the left image, shiny initial crack is obvious and at the right side, apparent fatigue beach lines are visible).

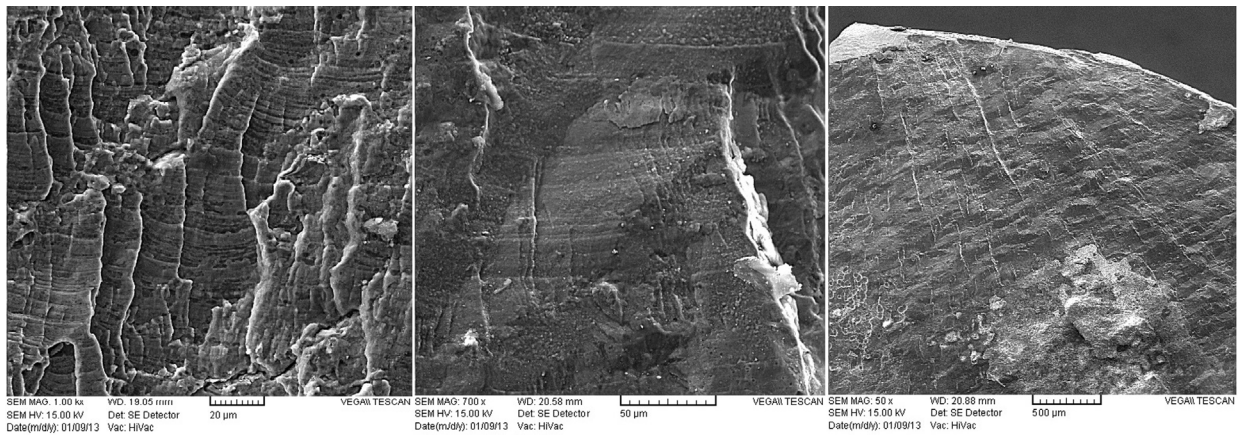
Greater magnitude of striations pictures is also shown by Fig. 7. This picture confirms that the crack is propagated through fatigue that comes from cyclic stresses of wing aerodynamic loads [4].

Fig. 7. SEM images in three different magnitudes from fracture surface.

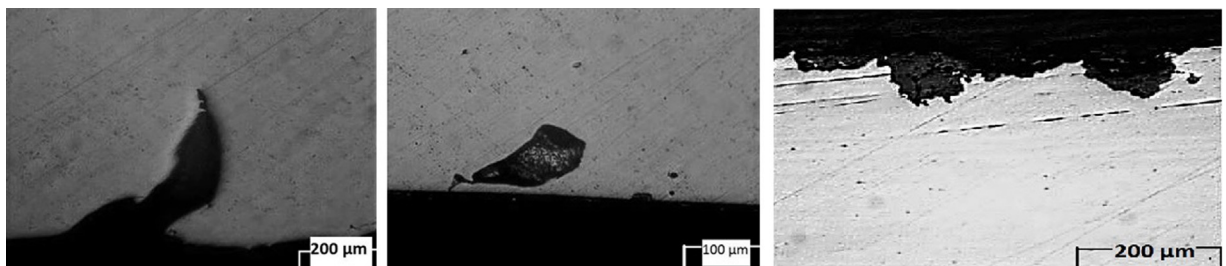
Over lower surface of the angle, a large number of micro cracks were detected through optic microscope inspection (Fig. 8) which were results of corrosion. These places are not accessible for cleaning at the time of maintenance because this

Fig. 8. Microscopic crack detected on the surface of the angle.

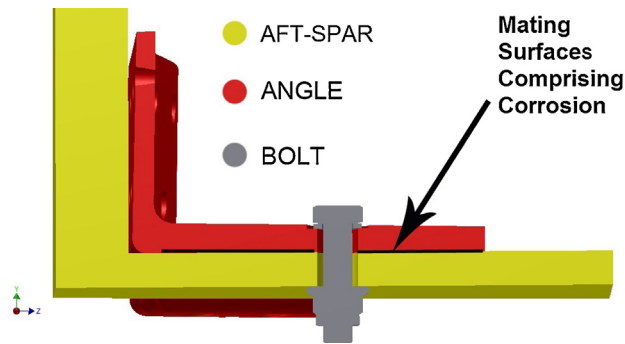
Fig. 9. Illustration of corrosion area between angle and spur.

surface is tangent to the lower cap of aft-spar. Thus, penetration of fuel, water, and other corrosives might result in corrosion over corresponding surface much more than the others. Fig. 9 illustrates the area of major corrosion. Based on fracture principles, such flaws bring about severe stress concentration if they become at exposure of tensile stress [7,8] (lift force of the wing generates tensile stress along lower surface of the wing and compressive stress along upper surface). Therefore, existence of these flaws should take into account as another reason of corrosion fatigue cracks in the component.

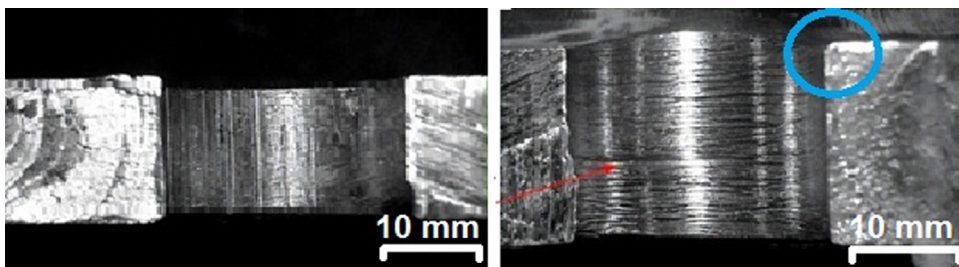
Evaluation of this region indicated several scratches on it. It had found that a special maintenance operation named cold working was the reason of these scratches. In this job by applying special tools an axial force was affected into the hole walls in order to convert potential cracks to notches and prevent crack progression. Therefore, ultimate life of the component would be extended. However, wrong implementation of this operation can damage the hole surface as it shown in Fig. 10 and creates scratches which can result in crack initiation as found in [5]. According to maintenance records, this component had detached 2 times during aircrafts service life and fasteners removal- installation could not make such severe and serial scratches. On the other hand, numerous holes on the component could make the technicians fatigue and lessen maintenance performance in a way that some holes became damaged. Therefore, another cause of producing crack origin could be this human error to cold work the hole of crack initiation. The fasteners should locate at the holes with push fit condition during assembling process and it can increase potentiality of making initial cracks [6].

Fig. 10. Illustration of hole internal surface (crack initiation is shown by blue ring and scratches are pointed by red arrow). (For interpretation of the references to color in this figure legend, the reader is referred to the web version of this article.)

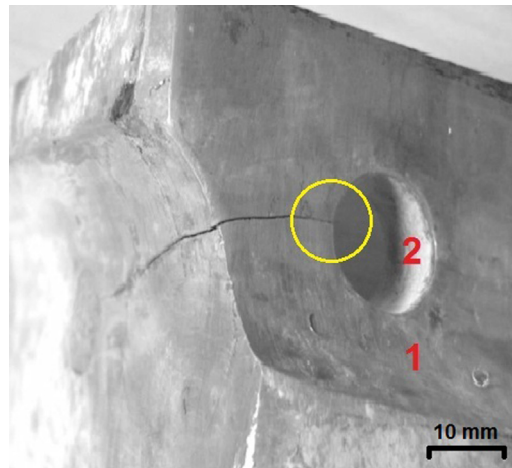
As the flaw was located at the limb of the hole, two surfaces should be inspected at the vicinity of the flaw. One was the internal surface of the hole; the other is external surface of angles main body. Important information had been collected from these surfaces. Fig. 11 shows both surfaces.

Fig. 11. Hole surface and main body surface (crack has initiated at the limb of this hole which is indicated by yellow ring). (For interpretation of the references to color in this figure legend, the reader is referred to the web version of this article.)

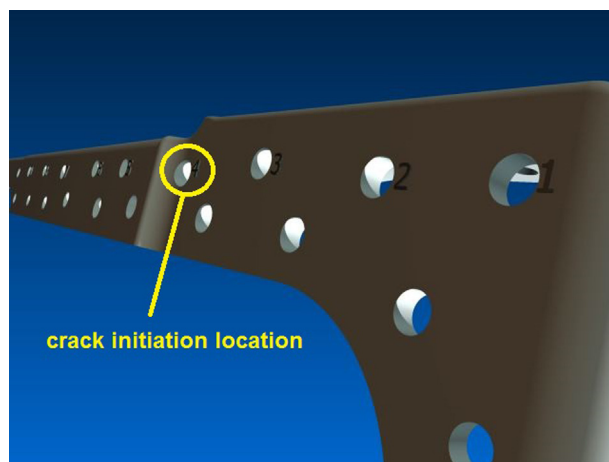
Fig. 14. Illustration of hole location on the angle.

Factual diameters of the holes are measured through caliper with precision of 0.01 mm. At the left side, a table shows the dimensions of the holes before cold working. The right table illustrates the dimension after final cold working. The results of caliper measurement are indicated at the right side of Fig. 13. Reddened values are not at the limit when greened values are consistent with defined limits. An apparent discrepancy has occurred at some holes including no. 4. It seems cold work expansion was not performed properly. It was not possible to obtain information about cold work from previous owner of the aircraft. However, according to professional structural repair engineers of temporary owner, the filet at the location of hole no. 4 would be a contributing factor to disturb technician to mount cold working equipment on the hole and do the job adequately. A detailed explanation of cold working is available at reference [13]. Nevertheless, this error is seen at other holes that are not closed to a filet. Fig. 14 illustrates hole numbers.
