Contents lists available at ScienceDirect

# Case Studies in Engineering Failure Analysis

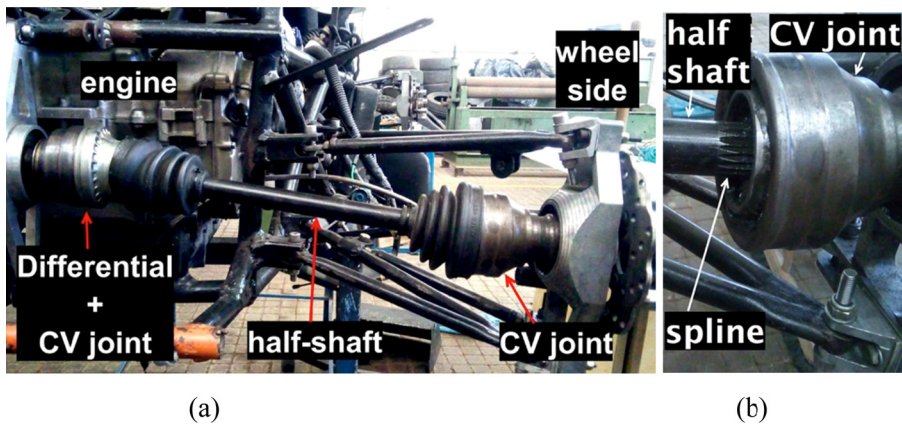
Fig. 1. Connection between the half-shaft and the CV joint connected to the wheel. On the end of the shaft a machined spline is present.

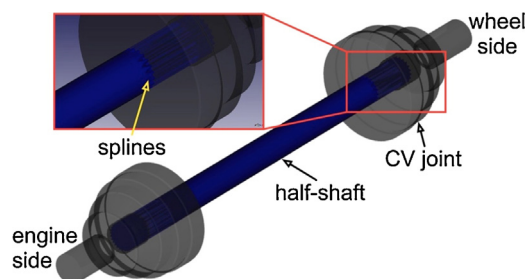
Fig. 2. Assembly of the half-shaft and the CV joints. In detail, the connection of the half-shaft with the CV joint on the wheel side.

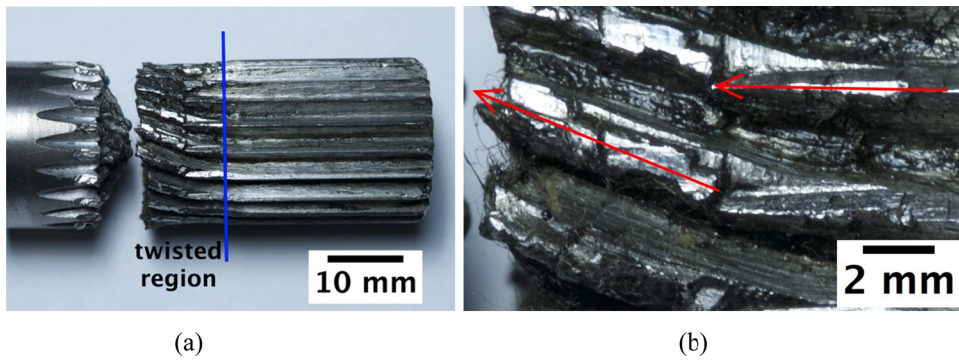
Fig. 3. (a) The fracture on the spline section of the half-shaft. The fracture was normal to the longitudinal axis of the component. A detailed view of the twisted region is shown in (b) with the red arrows indicating the alignment of the top part of the spline thread.

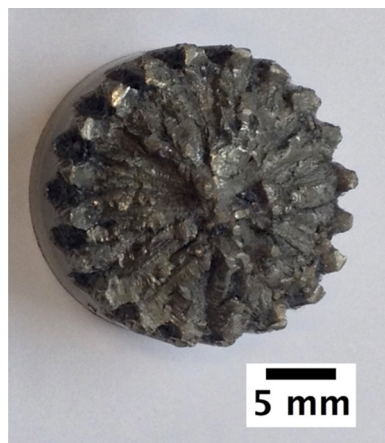
Fig. 4. Transverse view of the fracture surface.

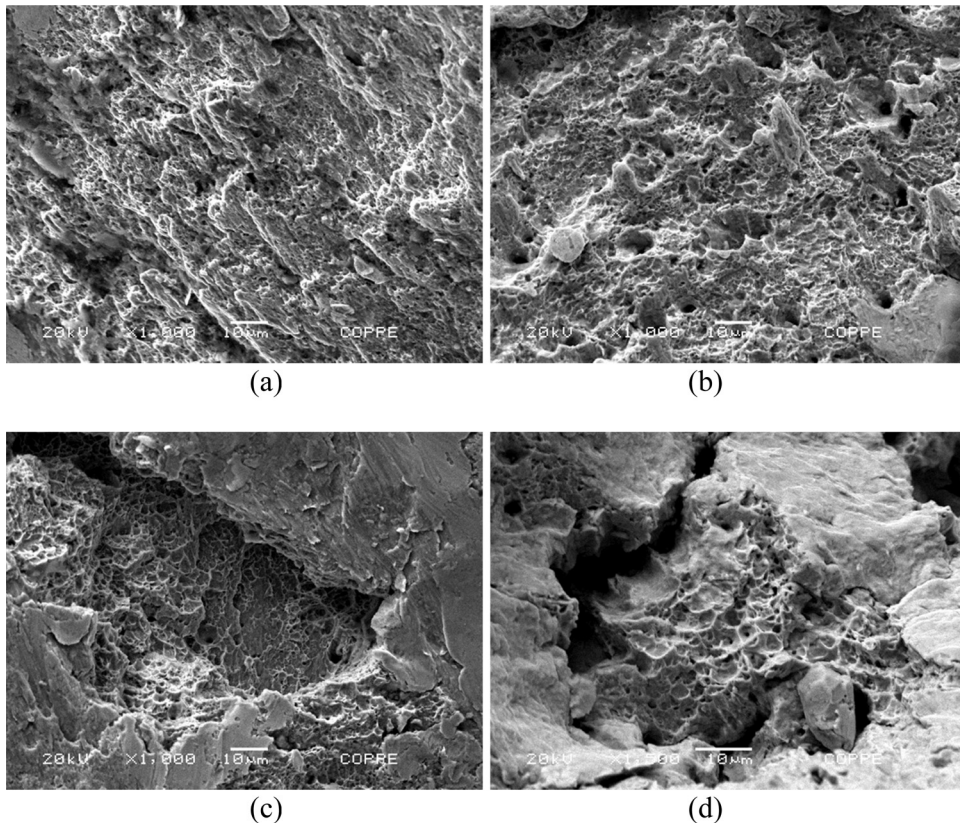
Fig. 5. Fracture morphology: (a) close to the edge; (b) at a quarter-radius from the edge; (c) at mid-radius; (d) at the center of the fracture surface.

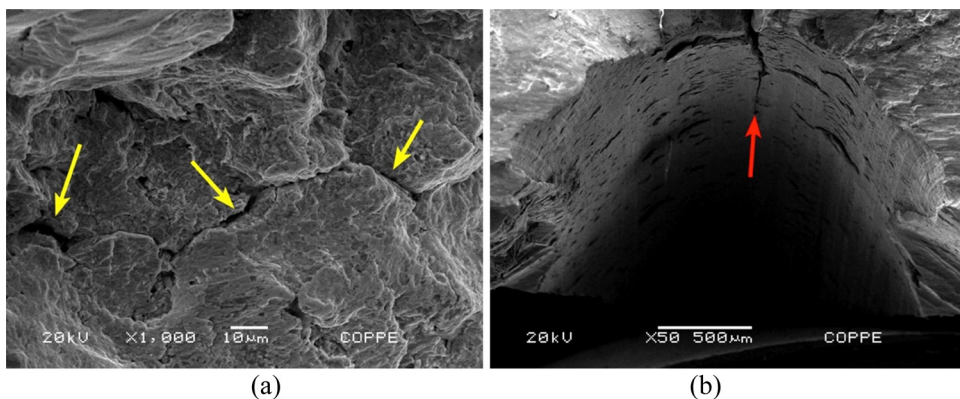
Fig. 6. (a) Secondary cracks observed on the fracture surface close to the edge (yellow arrows); (b) spline region with intense transverse cracking and a longitudinal crack at the base of the spline root (red arrow).

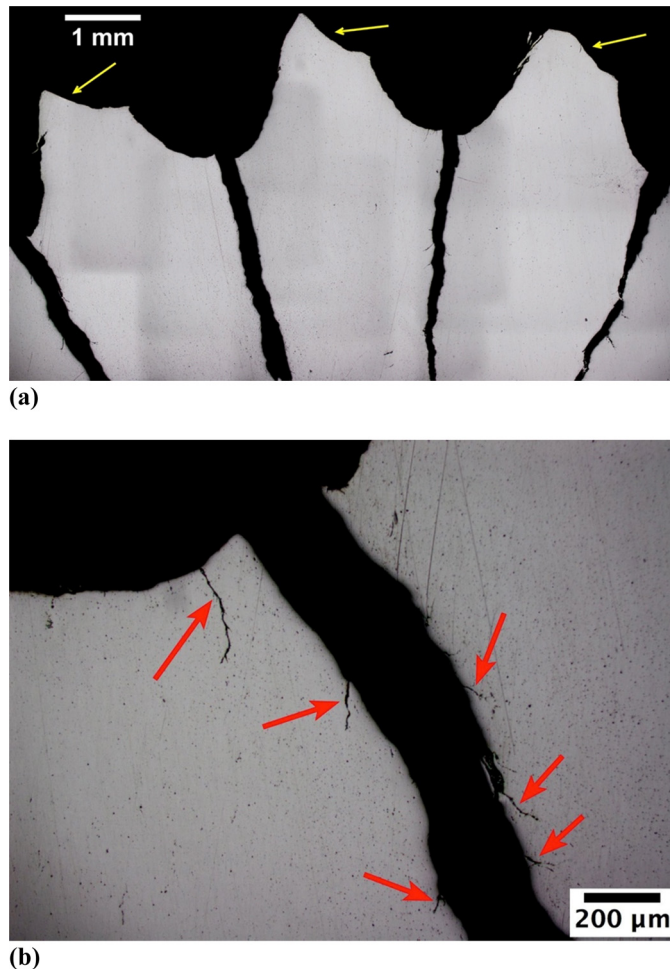
Fig. 7. Transverse view of the half-shaft close to the fracture surface: (a) large cracks emanate from the roots of the splines and the wear of the splines (yellow arrows); (b) secondary cracks (red arrows) observed inside the crack.

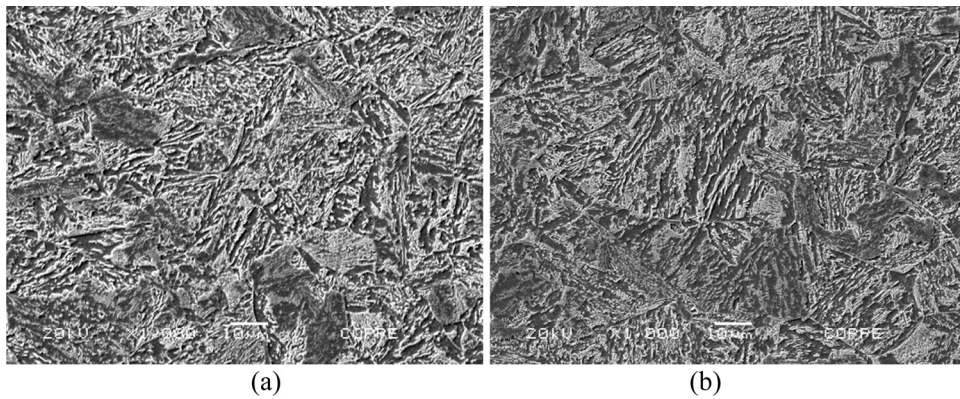
Fig. 8. Microstructure of the half-shaft: (a) close to the surface; (b) at the center. In both cases a bainitic microstructure was identified.

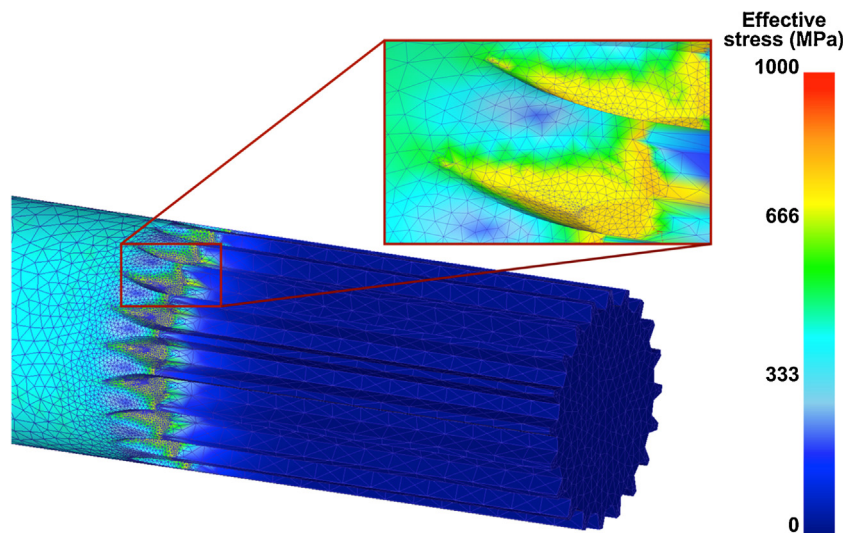
Fig. 9. Effective stress distribution on the surface of the half-shaft. Stresses higher than the yield strength of the alloy were observed at the fillet region of the spline (in detail).
