Case study

Failure analysis of a diesel generator connecting rod

C. Juarez^a, F. Rumiche^{a,*}, A. Rozas^a, J. Cuisano^b, P. Lean^b^a CITE Materiales, Pontificia Universidad Católica del Perú, Lima, Peru^b Mechanical Engineering Department, Pontificia Universidad Católica del Perú, Lima, Peru

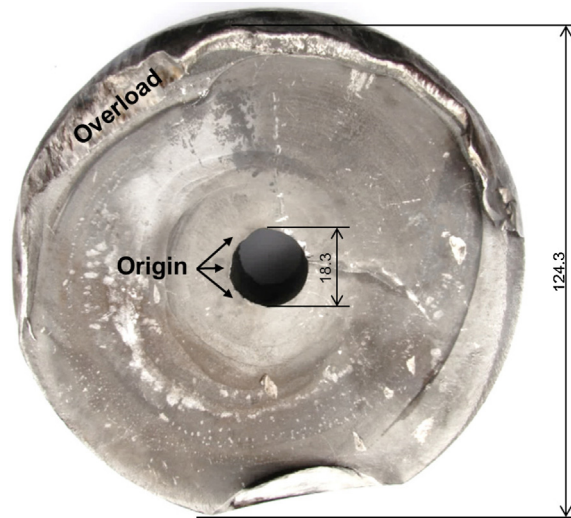
Fig. 3. Fracture surface of the connecting rod.

Fig. 3 shows the fracture surface of the connecting rod. The con-rod fractured in the body through a section perpendicular to its axis, close to the head. Previous investigations reveal that connecting rods are prone to fail in this area, since the highest deformation and level of stresses, according to finite element simulations, occur in this location [15,16]. A fatigue pattern with beach marks was observed; fatigue cracking initiates in multiple sites at the lubrication channel, as seen in Fig. 3(a), and propagates to the external part of the con-rod. Fatigued area covers more than 75% of the connecting rod section, suggesting low magnitude nominal stresses; the rest of the fracture pattern exhibits an overload pattern, as shown also in Fig. 3.

Although a fatigue fracture is typical in cases of failure of connecting rods, the observed pattern (i.e. from the center to the exterior), is not common. Therefore, the analysis at the fracture zone was focused on the origin of the fracture (i.e. the lubrication channel).

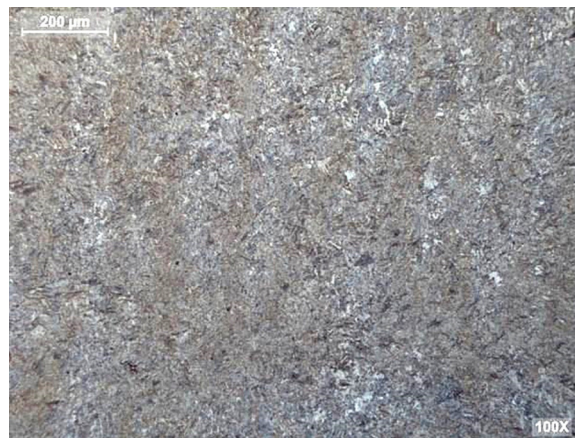
Table 3 shows the results of the hardness test. The obtained average hardness value was 276 VH. The metallographic analysis of the con-rod material revealed a tempered martensite microstructure, as observed in Fig. 4. The values of the properties and the microstructure are consistent with those reported for an AISI/SAE 4140 steel in the quenched and tempered state [17], and are appropriate for an application as a connecting rod.

Fig. 4. Microstructure of the connecting rod material.

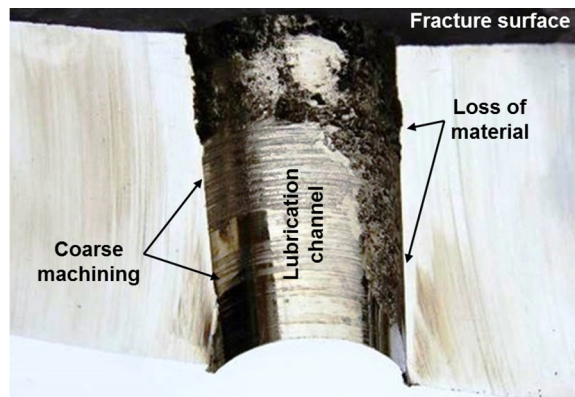
Fig. 5 shows an image of the longitudinal cut through the lubrication channel at the fracture zone. Very coarse machining marks as well as an area that exhibit loss of material were identified in the channel. Magnetic particle examination revealed

Fig. 5. View of the lubrication channel at the fracture zone.

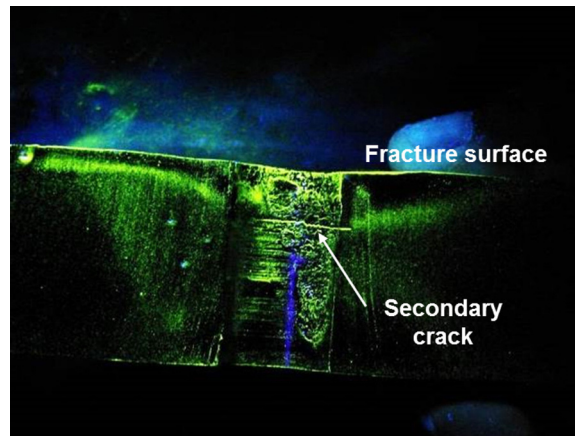
Fig. 6. Secondary crack revealed by magnetic particle inspection.

the presence of secondary cracks parallel to the fracture surface, as observed in Fig. 6. It is clear that cracks propagate from the lubrication channel to the exterior surface of the connecting rod, as indicated for one secondary crack (white arrow) in the figure.

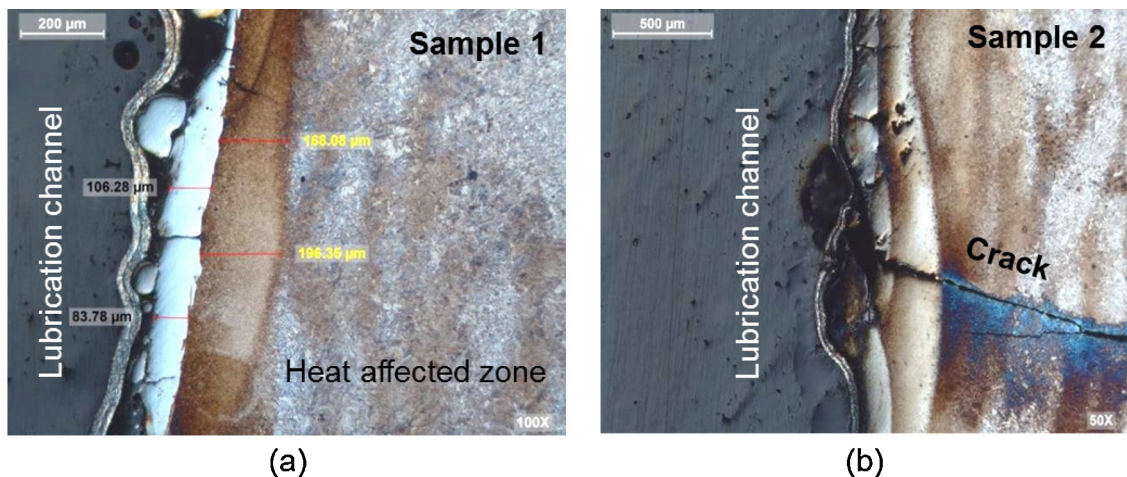
Metallographic samples examination (samples 1 and 2) revealed the presence of a white layer (as observed in the micrographs) in the surface of the lubrication channel, where cracks nucleate, as observed in Fig. 7(a). Cracks propagate toward the exterior of the con-rod, as seen in Fig. 7(b). The white layer exhibits a wide-ranging thickness, Fig. 7(a) shows two thickness measurements: 106.28 and 83.78 μm . In addition, a heat affected zone with a varied size was identified; Fig. 7(a) also shows two measurements: 196.35 and 168.08 μm .

Fig. 7. Micrographs of the microstructure at the lubrication channel, sample 1 (a) and sample 2 (b).

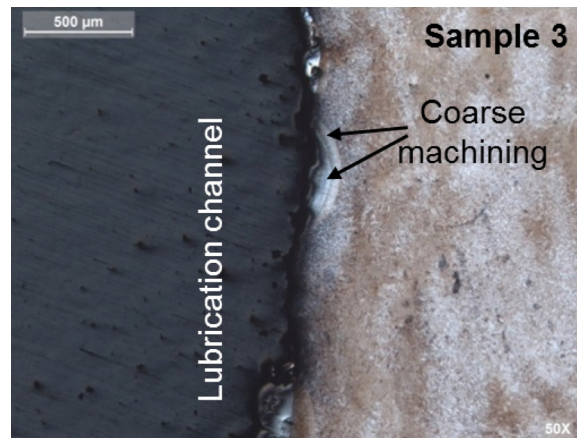
An analysis of sample 3, away from the fracture zone, do not show evidence of the white layer or the heat affected zone. However, a coarse machining finishing of the channel is observed in these areas, as shown in Fig. 8.

Fig. 8. Micrograph of the microstructure at the lubrication channel in sample 3.

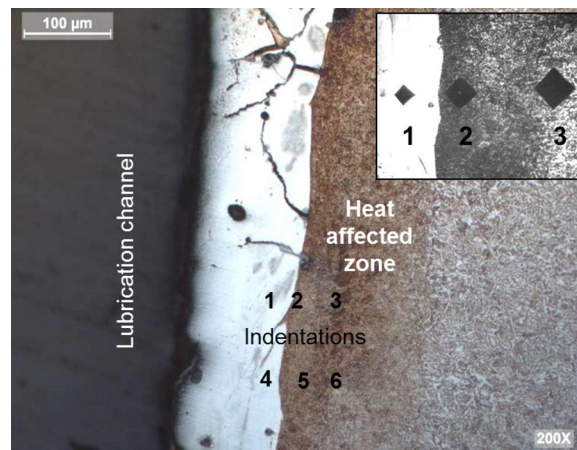
Fig. 9 presents the hardness test indentations (1–6) of the lubrication channel sample at the fracture zone, the inset shows a close up view of the indentations 1–3. Table 4 presents the results of the test. The white layer exhibits an extremely high hardness value, of approximately 1000 HV (indentations 1 and 4), which is not possible to attain with an AISI/SAE 4140 steel. Therefore, it is evident that the white layer is composed of a material that has been embedded in the steel matrix. The presence of a heat affected zone (indentations 2 and 5), with a hardness value of up to 408 HV, indicates that the process to embed this material in the steel involved high temperatures.

Fig. 9. Hardness test indentations (1–6) in the fracture zone.

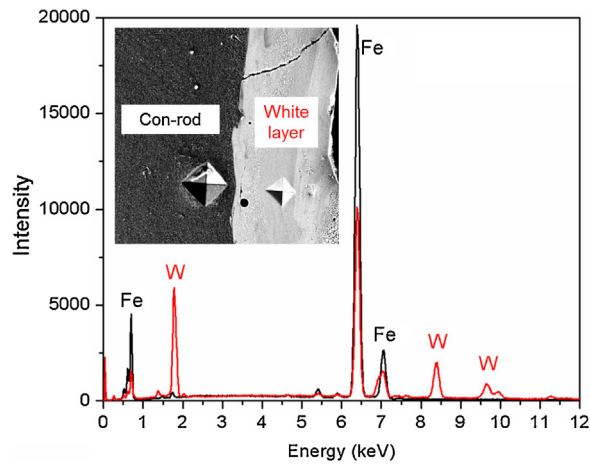
The microanalysis revealed the composition of the white layer. As observed in Fig. 10, which shows the superimposing of two energy dispersive spectra (i.e. the white layer (red line) and the rod material (black line)), the white layer contains a high amount of tungsten (W). This is confirmed with a line scan test, performed from the internal part of the rod to the white

The presence of tungsten and the evidence of exposure to temperatures high enough to promote its embedding in the steel substrate and the formation of a heat affected zone, are compatible with the process of electrical discharge machining (EDM). In EDM an electrically conductive material is machined by producing a controlled and localized electric spark between an electrode and a workpiece [18]. Temperatures involved in this process could reach values up to 12,000 °C and tungsten based materials are used as electrodes. Therefore, it could be presumed that EDM was used to machine the lubrication channel and that the embedding of W and the formation of the corresponding heat affected zone were produced as a result of its deficient application.

Fig. 10. Energy dispersive spectroscopy spectra for white layer and rod material. (For interpretation of the references to color in this figure citation, the reader is referred to the web version of this article.)

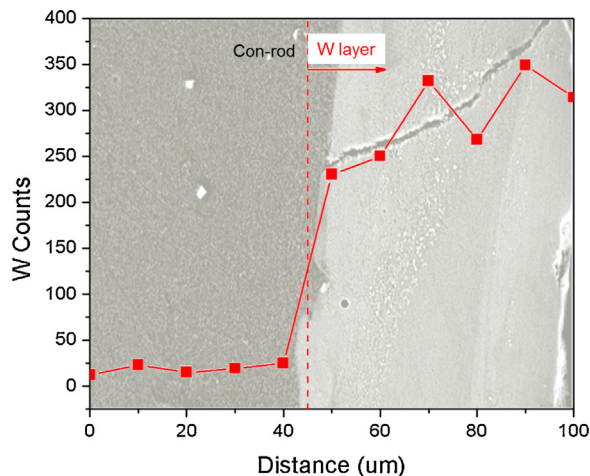
layer; as observed in Fig. 11 the content of W increases dramatically right at the interface between the heat affected zone and the white layer.

Based on all the findings a sequence of events is proposed: an overheating event during the machining of the lubrication channel produced the melting or plasticization of the tungsten based tool, which in turn, and assisted by the mechanical pressure exerted, has resulted in an embedded piece of W in the channel, generating a stress concentration area, where multiple cracks have nucleated. The cracks have growth and propagated by a fatigue mechanism, reducing the section of the con-rod until the remaining section was not able to withstand the stresses, producing the catastrophic rupture of the connecting rod.

Fig. 11. W content variation from con-rod material to W layer.
