Case study

Failure analysis of tube-to-tubesheet welded joints in a shell-tube heat exchanger

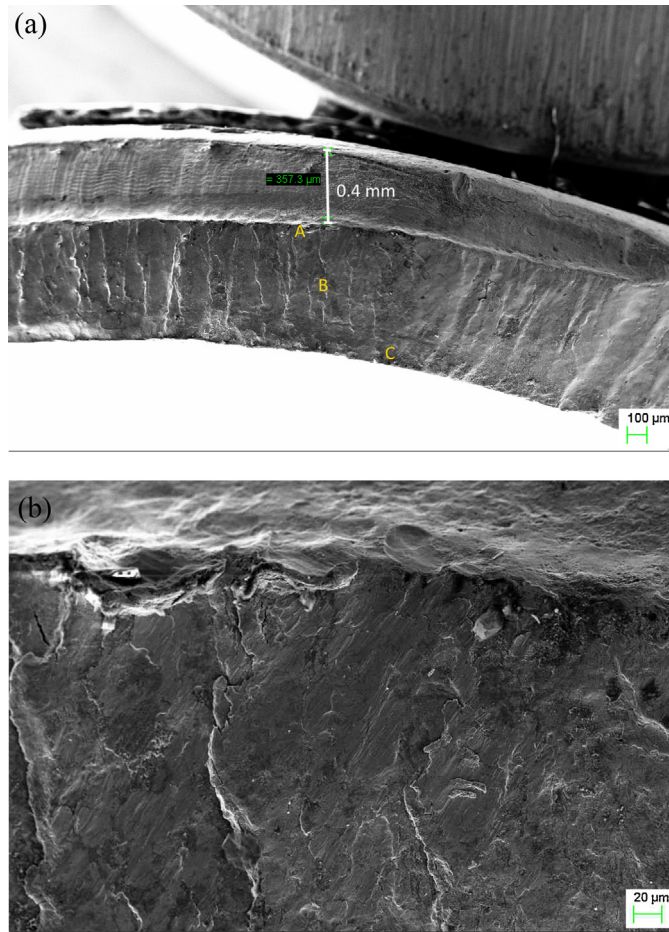
Fig. 4(a) shows the low magnification SEM micrograph of the fracture surface. The two different areas were seen more clearly. The bottom area near the inner surface of the tube was clearly a fracture surface, while the upper zone was an obvious non-fusion welding defect between the tube and the tubesheet. The depth of this area was about 0.4 mm. The

bottom fracture surface started from the interface between these two areas owing to the stress concentration induced by the welding defect. Radial lines were obviously seen from the interface between the two areas to the inner surface. Actually, the welding defect at this area was just like a crack. The interface between the upper and bottom areas in Fig. 4(a) was the tip of this crack which exhibited very high stress concentration and give rise to further propagation of the crack.

As shown in Fig. 4(a), grinding marks, which was formed due to the periodic crack opening and closing, were observed in a large area of the bottom fracture surface. However, when carefully distinguishing the fracture surface, three areas, including the initial region (marked as A), the propagation zone (marked as B), and the final zone (marked as C), could be identified in the non-grinding areas. Thus, the fracture surface showed a fatigue failure feature which was caused by a periodic load. Fig. 4(b) shows that the initial region was located at the interface between the upper and bottom areas mentioned above. Multi-crack origins could be confirmed by the numbers of radial lines. As shown in Fig. 5(a), in the fatigue crack propagation zone, fatigue striations could be seen under higher magnification. Fatigue striations were the microscope characteristic of fatigue, which is the typical evidence of a fatigue failure. Microscopic examination of the fracture further confirmed that the failure of the welded joint was due to fatigue crack propagation, which is a cumulative damage. Fig. 5(b) shows the morphology of the final zone at the inner edge of the fracture surface. Typical dimple feature can be observed in this area. The proportion of final zone area in the whole fracture surface zone was relative low, which indicated that the fatigue stress amplitude was not very large.

Fig. 4. Low magnification image of (a) the fracture surface of a failed tube and (b) the crack origin.

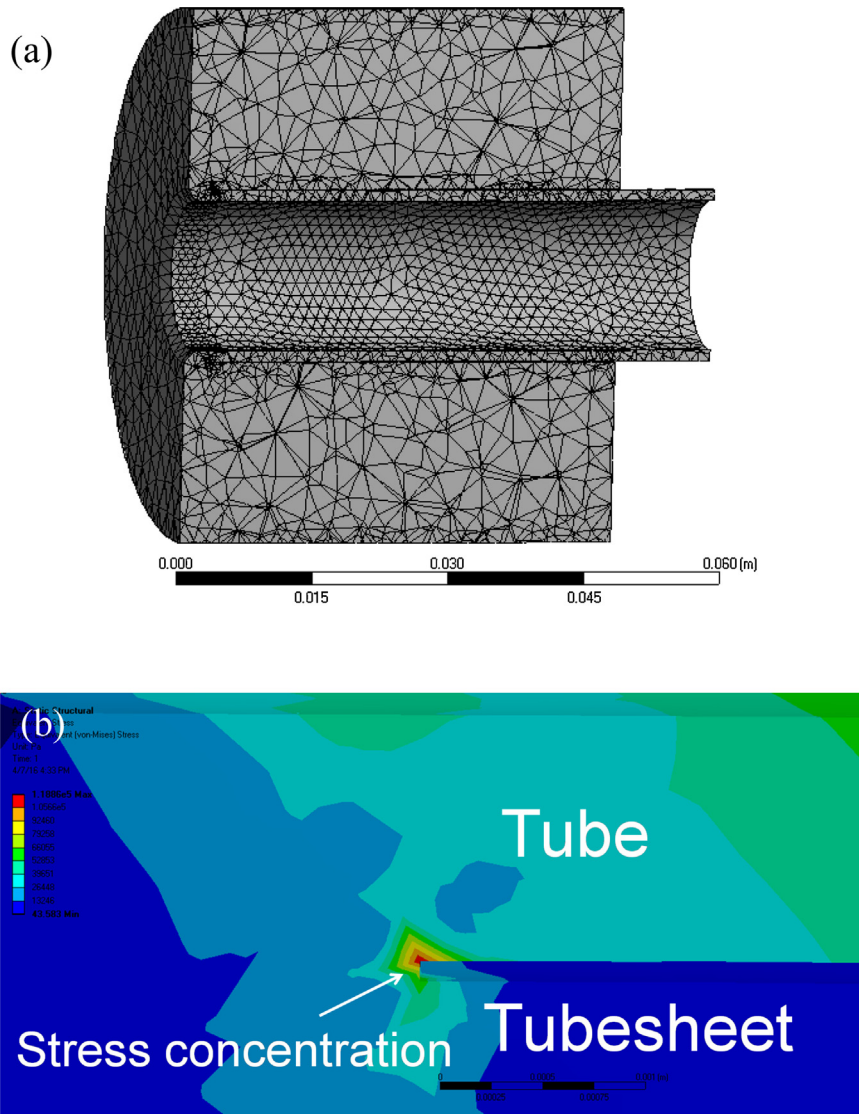
Either the welding defects or the bad expansion process might introduce stress concentrations at the welded joint. To confirm the exact position of the stress concentration, a finite element analysis was performed on the welded joint. A three dimensional model containing the tube, tubesheet and the welded joint was constructed and analyzed. As shown in Fig. 7(a), 96,553 nodes and 57,282 elements were meshed in the model. Elastic strain was simulated using the isotropic Hooke's law with Poisson's ratio and Young's modulus. As shown in the Von-Mises stress distribution (Fig. 7(b)), stress concentration, which was coincident with the crack initiation location of the failed welded joint, could be seen obviously.

Fig. 7. (a) Finite element mesh of the welded joint model; (b) Von-Mises stress distribution of the tube-to-tubesheet structure.
