Contents lists available at ScienceDirect

Case Studies in Engineering Failure Analysis

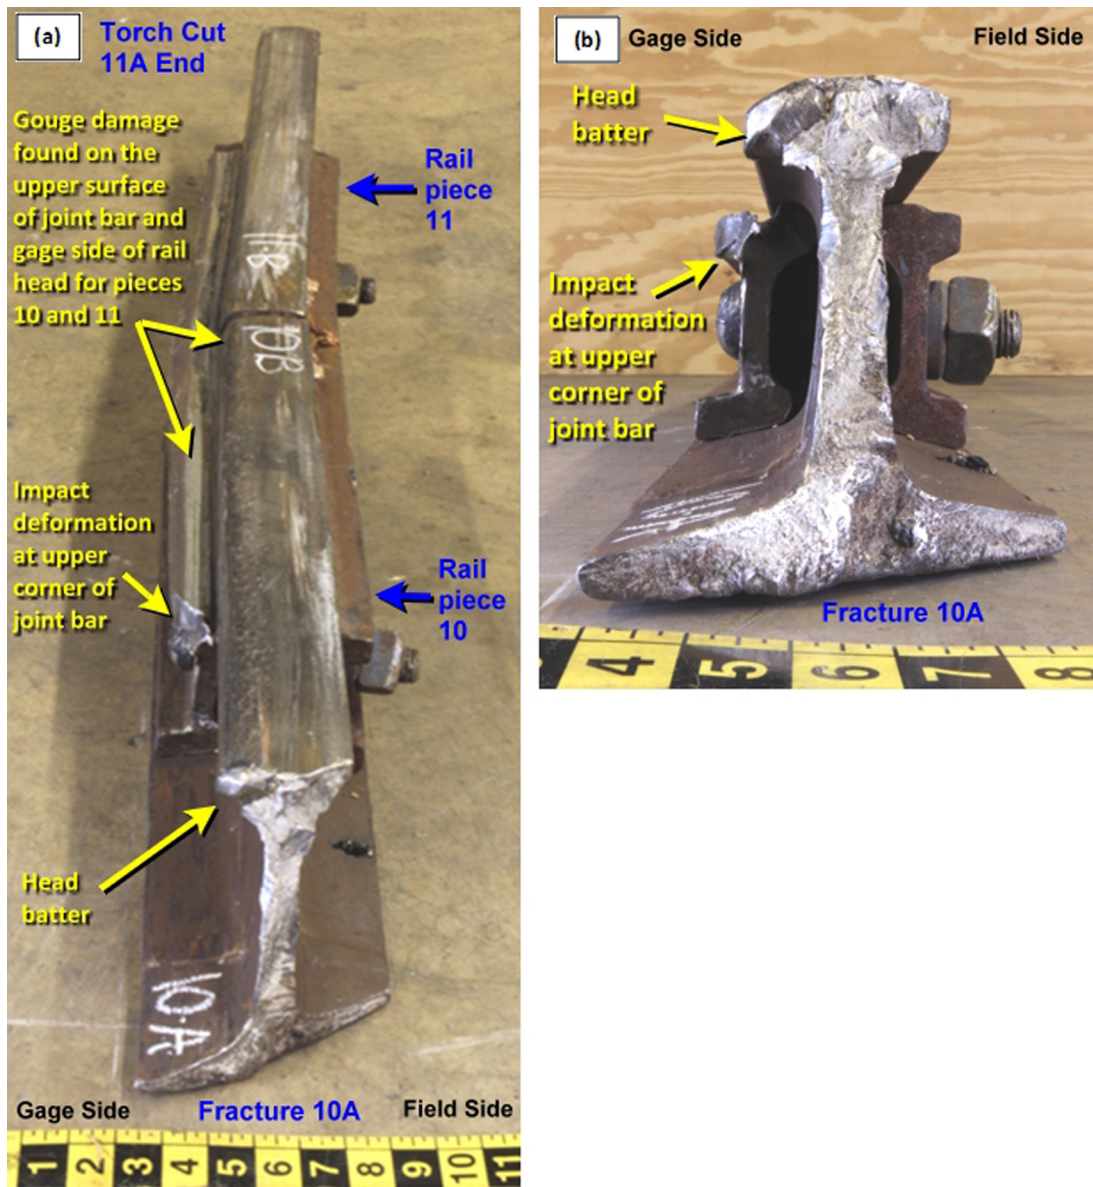
Fig. 1. Rail samples 10 and 11 showing (a) the fracture face 10A end and (b) a close-up photograph of the fracture face 10A.

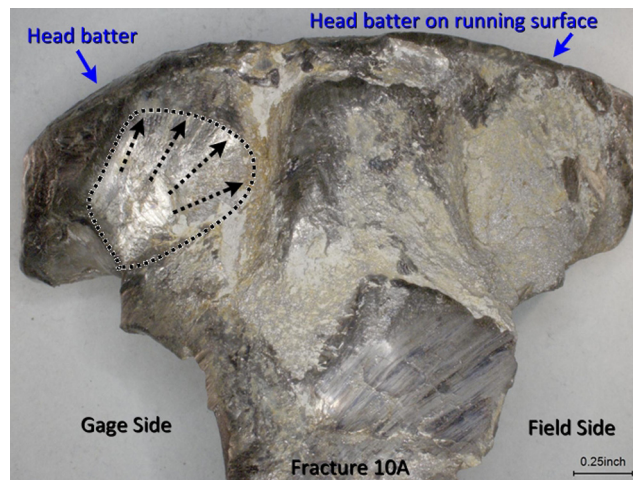
Fig. 2. Fracture face 10A excised from rail sample 10, after cleaning. The dashed circled area outlines the detail fracture (propagating in the direction of the arrows) that was present on the battered fracture surface.

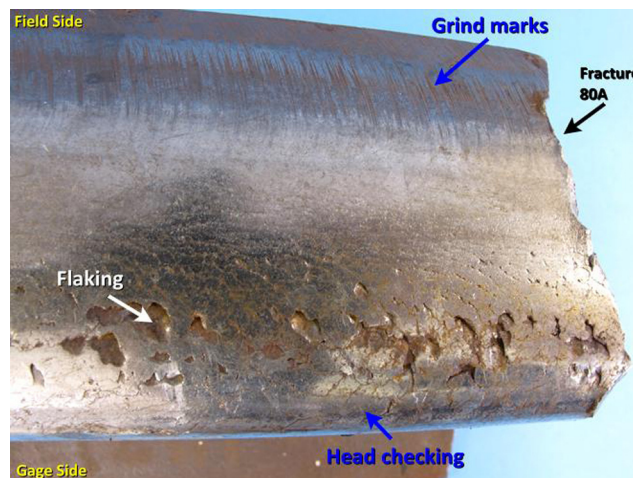
Fig. 3. The running surface of rail sample 80, showing the damage on the head adjacent fracture surface 80A. The flaking indicated in the figure refers to shallow features in the metal surface that separated from the gage corner of the rail head.

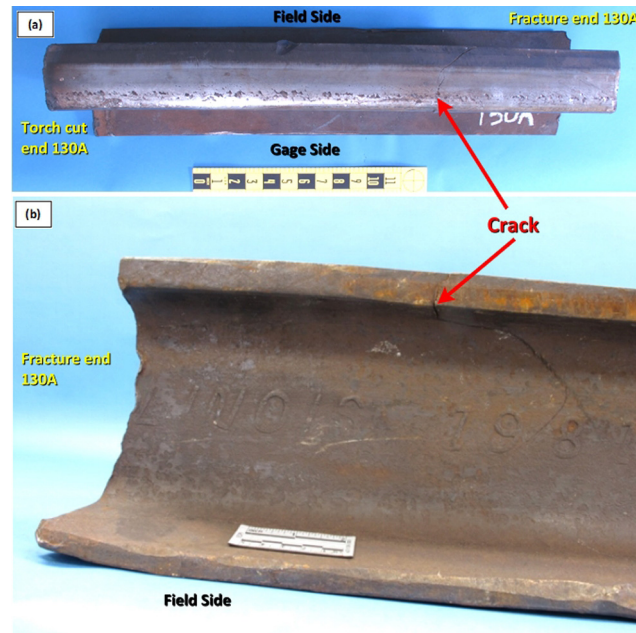
Fig. 4. Rail sample 130 from (a) running surface of the head and (b) the field side. The upper corner of the head on the gage side contained shell crack. An internal crack was visible on both the running surface and the field side of the web.

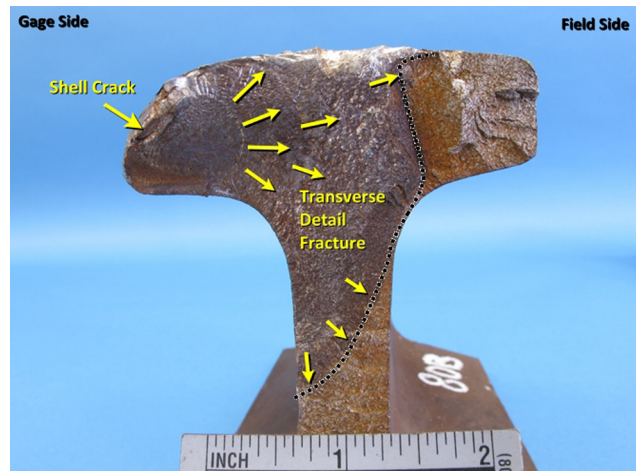
Fig. 5. Fracture surface 80A from rail sample 80, showing a transverse detail fracture that extended into the web portion from an open shell crack in the upper corner of the head.

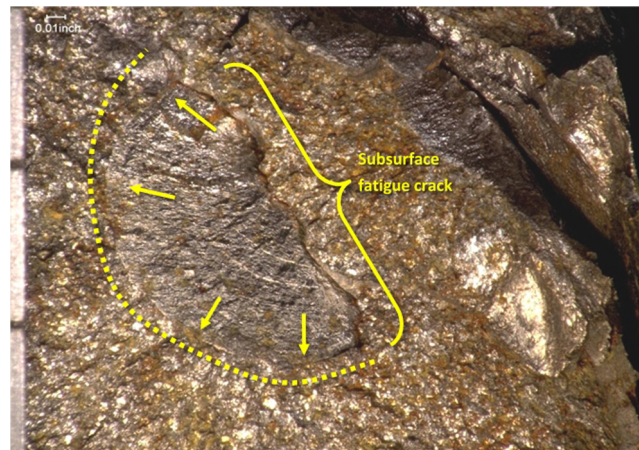
Fig. 6. The exposed fracture from the intentionally opened crack in Fig. 4, showing a subsurface fatigue crack on the gage side of the head of sample 130.

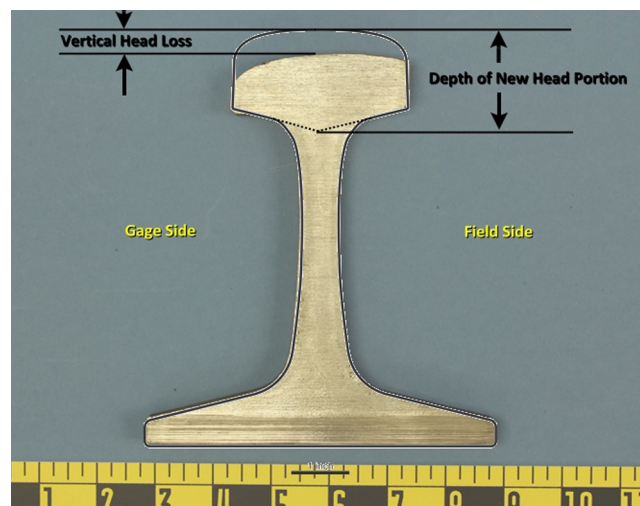
Fig. 7. Cross section of rail sample 10, 1 in. from fracture surface 10A, superimposed against the profile of new 132 pound/yard rail (indicated by black outline). The amount of vertical head loss for this piece was calculated to be approximately 29% relative to a new head.

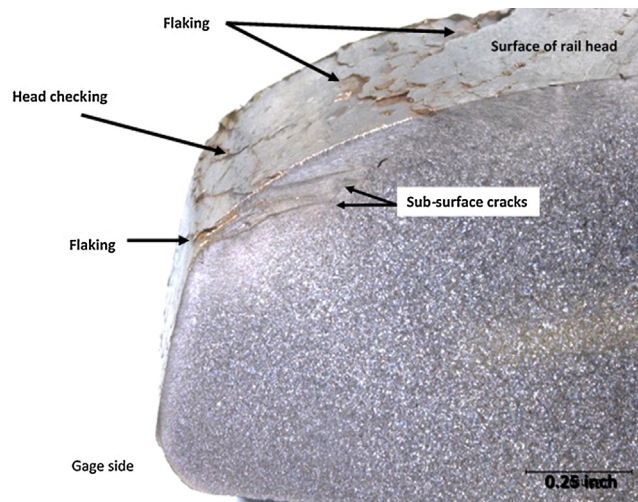
Fig. 8. Optical metallography of a cross section of the head of sample 130, showing the upper corner of the head on the gage side angled to view running side damage and prepared face. Sub-surface cracks extended from flaking areas (4% Nital etch, bright field).
