Case Studies in Engineering Failure Analysis

Damage analysis of choke bean used in an oil–gas well

A choke bean used in an oil–gas field has catastrophically failed during operation. It is shown that the damage has been caused by leakage of the corrosive and abrasive drilling fluid. The choke bean adapter made of carbon steel has been corroded and embrittled by hydrogen ingress leading to its fracture in the presence of stresses created by the pressure of accumulated fluid at the bottom section. On the other hand, the choke corner body made of stainless steel has been damaged by abrasive wear of its outer surface.

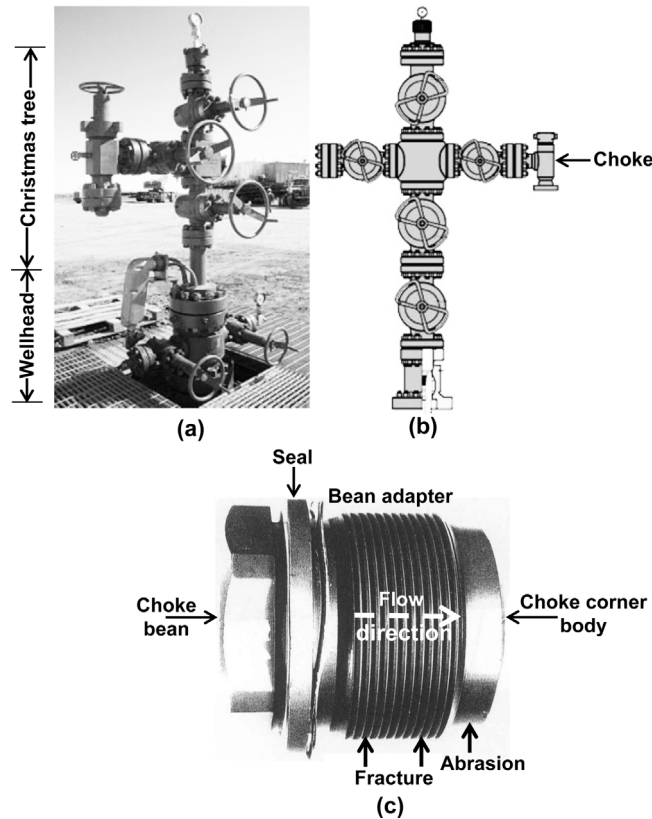
Fig. 1. An illustration of the layout of Christmas tree and wellhead showing the coke used to control the production rate and backflow of the drilling fluid. (a) A photograph showing the Christmas tree and wellhead used in oil–gas wells [2]. (b) A schematic illustration of the Christmas tree showing the location of the choke [2]. (c) A photograph of unused choke in the present study showing its components and the locations of the damage sustained during operation.

In the present case, an adjustable choke bean has been used in service at intermittent periods in an oil–gas well. During the last operation, the choke bean has catastrophically failed within the first hour of operation. The components of a choke bean never used in service are shown in the photograph of Fig. 1c. On-site inspection has shown two types of damage at the bottom of the choke as illustrated in Fig. 1c: (i) the choke bean adapter has fractured along the longitudinal direction, which is parallel to the flow direction and (ii) the outer surface of the choke corner body has sustained severe abrasive wear near the bean adapter. According specifications, AISI 1045 carbon steel and 316L stainless steels have been used to manufacture the choke bean adapter and the choke corner body respectively. The internal surface of the choke corner body has been protected by a surface layer of tungsten carbide. A water-based mud has been used as the drilling fluid. The base is an aqueous solution of Ca and Zn bromides and the solids consist of: (i) clays, (ii) organic colloids, (iii) barium sulfate to increase the fluid density and (iv) substances from the formation (region of the oil–gas reservoir) which are incorporated into the mud during drilling [14]. Items received to determine the most probable cause of failure included the failed choke components, a sample of the drilling fluid and as well as a solid mud sample.

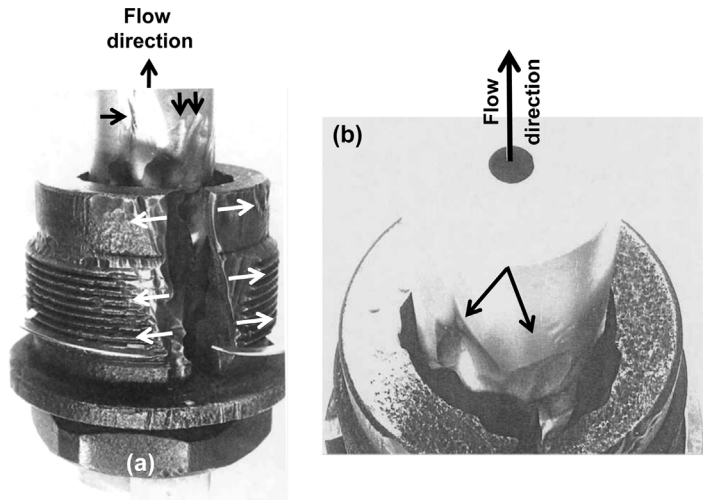
Fig. 2. Photographs illustrating the damage sustained by the choke. (a) Longitudinal fracture of the choke bean adapter and abrasive wear of the outer surface of choke corner body. (b) An illustration of the abrasive wear in comparison with the normal passage of the drilling fluid.

Since catastrophic failure has been encountered within the first hour of last operation, it is most likely that the damage sustained by the choke has been accumulative and reached the critical stage prior to the incident of failure. Photographs illustrating the respective damage are shown in Fig. 2 as well as the prescribed flow direction of the drilling fluid through the inner protected surface of the choke corner body. As shown in Fig. 2a and b, the outer surface of the choke corner body appears to have sustained severe damage by abrasive wear leading to considerable loss of material. On the other hand, the bean adapter has fractured along the longitudinal direction as shown in Fig. 2a with corrosion product observed at the exposed surfaces.

It is evident from the observations of Fig. 2 that there has been considerable leakage of the drilling fluid bringing it into contact with the wrong surfaces. Evidently, this leakage has led to continuous dripping and accumulation of the corrosive fluid at the bottom section of the choke bean adapter. Simultaneously there has been fluid flow bypassing the internal surface of the choke corner body and coming into contact with the outer surface at high speed. Fig. 2a shows that fracture of the bean adapter has occurred normal to the direction of maximum tensile stress (tangential stress) created by the fluid pressure.

To summarize, the above observations indicate that the failure has occurred due to leakage of highly abrasive and corrosive fluid bring it into direct contact with the wrong surfaces (inner surface of the choke bean adapter and outer surface of the choke corner body). This is further supported by the detailed microstructural characterization presented later.

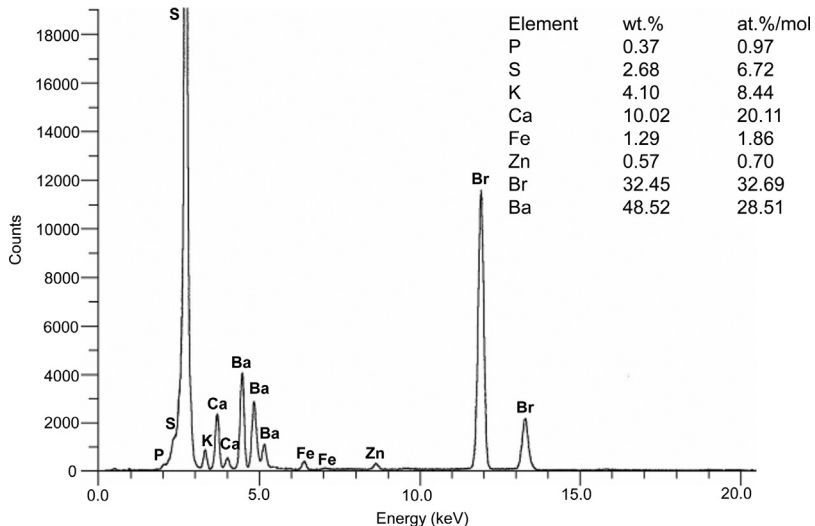
Fig. 3 summarizes the results of analyzing the composition of the drilling fluid by X-ray fluorescence noting that detection is limited to elements with atomic number ≥ 11 . The results of quantifying the spectral data are shown in the inset. It is

Fig. 3. X-ray fluorescence spectrum showing the elemental composition of the drilling fluid and the results of quantifying the spectral data.

observed that the major elemental constituents are Ba and Br with smaller concentrations of Ca, K, S and Fe, and minor concentrations of P and Zn. Fig. 4a is a secondary electron SEM image showing the morphology of the mud sample. The corresponding EDS spectrum and results of quantifying the spectral data are shown in Fig. 4b. As can be seen, Ba, O and C are the major elemental constituents with smaller concentrations of S and Ca, Mg, Si, Al and Fe, and minor concentrations of K and Na. It is possible to conclude from the data of Figs. 3 and 4 that the water-based mud of the drilling fluid has likely contained some dissolved CO₂ and H₂S as confirmed later by the results of analyzing the corrosion product deposited at the inner surface of the choke bean adapter.

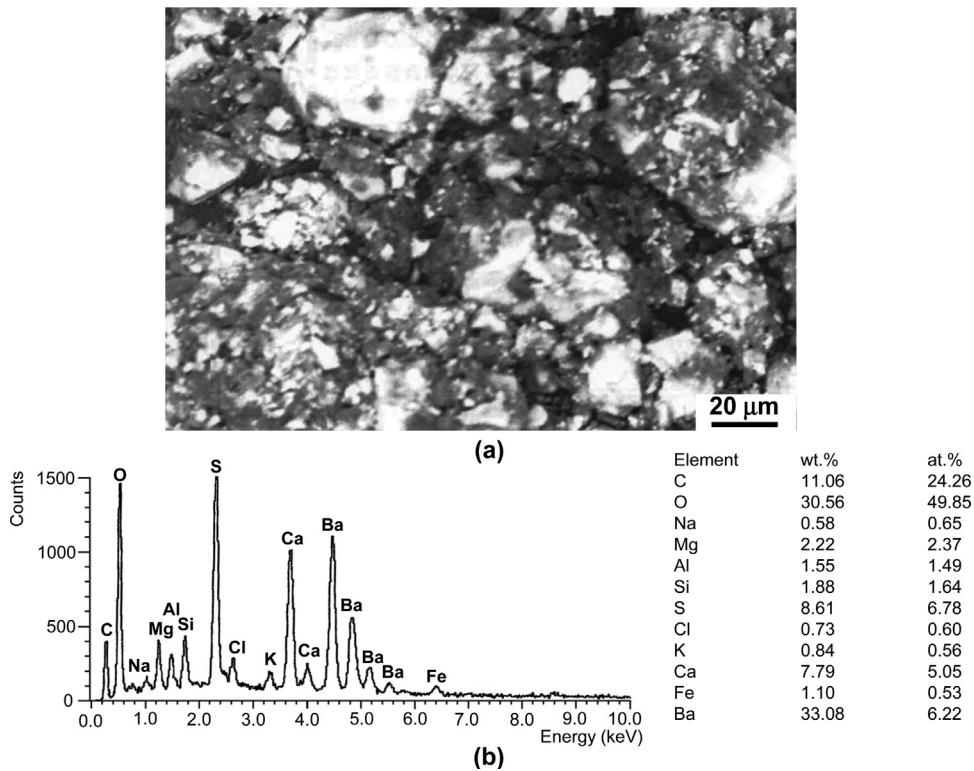
Fig. 4. Analysis of solid mud sample using SEM and EDS. (a) Secondary electron SEM image illustrating the mud morphology. (b) Corresponding EDS spectrum illustrating the elemental composition and the results of quantifying the spectral data.

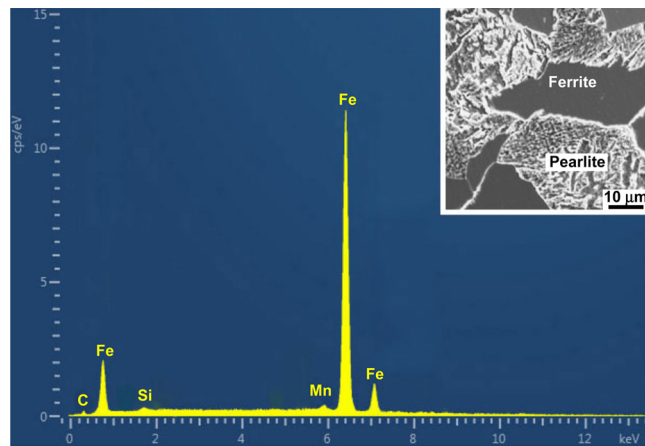
Typical microstructures of unused sections of AISI 1045 carbon steel and 316L stainless steel used in the choke application are shown in Figs. 5 and 6 respectively. Fig. 5 shows the microstructure of AISI 1045 carbon steel (choke bean adapter) consisting of a mixture of ferrite and pearlite, and corresponding EDS spectrum illustrating its elemental composition. Typical of 316L stainless, its microstructure consists of equiaxed grains with high density of annealing twins as shown in Fig. 6 with elemental composition shown in the corresponding EDS spectrum.

Fig. 5. EDS spectrum and corresponding microstructure of a specimen removed from a section of choke bean adapter never used in service (AISI 1045 carbon steel).

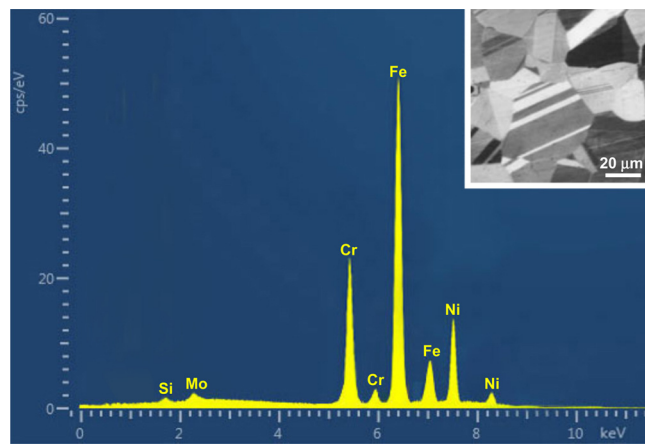
Fig. 6. EDS spectrum and corresponding microstructure of a specimen removed from a choke corner body never used in service (316L stainless steel).

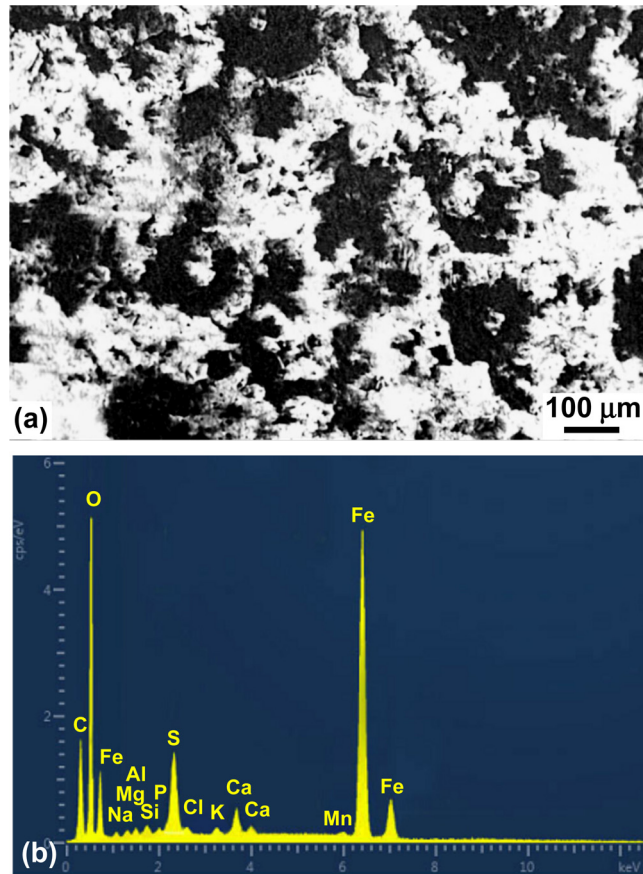
A secondary electron SEM image illustrating the gross morphology of the surface exposed by fracture of the bean adapter in the as received condition is Fig. 7a. The corresponding EDS spectrum of Fig. 7b shows that Fe and O and C and S are the major elemental constituents of the surface scale with smaller concentrations of Ca and minor concentrations of Na, Mg, Al, Si, P, K and Mn suggesting that iron carbonate (FeCO₃) is the major component of the scale with smaller amount of iron

sulfide (FeS) With the exception of Mn, which is present in the steel, Ca and other minor elements could have been incorporated into the scale from the drilling fluid.

Deposition of both iron carbonate and iron sulfide at the surface of carbon steel as suggested by the spectral data of Fig. 7b is shown to be possible in acidic solutions due to the presence of aqueous solutions of CO₂ and H₂S in oil–gas wells [15,16]. Formation of the two phases occurs according to the following reactions [15]:

Fig. 7. Analysis of the corrosion deposit observed at the internal surface of the bean adapter near the fracture surface. (a) Secondary electron SEM image illustrating the gross morphology of the corrosion product. (b) Corresponding EDS spectrum illustrating the elemental composition.

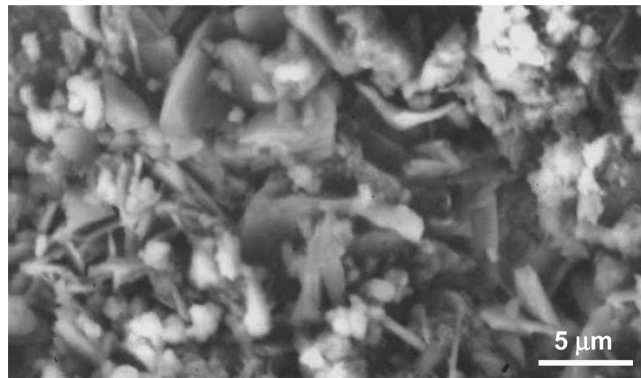
Fig. 8. Morphology of the corrosion deposit in Fig. 7a as viewed at higher magnification.

The morphology of the scale shown in Fig. 7a as viewed at higher magnification is shown in Fig. 8.

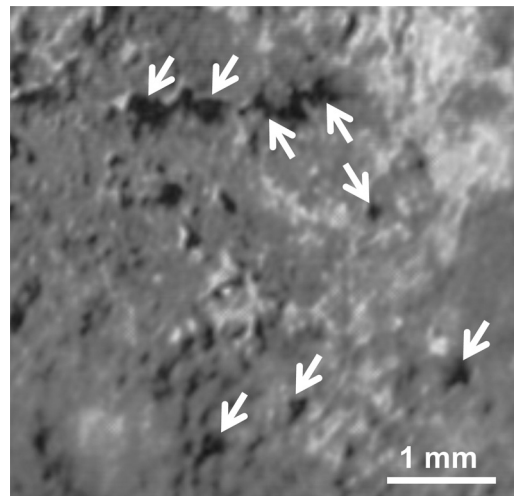
An example illustrating characteristic macroscopic features of the surface exposed by fracture of the choke bean adapter after descaling is shown in Fig. 9. Voids scattered throughout the surface and small secondary cracks are observed as indicated by the arrows. Fig. 10 shows the morphology of the fracture surface in comparison with the microstructure of a sound section of the steel as viewed at the same magnification. A one-to-one correspondence appears to exist between the two images in Fig. 10 suggesting that fracture has occurred intergranularly particularly near the pearlite colonies. On the other hand, the average surface hardness in the vicinity of the major crack is found to be R_c 86, which is comparable to that of

Fig. 9. Secondary electron SEM image illustrating the macroscopic morphology of the surface exposed by fracture of the choke bean adapter after descaling, voids and secondary cracks are indicated by the arrows.

the steel never used in service (R_b 84–87) indicating that the fracture is not related to a hardening effect. Instead, most evidence points out that it is related to hydrogen embrittlement as discussed below.

grain boundaries, twin boundaries and dislocations. Continued absorption of elemental hydrogen, can eventually lead to precipitation of molecular gaseous hydrogen (H_2) at internal interfaces. This precipitation is relaxed by formation of internal voids and cracks, which can cause severe embrittlement [17,18]. It is well known that the resistance of steels to hydrogen embrittlement is dependent upon the exact microstructure with the lowest resistance exhibited by pearlitic-type such as that used in the present application [17,19,20]. It is likely, however, that the intergranular effect near the pearlitic colonies results from their preferential anodic dissolution.

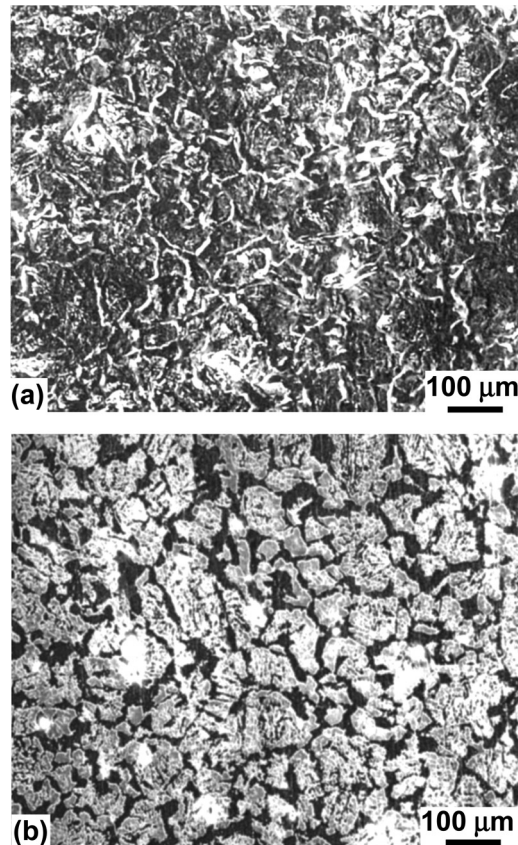
Fig. 10. Secondary electron SEM images illustrating the morphology of fracture surface of the choke bean adapter (a) in comparison with the grain structure of the bean adapter as revealed by polishing and etching (b).

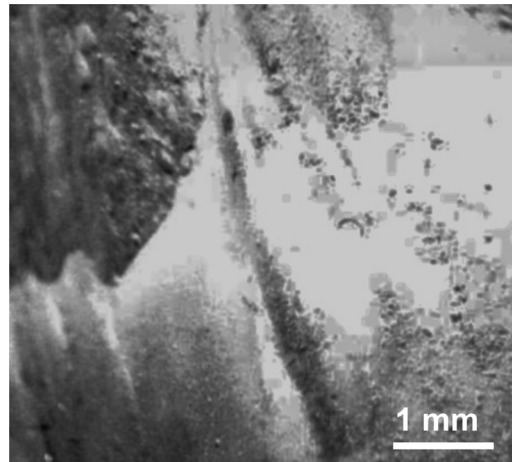
Fig. 11. Secondary electron SEM image illustrating the macroscopic morphology of the outer surface of the choke corner body.

Fig. 11 is a secondary electron SEM image showing the macroscopic morphology of the outer surface of the choke corner body. The morphology is characteristic of that produced by abrasive wear of stainless steels [21]. Abrasive wear is known to involve three mechanisms: (i) plowing, (ii) cutting and (iii) fragmentation [21,22]. Plowing usually occurs by the formation of plastically deformed grooves [23,24] such as those shown in Fig. 12a. Closer examination of the grooves at higher magnification reveals the presence of two characteristic features as shown in Fig. 12b: (i) fine striations (region 1) resembling slip traces and (ii) dimple-type rupture morphology (region 2) resembling that of fracture produced by microvoid coalescence. Furthermore, fine closely-spaced ridges are also observed within the grooves as shown in Fig. 12c, which can be related to removal of material in the form of chips leaving behind ridges at the metal surface [25].

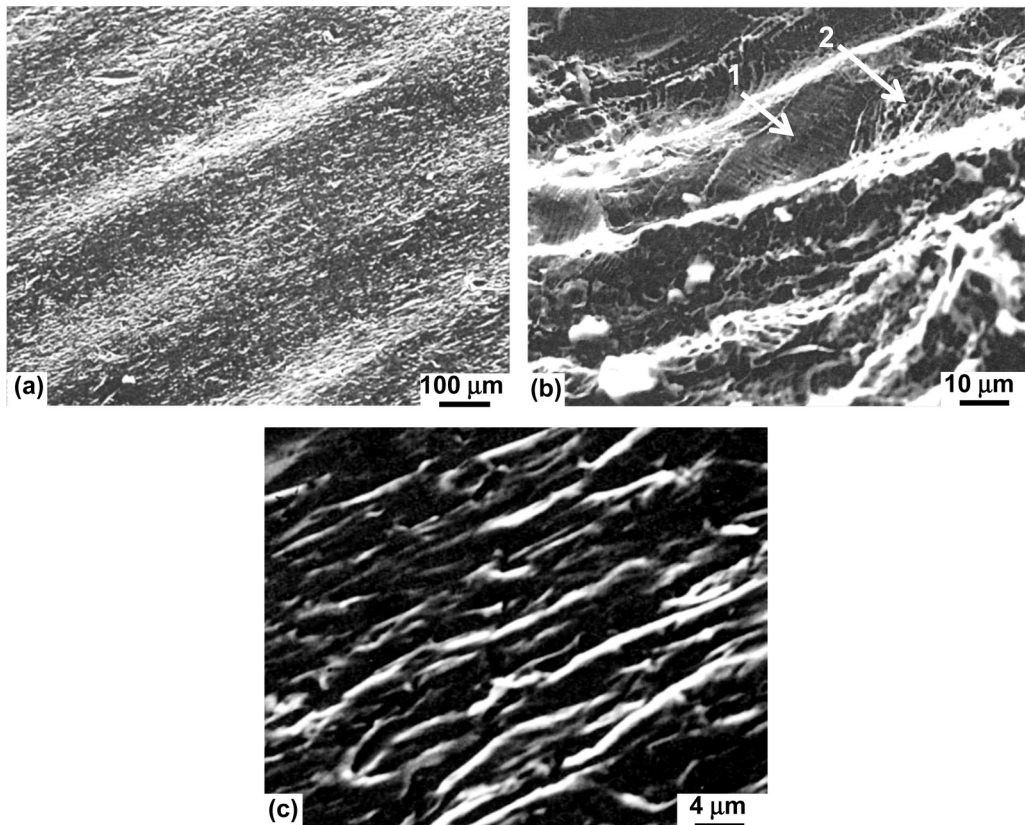
Fig. 12. Secondary electron SEM images illustrating the morphological details of the outer surface of the choke corner body. (a) Gross morphology of grooves created by plowing. (b) Fine striations resembling slip traces (region 1) and region with morphology characteristic of dimple-type rupture (region 2) observed in a groove. (c) Closely spaced ridges observed at higher magnification.
