Case Studies in Engineering Failure Analysis

Effect analysis of an arc-strike-induced defect on the failure of a post-tensioned threadbar

A temporary threadbar used for precast segmental construction broke during the post-tensioning stage before reaching the service load. Failure analysis showed that the premature failure of the bar was due to the presence of an arc strike. The arc strike effects on the material and threadbar integrity are considered.

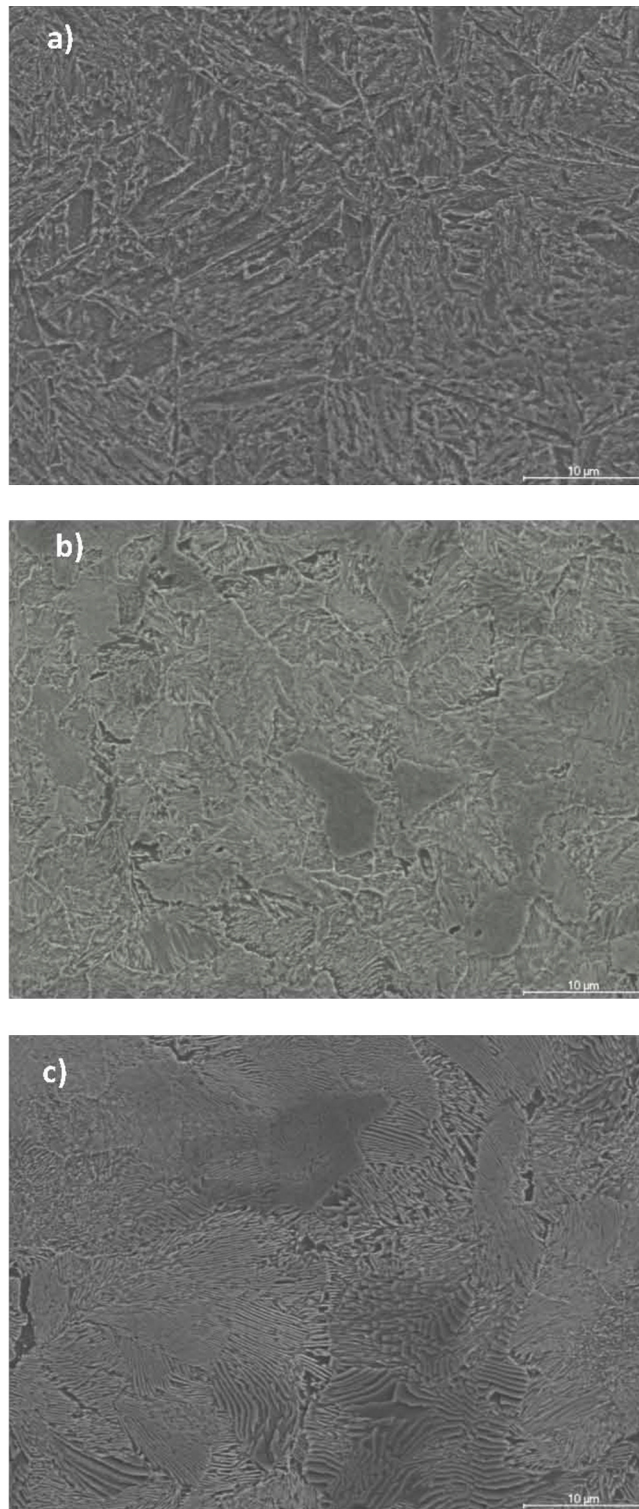
Microstructural analysis was performed on a cross section far from the fracture, which was etched with 2% Nital. The microstructure was a fine perlite in the bar center and a tempered martensite on the surface ring that was approximately 1.4 mm deep, Fig. 1. These microstructure differences are caused by cooling rate differences from the rolling temperature to room temperature during bar processing.

Fig. 1. SEM micrographs showing the threadbar microstructure far from the fracture. (a) Near the surface, the microstructure consists of tempered martensite. (b) At one-quarter of the diameter, the microstructure consists of bainite and fine perlite. (c) Near the bar center, the microstructure consists of perlite.

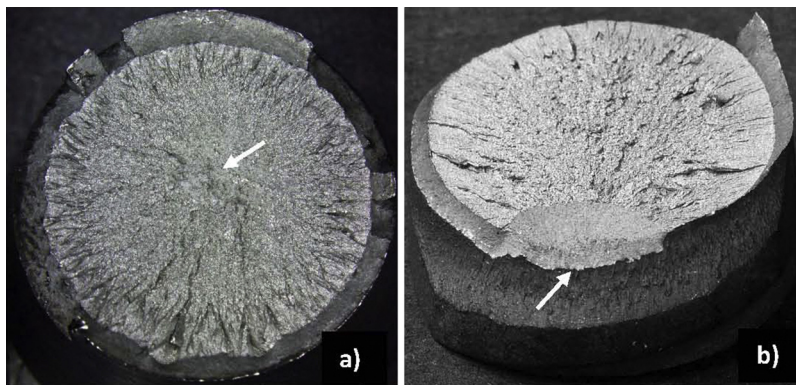
Two types of samples were tested: threadbar samples with a 700 mm length and tensile specimens with a 24.4 mm diameter and 150 mm gage length. This diameter was chosen to obtain from the threadbar cross section, the maximum circular cross section at the specimen gage length. Tensile tests of the threadbars were carried out according to ISO 15630-3 [3], whereas those of the specimen were carried out according to ISO 6892-1 [4]. Table 2 presents the pull test results. To obtain the YS and UTS of the threadbar, the nominal cross section (552 mm^2) was considered. The obtained results for both test types agree with each other and confirm the ASTM A722 standard specifications [5]. In both cases, the fracture occurred after an appreciable plastic deformation. Apparently, the fracture initiation modes are different, as shown in Fig. 2. In the tensile specimen, the fracture initiates at the cross section center, and in the threadbar, the fracture initiates at the surface. This can be explained by taking into account the fact that the ductile fracture initiates at the location where the stress triaxiality state is maximum. For the tensile specimen, the fracture initiates at the center of the cross section, which is the location where the stress triaxiality state is maximum (once the necking has developed) after, the fracture concentrically advanced via microvoid coalescence and finalized unsteadily via a cleavage mechanism with isolated ductile areas. For the threadbar, the fracture occurred similarly, except for the fracture initiation, which occurred at the surface ridge basis because this is the location where the stress triaxiality state is maximum. It is likely that small elongation differences were caused by these fracture initiation mode differences.

Fig. 2. Appearance of fractures in the tensile specimens: (a) Machined tensile specimen. (b) Threaded bar sample. The white arrows indicate the initiation point of the fracture.

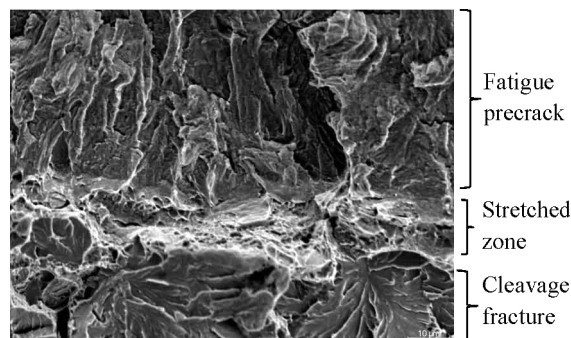
Fig. 3 shows a typical SEM image of the fracture mode of the specimens. It demonstrates the fatigue precrack, the stretching of the fatigue precrack-tip with some isolated microvoids and the final fracture via cleavage.

Fig. 3. SEM micrograph showing the fracture surface fractographic features of the fracture toughness specimens.

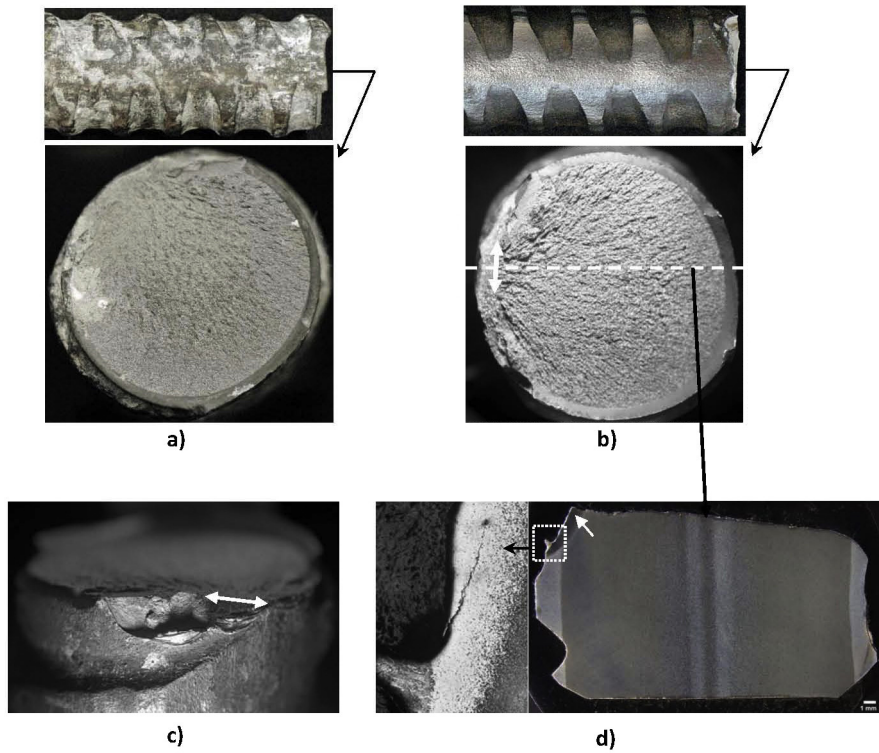
The threadbar failure occurred without plastic deformation. When the fracture surface was observed with a naked eye, some directional tear ridges were observed (Fig. 4(a) and (b)). By tracing back the directional features it was possible to identify the fracture initiation zone. The fracture started from a linear segment with an approximate 9 mm length located

2.5 mm from the bar surface. By analyzing the bar surface in the immediate vicinity of the fracture initiation zone, a material alteration, presumably caused by an arc strike (AS), was observed (Fig. 4(c) and (d)).

To demonstrate how the AS modified the threadbar material, a longitudinal cross section containing the fracture profile through the initiation zone was metallographically prepared, as shown in Fig. 4(b) and (d). The following was observed: a remnant of molten metal with a microstructure consisting of proeutectoid ferrite and ferrite side plates in prior austenitic grain boundaries and intracolumnar very fine perlite (Fig. 5(a)); a cracked white layer of approximately 1 mm thickness of unmelted material transformed by the heat to martensite with a profusion of defects in the grain boundaries (Fig. 5(b)). The fracture initiation took place at the interface between the molten metal, which was presumably lost during fracturing, and the martensite layer, as shown in Fig. 5(b) (left). Furthermore, the Vickers hardness (9.8 N) variation with distance from the surface at the AS vicinity was investigated. Fig. 6 reveals that the hardness increases from 350 HV1 in the unaffected material to 800 HV1 in the martensite layer. The hardness of the molten metal remnant was 388 ± 60 HV0.3 ($n=5$).

Fig. 4. Macroscopic aspects of the threadbar broken during service: (a) as received state. (b) After the cleaning process. The double white arrow indicates the linear segment from which the fractures initiated. (c) View of the surface affected by the AS. (d) The longitudinal cross section showing the AS-induced material alteration; the white arrow indicates the fracture initiation point.

Fig. 4(a) (bottom) shows the macroscopic view of the fracture in service. The fracture surface immersion in a 6 N hydrochloric acid solution containing 2 g/L of hexamethylenetetramine inhibitor for 1 min was sufficient to gently remove the traces of rust from the fracture surface.

In terms of the equivalent carbon, the steel used for the manufacture of prestressed threadbars is not weldable. Therefore, it should be neither welded nor locally heated to high temperatures.

Contact with molten slag and unintentional arcing should be anticipated.

The work system should include protection and inspection of the bars until the completion of any welding work.

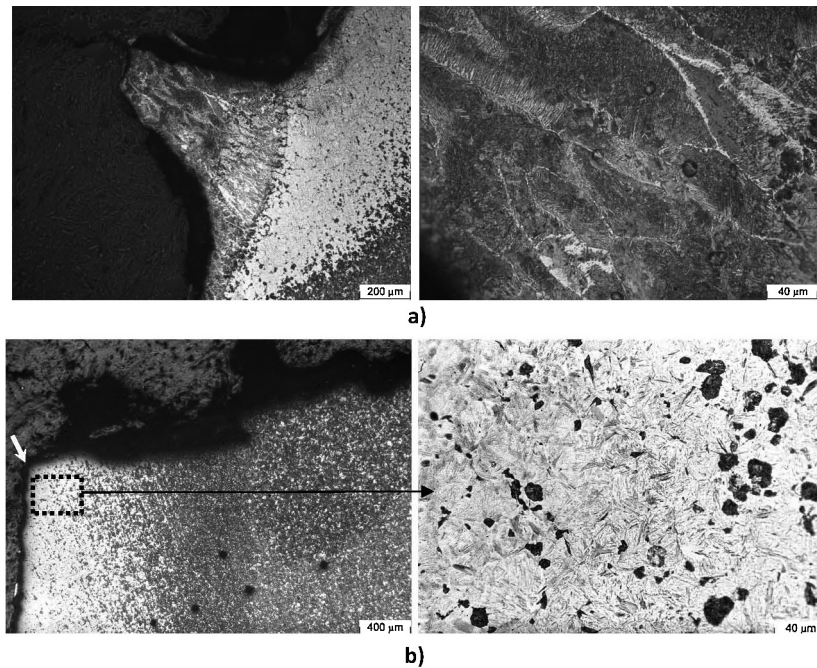
Fig. 5. AS-induced microstructure: (a) microstructure of the molten metal showing a columnar grain structure with proeutectoid ferrite and ferrite side plates at the prior austenitic grain boundaries and intracolumnar very fine perlite. (b) Under the molten metal: martensite with a significant profusion of defects in the prior austenitic grain boundaries; the white arrow indicates the fracture initiation point.

The hydrogen in molten metal results from the arc-induced dissociation of organic molecules on the bar surface or environmental moisture. Because the molten metal was not environmentally protected during the AS process, it is probable that hydrogen was present in the molten metal and martensitic layer. Furthermore, as shown in Fig. 5(a) (right), in the molten metal, the spherical cavities around the inclusions are presumably a consequence of the recombination of atomic hydrogen to form molecular hydrogen or even methane bubbles from the reaction of carbon with hydrogen. Because of the low martensite toughness, the hydrogen bubbles at the martensitic layer grow and merge to form extensive intergranular discontinuities, as shown in Fig. 5(b) (right).

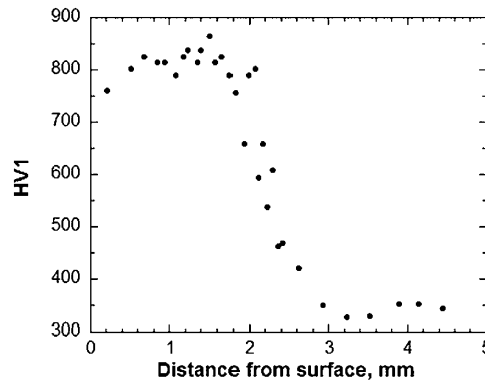
Fig. 6. Variation of the Vickers hardness (9.8 N) with distance from the bar surface in the AS affected zone.

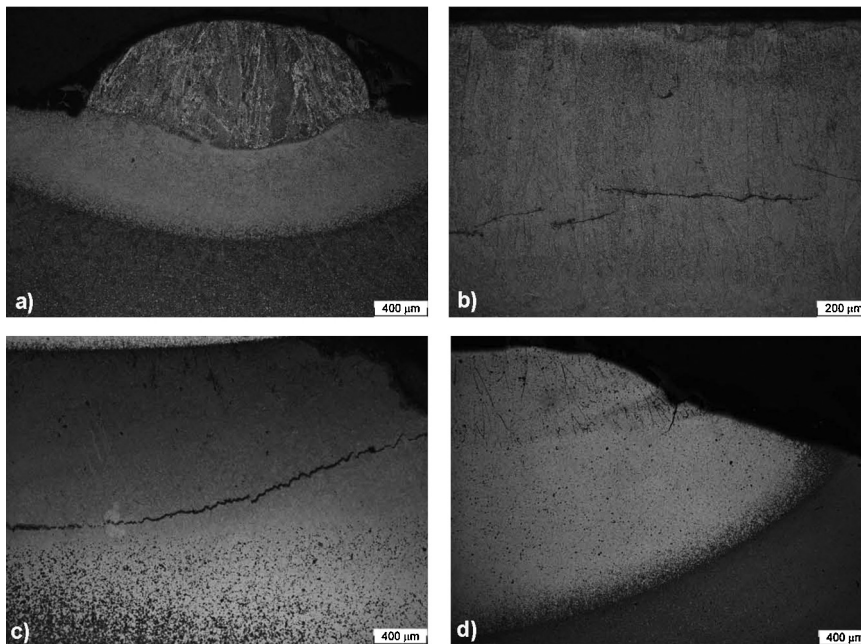
The AS longitudinal and transverse cross sections were prepared metallographically to evaluate the AS-induced damage. Fig. 7 shows representative AS-induced defects found in the bars. Only in one AS were no defects observed (Fig. 7(a)). In other cases, cracks at the molten metal parallel to the bar axis (Fig. 7(b)), at the heat-affected zone bordering the molten metal (Fig. 7(c)) or a small surface crack emerging at the toe of the molten metal and contouring it (Fig. 7(d)) were found. Because of

the cracking runs parallel to the contour of the solidified molten metal (Fig. 7), the possible damage to the threadbar is limited to the AS-affected material spalling. These defects are similar to those referred to in welding as “cold cracking” [10].

Fig. 7. Optical micrographs showing the representative details found in the bars of the AS-induced damage. (a) No macroscopic AS-induced damage. (b) Crack at the molten metal parallel to the bar axis. (c) Crack at the heat affected zone bordering the molten metal. (d) Surface crack at the toe of the molten metal.

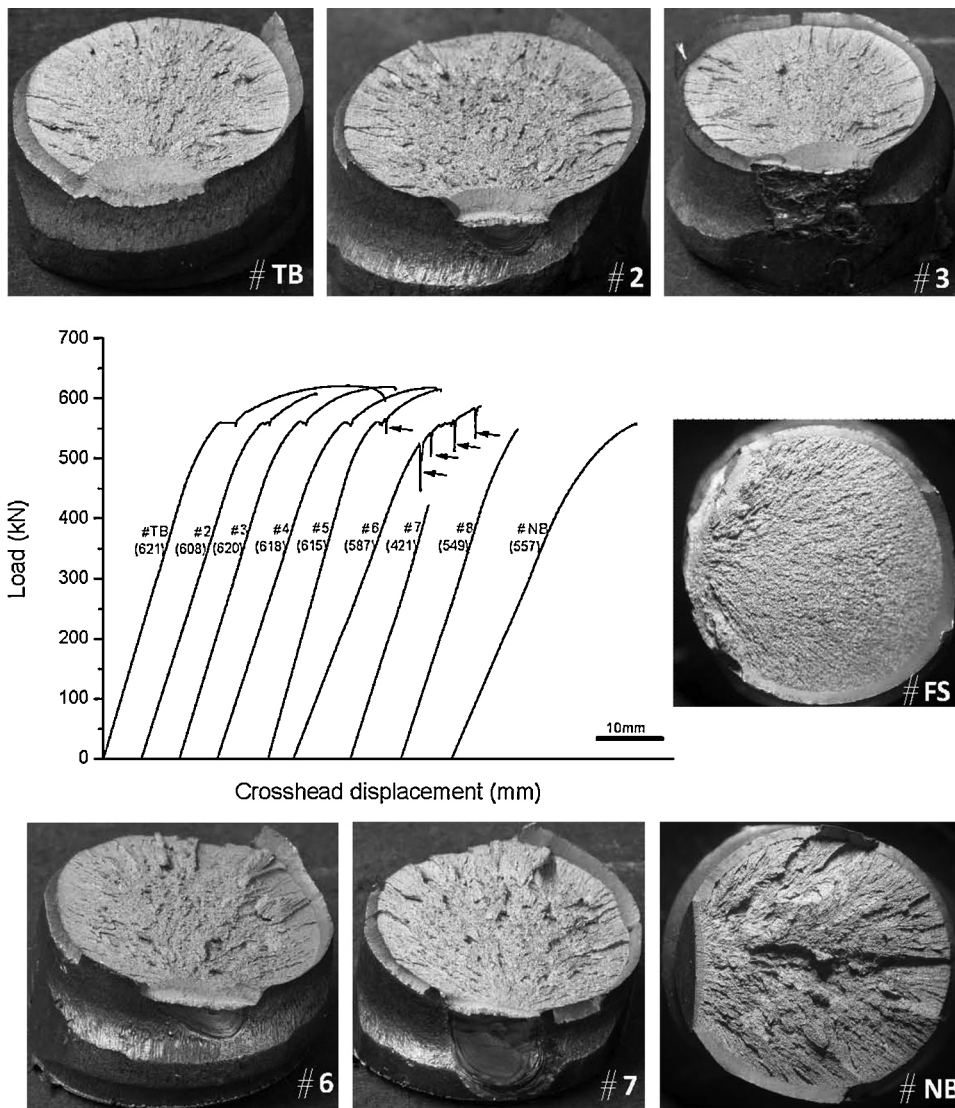
Fig. 8. Load-displacement curves for the undamaged (test #TB), AS-affected (tests #2 to #8), and notched (test #NB) bars, and macrofractographs showing the appearance of the fracture surface of the samples. Additionally, for comparative purposes, the fracture appearance of the broken during service threadbar is shown. The black arrows indicate a pop in. The numbers in brackets are the rupture load values.

Tensile samples of the AS-affected threadbar were tested at the same conditions as the abovementioned undamaged sample. Fig. 8 shows the AS effect on the tensile behavior and the corresponding fracture appearance. For comparative purposes, the following information was included in the figure: the test curve of an undamaged threadbar (TB), the test curve of a threadbar with a transverse arc-shaped notch with a 100 mm curvature radius, 0.25 mm thickness and 1.95 mm depth (NB); and the fracture appearance of the bar that was broken during service (FS). The first conclusion one draws from this figure is the wide tensile behavior variation of the AS-affected threadbar. It is remarkable that for some samples (#2, #3, #4, and #5) the AS did not affect the yield load. Whereas for others (#3 and #4), the AS did not affect the yield load or the ultimate load. However, the location of the rupture is AS-determined. In test #5, a local brittle fracture (pop-in) was noted during tensile testing, but the material fracture toughness was sufficient to stop the crack and allow further plastic deformation to reach the final brittle fracture condition. In test #6, four pop-ins took place prior to reaching the final brittle fracture condition. Test #7 was the only test in which the sample broke in the elastic region of the load-elongation curve prior to reaching the service load of 0.7 times the ultimate load. Moreover, the fractographic features of the fracture surface of the sample are very similar to that of the fractured bar in service. It is worth mentioning that except for test #7, in the remaining tests, some ductile crack extension prior to the final brittle fracture was produced. In tests #8 and #NB, the final brittle fracture took place at approximately the yield load. It is clear that the AS-induced defect severity can be higher than in the notched sample.

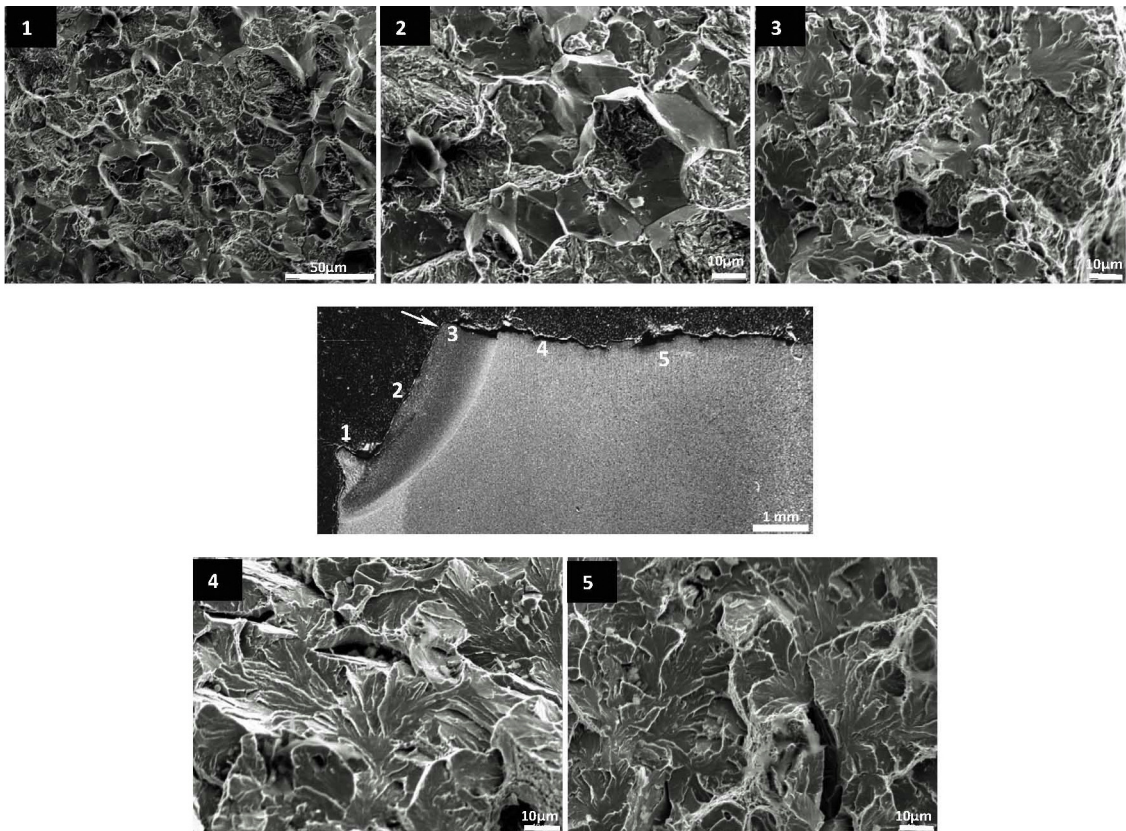
Fig. 9 shows a series of SEM micrographs taken at different positions along the fracture surface near the fracture initiation point. SEM micrographs #1 and #2 show the fractographic features of the spalled zone. SEM micrograph #1 of the molten metal fracture surface shows a mixture with a similar ratio of microvoid coalescence and intergranular brittle fracture. SEM micrograph #2 shows the fracture surface morphological features of the unmelted heat affected zone that consists of the intergranular brittle fracture and, to a lesser extent, microvoid coalescence. The fractographic features near the fracture initiation point (SEM micrograph #3) consisted of the cleaved facets with some microvoid coalescence zones. When the region near the initiation site was studied at successively higher magnifications, it was not possible to identify the microstructural feature that triggered fracture initiation from the converging segment of distinct fan-like radiating fracture patterns. The fractographic features in SEM micrographs #4 and #5, which correspond to the crack propagation stage, primarily consist of the cleavage facets with isolated patches of microvoid coalescence.

Although the failure mechanism of the threadbar it is still not fully clear, the above findings seem to indicate that a microcrack initiates at the martensitic layer and propagates unsteadily toward the bar surface across the molten metal to form a semielliptical surface crack. If crack extends throughout the remainder bar cross section depend on the size of that surface crack. If the crack size is smaller than a critical value a pop in will take place, as occurred in the tests #5 and #6 (Fig. 8). Otherwise, the dynamically growing crack will extend across the remainder cross section.

Fig. 9. SEM fractographs of the bar broken during service. The #1 and #2 SEM fractographs show the intergranular brittle fracture with microvoid coalescence at the spalled zone. The #3 SEM fractographs show the cleavage fracture with isolated areas of microvoid coalescence near the initiation point. The #4 and #5 SEM fractographs show the essentially brittle fracture with extensive cleavage facets at the unsteady propagation zone. The white arrow indicates the fracture initiation point.
