Case study of severe strip breakage in rolling mill of Thin Slab Casting and Rolling (TSCR) shop of TATA Steel, Jamshedpur

Quality Assurance – Thin Slab Caster and Rolling, Product Technology – Flat Products, TATA Steel Ltd, Jamshedpur 831001, India

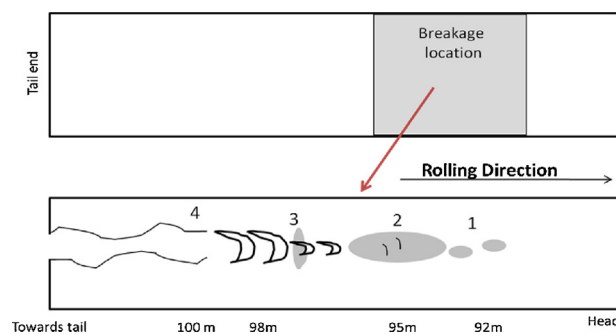
Strip breakage was observed in between F5 and F6 stands of the finishing mill. The processing details of the low-C low-Mn slab under study are represented in Table 1. Visual observation of the stock piece around the breakage location is schematically represented in Fig. 1. A white stringer like defect was observed at location 1 (Fig. 1) as shown in Fig. 2. At location 2 (Fig. 2) of the stock, heavy amount of whitish patches were noticed as seen from Fig. 2. Through thickness cracks in the strip were also observed at the location of the white patches. Large holes (location 3) were found at close vicinity to the white patch (~3 m) as shown in Fig. 2. Finally, complete splitting (location 4) was noticed with material missing from the central portion of coil behind the holes as shown in Fig. 2. It is at this location that the mill was stopped on emergency. The white stringer, heavy white patches, holes and complete separation were noticed along the same axis of the coil: 630 mm from its drive side. It may be noted that no anomalies were observed in stock portions remaining in the mill behind the F5 stand.

Fig. 1. Visual observation around strip breakage portion collected from mill between F5 and F6 stands (Schematic representation).

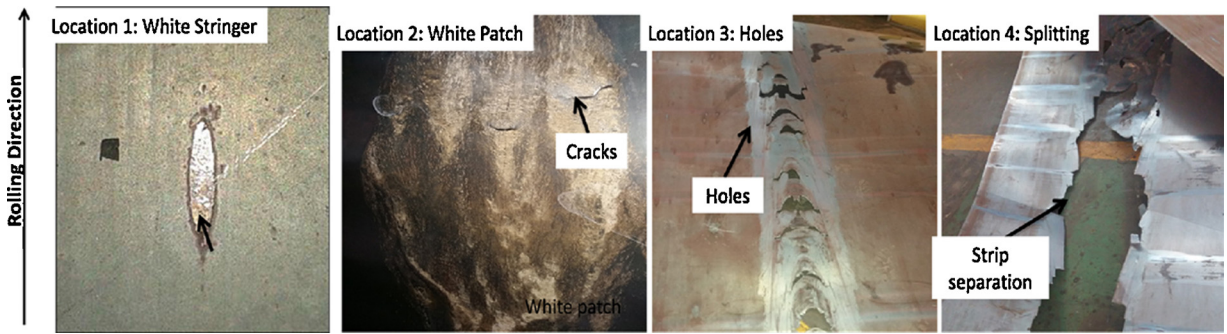
Fig. 2. Location 1 – White stringer; Location 2 – Large white patch; Location 3 – Chevron holes; Location 4 – Complete separation along the central location of coil.

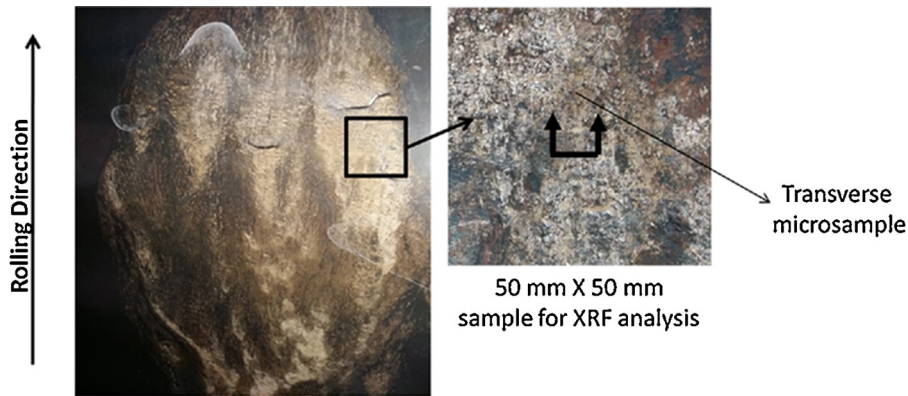
Fig. 3. Sampling procedure from the location of white patch.

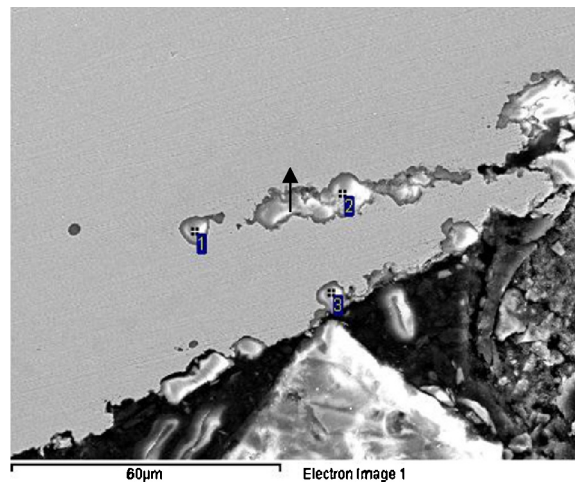
SEM micrograph of unetched transverse microsample prepared from location 1 revealed entrapment of non-metallic inclusions (NMI) as shown in Fig. 7. Optical microscopic observation (Leica, model: DMRX, Germany) of the strip at the

Fig. 7. SEM observation at the location of white stringer revealing inclusions.

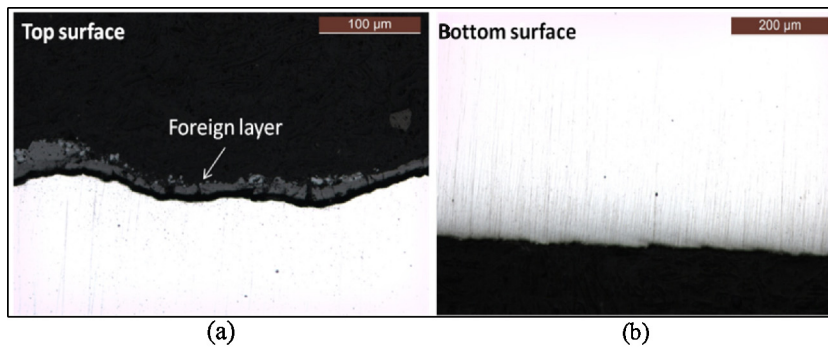
location 2 is shown in Fig. 8(a). It revealed an undulated top surface with a loose layer of foreign material of 35 μm thickness in its close vicinity. Such undulations or foreign layer are not observed at the bottom surface of the strip at this location as shown in Fig. 8(b). Since the white patch was also observed on the top surface of the strip, it may be believed that the loose foreign layer in the microstructure is nothing but the white patch.

Fig. 8. Optical microscopic observation of (a) top surface revealing undulations and loose foreign layer and (b) bottom surface without undulation and foreign layer.

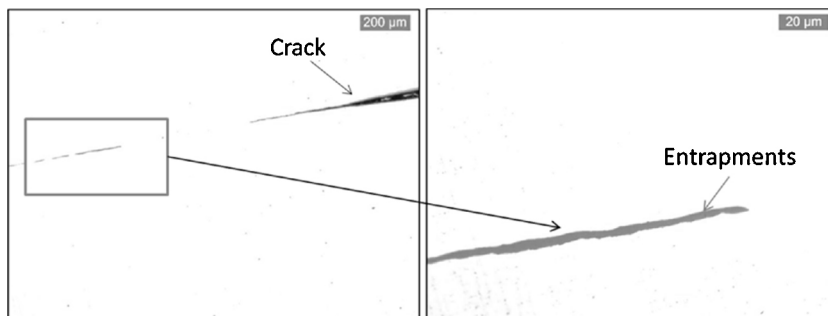
The crack like defect at the edges of the first hole reveals the entrapment of similar foreign entrappings at the tip of the crack as shown in Fig. 9 [2].

Fig. 9. Optical microscopic observation revealing entrappings at the tip of the crack.

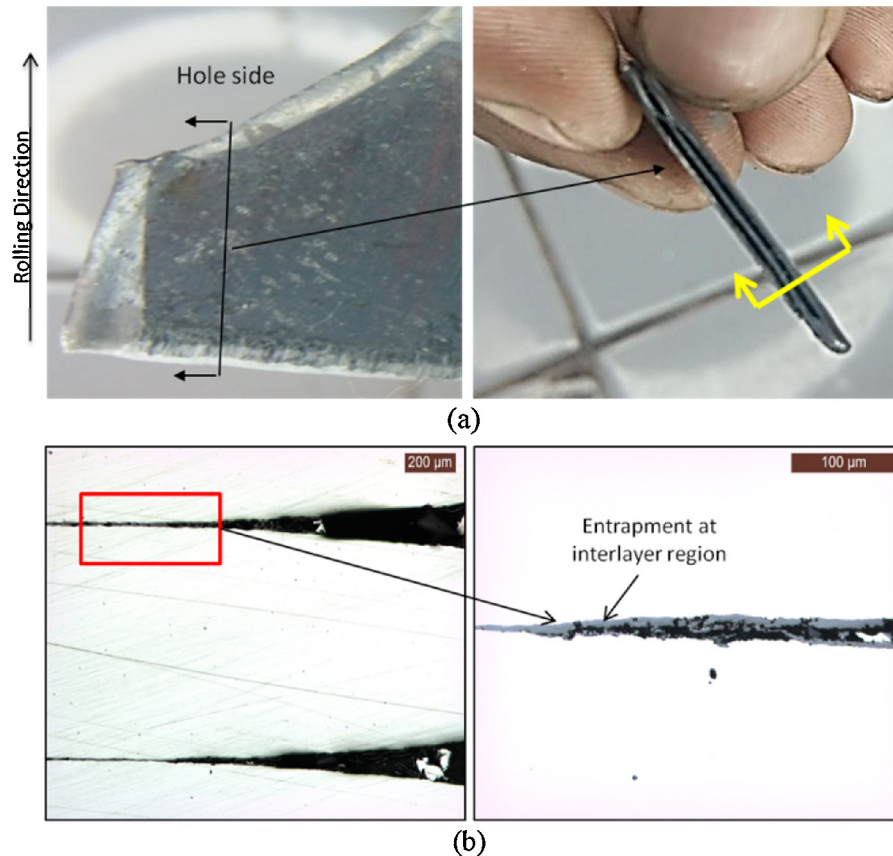
Stereo observation of longitudinal specimen prepared from the other hole as shown in Fig. 6 reveals three different layers. These are shown in Fig. 10(a) and indicate material overlapping. The inter-layer region in the longitudinal microsample also shows the presence of foreign materials as seen in Fig. 10(b). The same microsample on etching revealed a gradient of ferrite

Fig. 10. (a) Observation of multi-layer in the longitudinal sample from the hole. (b) Optical microscopic observation revealing entrapments at the inter-layer region.

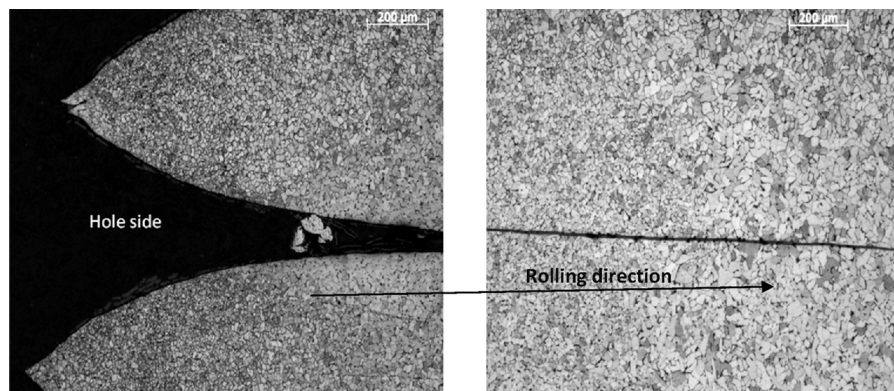
grain size along the rolling direction as seen from Fig. 11. Material adjacent to the hole is seen to have a much finer microstructure and locations away from the hole are observed with coarse grains as observed from Fig. 12.

Fig. 11. Optical microstructure (longitudinal) revealing grain size variation along longitudinal direction at the chevron-crack location.

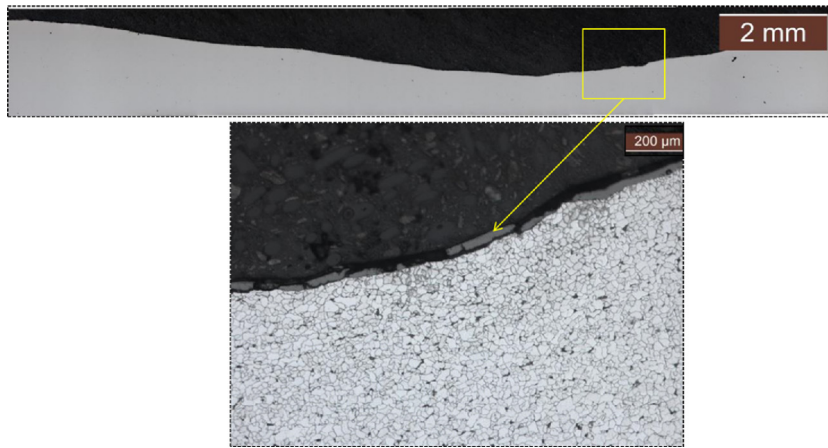
The longitudinal microsample prepared from location 4 revealed foreign materials along the separated edge of the strip as shown in Fig. 12.

Fig. 12. Longitudinal microstructure along split edge of strip showing the presence of foreign material.

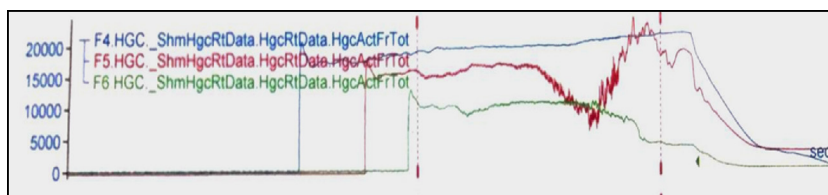
The Level-2 automation system recording of roll separating forces experienced by F4–F6 stands during rolling of the strip under study are represented in Fig. 13 [4]. It can be observed that roll force of F4 stand was fairly stable. However, the roll force profile of F5 stand was anomalous, showing a sudden drop followed by a sharp rise. The drop of roll separating forces indicates the presence of discontinuities in the stock entering F5 stand. Therefore, it may be believed that such discontinuities (holes) may have formed during rolling in F4 stand.

separating force as observed, explaining the subsequent drop in the roll forces of F5. The roll forces of F6 show a drop before the stoppage of mill, indicating the same discontinuities passing through it. No such rise in the roll separating forces of F6 stand is observed. This clearly indicates that the overlapped material at F5 is rolled to its target thickness, further validating the reason for the rise of roll forces of F5.

Fig. 13. Profile of roll separating force in F4 and F5 rolling stands.

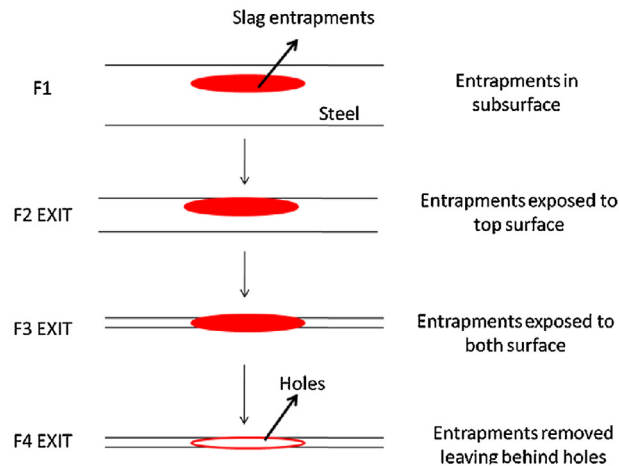
At the locations of heavier concentration of such foreign material, rolling to lower thicknesses may have exposed the material on both the surfaces. The material ultimately gets removed due to their low deformability, leaving behind holes. Remnants of such foreign materials at the crack like defects at the corner of the holes in location 3 clearly relate the origin of these holes to these foreign materials. The hypothesized mechanism of formation of holes is represented in Fig. 14.

Fig. 14. Mechanism of hole formation in strips during rolling.

The presence of foreign materials leads to differential rolling which is the root cause of the strip breakage. The foreign material is identified to be of secondary steelmaking type slag. It is known that ladle slag can be drawn into the tundish towards the end of teeming from the ladle. To prevent slag from entering the tundish, a slag detection system is installed in the slide gate of the ladle. Slag detecting systems like AMEPA[®] detects the presence of slag through electrical resistivity method, based on which feedback is received by the slide gate mechanism to continue or block the flow of liquid steel. The slag detection system generally gets activated when 15–20 T liquid steel is remaining in the ladle, below which chances of entrapments increases. Since in thin slab casting, there is a practical constraint of slab inspection or scarfing, it is recommended that such slag detection systems must remain activated throughout the duration of casting from a ladle. In case any slag entrapment is noticed, such slabs should be rolled into thicker sections in order to avoid such breakages.
