# Case Studies in Engineering Failure Analysis

# Fracture failure analysis of 4Cr13 stainless steel linkages in circuit breakers

Wu Wang-ping

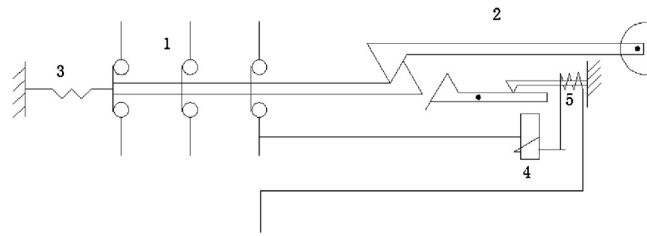
In this study, some single-phase circuit breakers (voltage 220 V, frequency 50 Hz) did not normally work during installation processing in one workshop. The 1.45In ampere-second characteristic test was disconnected. The schematic diagram of the circuit breaker is shown in Fig. 1. The free linkage 2 was fractured at the position of 90° angle. It was found that 4Cr13 steel linkage was fractured in the circuit breaker. Fracture modes of many steels were ductile, brittle intergranular or transgranular, fatigue fracture, hydrogen-brittleness. The other reason of fracture failure was even the presence of flaws and foreign inclusion. Hou et al. [3] analyzed fracture mechanism of a 30CrMnSiA steel shaft was fatigue fracture resulting from

Fig. 1. Schematic diagram of a circuit breaker. 1 – main contact, 2 – free linkage, 3 – main drawspring, 4 – short-circuited release, 5 – overload release.

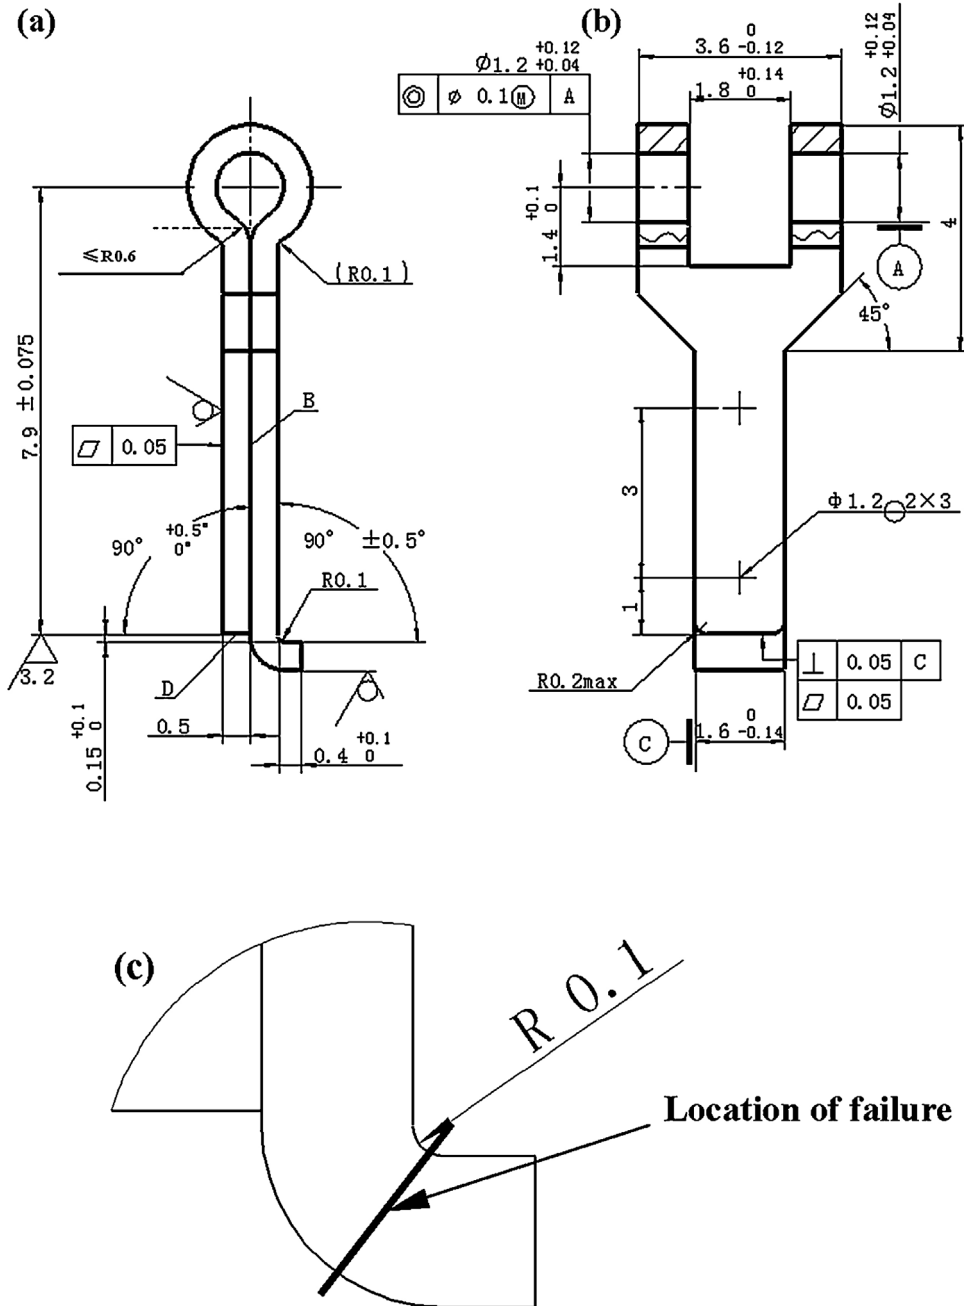
Fig. 2 shows the planar geometrical graphs of linkage component. The component was composed of one 90° right angle (the location of failure in Fig. 2c), three R0.1 chamfers and one R0.6 chamfer. The components were manufactured by twice annealings, then twice bendings, subsequently spot welding, quenching and tempering, lastly plating an electroless nickel phosphorus layer. In the first state, the annealing operation of the component was set at a temperature of  $880 \pm 10$  °C and holding 1–2 h, and the subsequent the furnace cooled to room temperature. In the second stage, the upper plate was bonded tightly to down plate by a spot welding process. Subsequently, the annealing operation was again done at a temperature of  $700 \pm 20$  °C and keeping 1–2 h, and then slow cooling to room temperature. The quenching was set at a temperature of  $700 \pm 20$  °C and holding for 25 min, and following oil cooling to room temperature. The tempering temperature was in the range of 510–530 °C.

Fig. 2. Planar geometrical graphs of 4Cr13 linkage. (a) Side view, (b) front view and (c) location of failure.

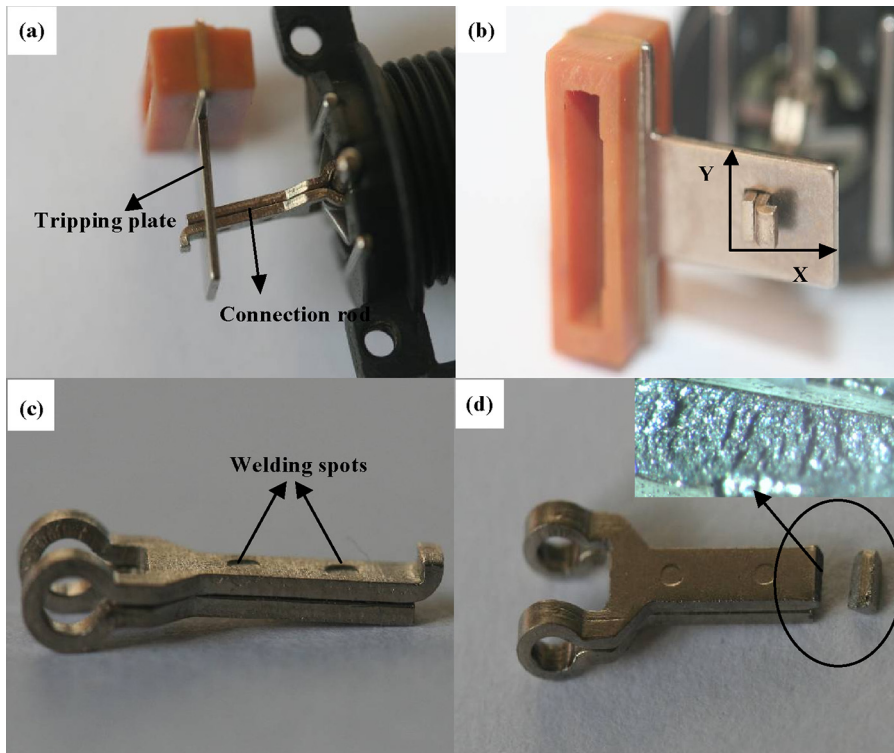
Fig. 3 shows the macrographs of 4Cr13 linkage and the other components. In Fig. 3a and b, the tripping plate was connected with the rod through a square opening with the size of  $1.05 \text{ mm} \times 1.8 \text{ mm}$ . The size of lateral (X) and longitudinal (Y) directions was 1.0 mm and 1.6 mm, respectively. Therefore, the rod could solidly connect with the tripping plate. During loading condition, there was an elastic force at the position of 90° angle. In Fig. 3c, two solder joints were present on the surface. The spot welding had an influence on the microstructure and mechanical properties of local region near the solder joint on the surface of the component. The component had to be annealed, subsequently. Fig. 3d displays the macrograph of the fractured rod. From the optical micrograph, the fracture surface shows the metallic silver, and a 45° angular along the fracture surface was observed. After the observation and analysis, the fracture failure of the component was brittle fracture in an overloading condition.

Fig. 3. Macrographs of the linkage and the other components. (a) The tripping plate with positive side and rod, (b) the tripping plate with the other side and rod, (c) linkage and (d) fractured sample.

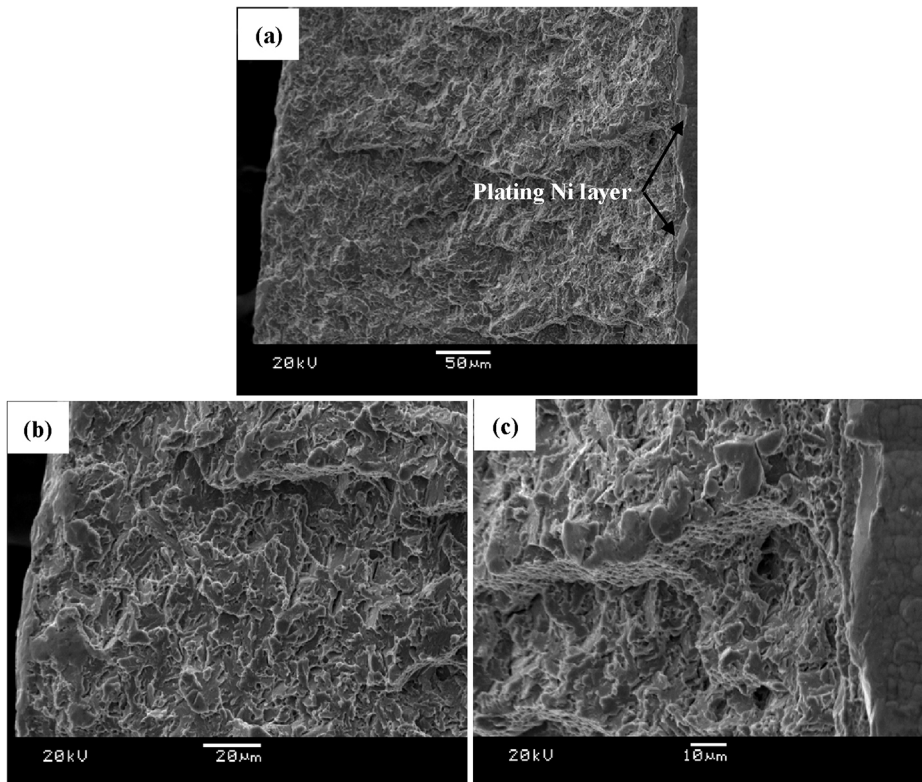
Fig. 4 shows the SEM images of the fracture surface of the component. Fig. 4a illustrates the low magnification image of the fracture surface. The nickel phosphorus layer was plated on the surface of the component. The inner and outer zones of the fracture surface are shown in Fig. 4b and c, respectively. It can be observed that the fracture surface was composed of cleavage terrace, dimple and river pattern. It can be inferred that the fracture failure mode was quasi-cleavage fracture with tore edge.

Fig. 4. SEM images of fracture surface of the component. (a) Fracture surface, outer (b) and inner (c) zones at the position of 90° angle

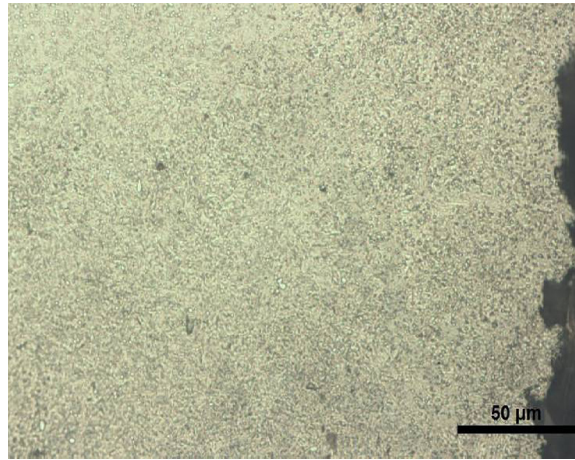
Fig. 5 displays the optical image of the fracture surface of the component. It can be observed that the grains were fine, and no cracks were present on the fracture surface. After high-temperature tempering, the microstructure of 4Cr13 component

was mainly composed of tempered sorbite, which was a dispersed variety of pearlite with a eutectic mixture of ferrite and cementite. These structures were in line with those of 4Cr13 stainless steel after quenching and tempering.

Fig. 5. Optical image of the fracture surface of the rod.

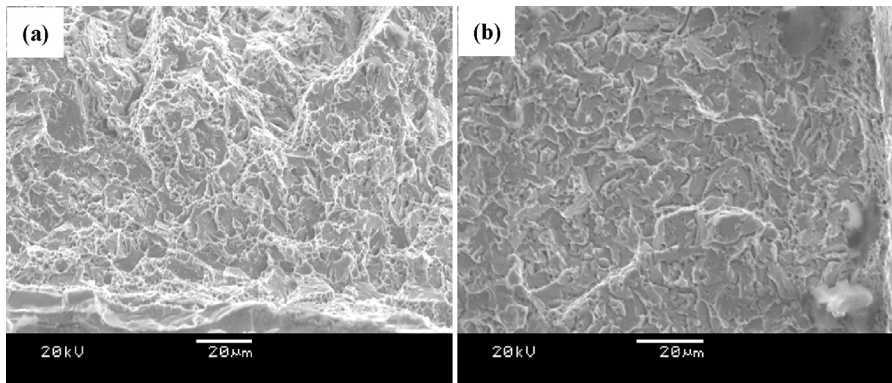
The SEM images of the fracture surface of the component are shown in Fig. 6. Fig. 6a shows the SEM image of the fracture surface of the standard sample. Fig. 6b displays the SEM image of the fracture surface of the substandard sample. Compared with the fracture surface of the standard sample, the cleavage terrace and dimple on the fracture surface of the substandard sample were obvious. It can be inferred that the heat treatment influenced the microstructure of the component. The effect of manufacturing process on the microstructure and mechanical properties of linkage component was further discussed.

Fig. 6. SEM images of fracture surface of standard (a) and substandard (b) samples.

During heat treatment and manufacturing processing for 4Cr13 linkage component, the microcrack was induced sensitivity, finally resulting in the fracture failure of the components under overloading condition. The prevention of 4Cr13 components should control and check the raw material, which could affect the properties of the components. Furthermore, we should control the several special processes, such as the heat treatment processing, annealing, quenching and tempering, and observe the surface of the bending parts after twice bendings, and even plan to test the hardness of the components and other detection technologies. Last, the microcracks should be carefully checked again in each special process. Avoid mechanical damage to the surface, such as scratches and dents, because they can act as crack initiation sites. It was carefully adapted to make installation, operation or maintenance, which was recommended as necessary corrective actions for failure prevention.
