Case Studies in Engineering Failure Analysis

Research on the failure of the induced draft fan's shaft in a power boiler

Center of Technology Research, Shenhua Guohua Electric Power Research Institute Co., Ltd, Beijing 100025, PR China

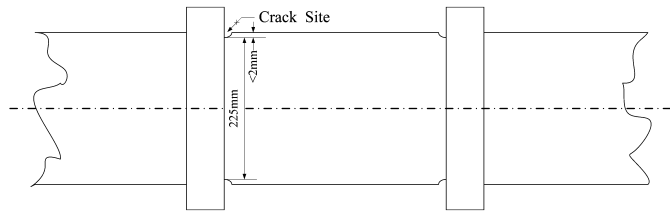
Fig. 1. The schematic diagram of the cracking location on the shaft.

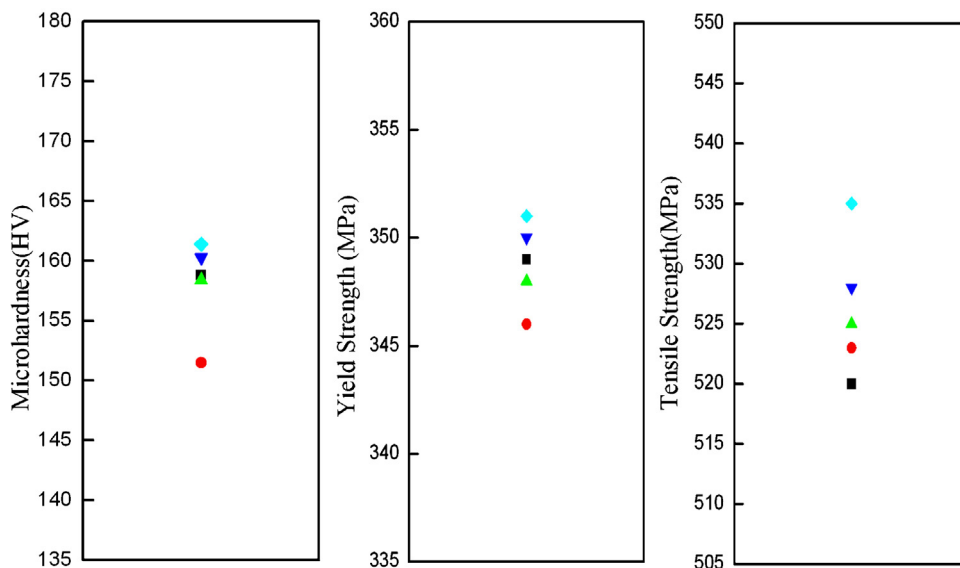
Fig. 4 showed the microhardness, yield strength and tensile strength of the failed material. The average of microhardness, yield strength and tensile strength were about 157 HV, 349 MPa and 527 MPa respectively, which showed the material property met the corresponding National standard [10]. That proved the material applied was good at the quality and the shaft failure was not relate to the material property.

Fig. 4. The mechanical property of the applied material.

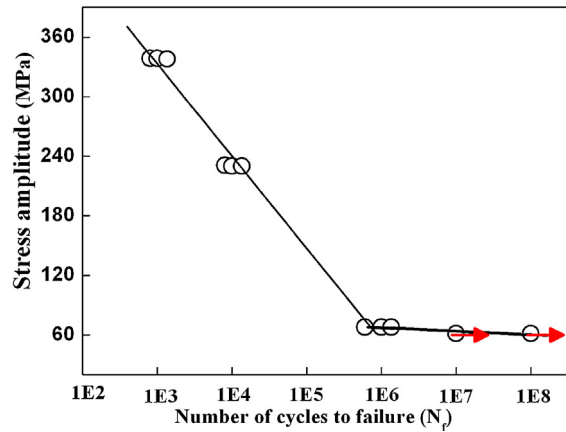
The S–N curve of Q345B based on the ultrasonic fatigue experiment was shown in Fig. 5. With the reduction of the stress level, the fatigue life increased gradually. But the cyclic time was always higher than 10^6 when the stress amplitude was lower than the shaft's fatigue strength (σ_{-1}) which was about 265 MPa. It was close to the value (269 MPa) which was calculated by following the equation [11]

Fig. 5. The applied material's S–N curves based on the ultrasonic fatigue.

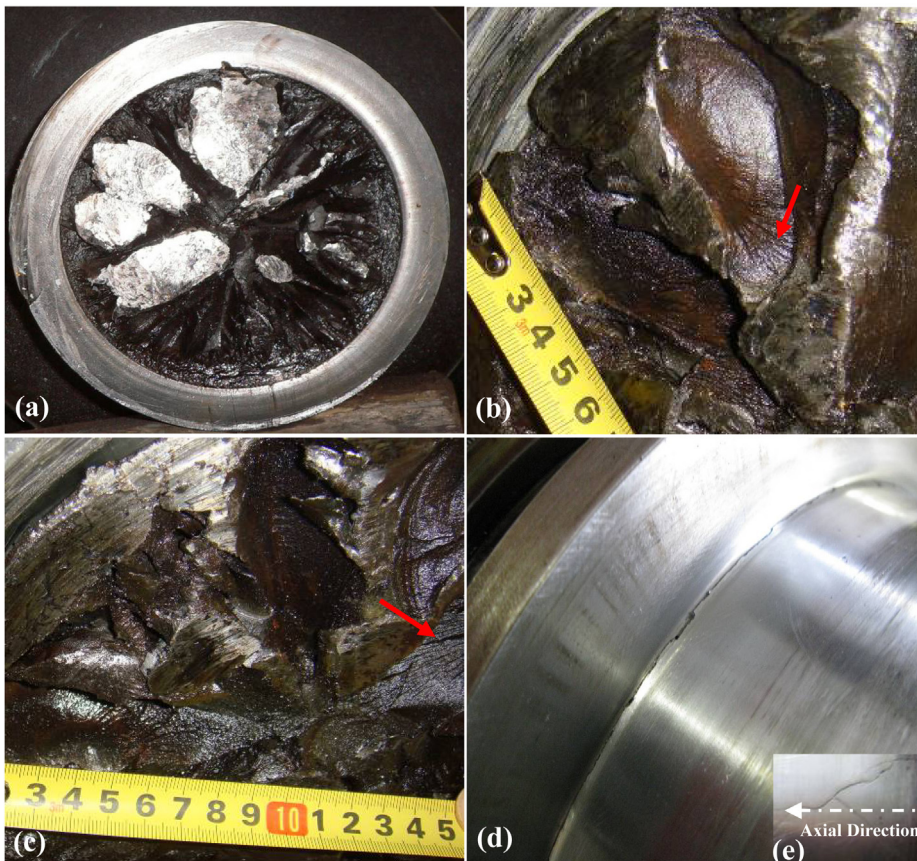
Fig. 6 showed the macroscopic feature of the shaft's fracture. From Fig. 6(a), the fracture was scraggly and it was more than 40 mm between the highest site and the lowest site for the fracture by means of the stereo microscope. So it was the

Fig. 6. The macroscopic feature of the shaft's fracture (a) whole fracture morphology; (b) beach marks; (c) fatigue cracks; (d) location of crack; (e) direction of crack growing.

typical morphology of the ratchet-like fracture. Some beach marks and fatigue cracks were observed, as shown in Fig. 6(b) and (c). Fig. 6(d) showed the cracks on the surface of other shaft which was same to the failed shaft from the view of material selection and service condition. Some cracks appeared at the surface of the shaft's shoulder chamfering and the crack grew along an angle of 45° to the axial direction, as shown in Fig. 6(e). It was confirmed that this shaft having cracks would fracture if it continued to work and the fractured position was also in the site of the minimum diameter.

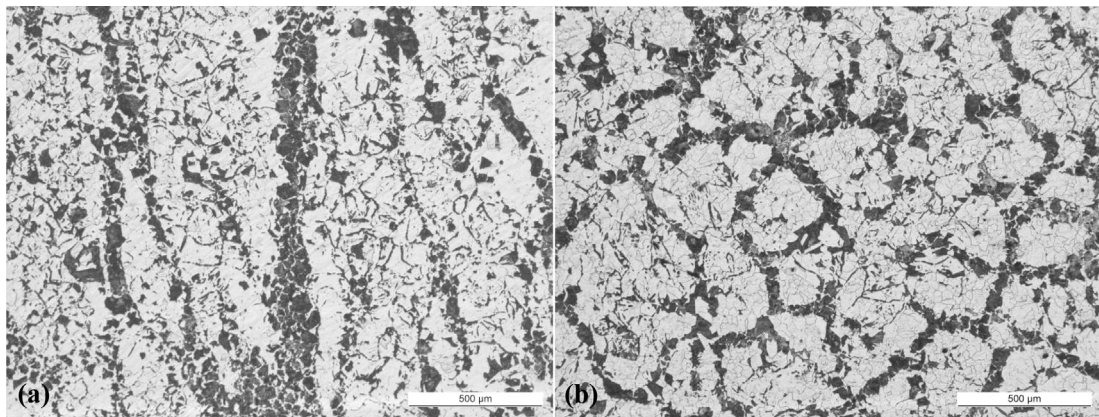
Fig. 7. The microstructure of the fracture's different section (a) band-pearlites at the vertical section (b) network-pearlites at the cross section.

Fig. 7 showed the microstructure of the fracture's different section. The microstructure of material was ferrite and pearlite. The massive lamellar pearlites presented the obvious zonal distribution from the vertical section; the slender strip's pearlite showed the reticular distribution from the cross section and distributed along the ferrite grain boundaries. According to the National standard [12], the banded structure was evaluated as the degree 4. Although material mechanical

properties were good, the networked-like pearlite structures might affect the material's applying performance once it served under the improper operational condition.

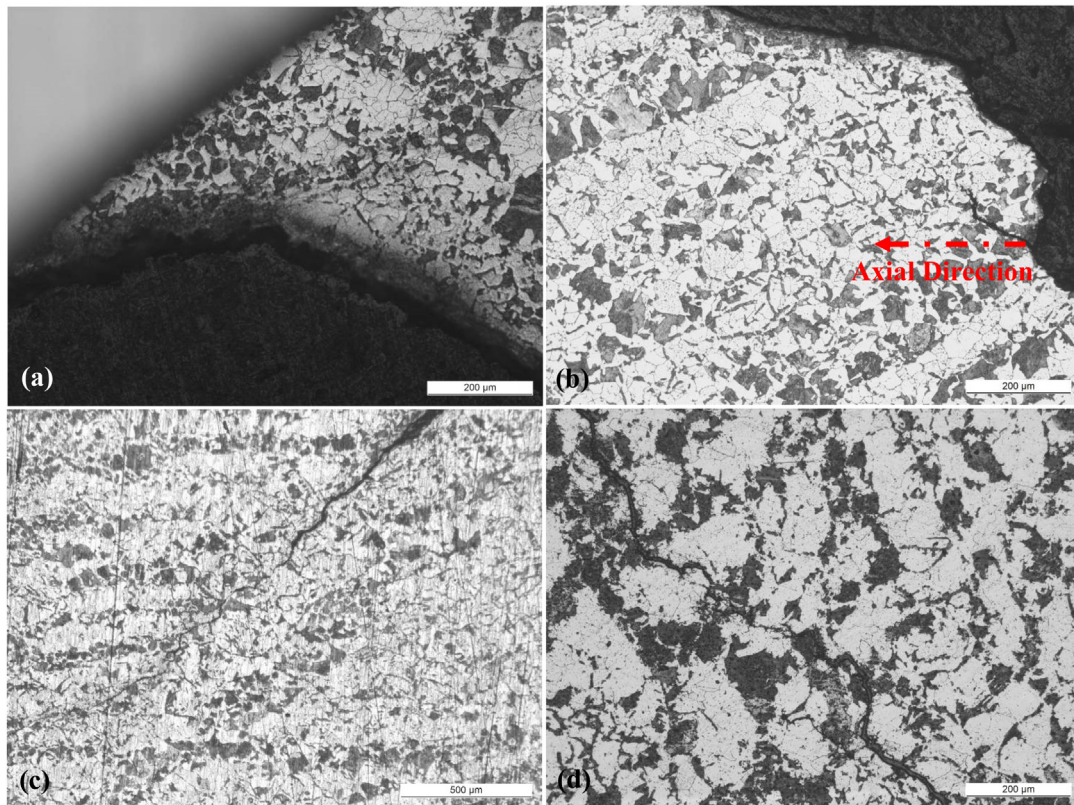
Fig. 8. The crack's initiation and propagation (a) the crack at the chamfer, (b) the secondary crack, (c) the crack's propagation (the longitudinal section), and (d) the crack's propagation (the cross section).

The crack's initiation and growth at the different section of the unfractured shaft were shown in Fig. 8. The crack initiated from the edge of the chamfer and grew along an angle of 45° to the axial direction. From Fig. 8(c) and (d), it was found that crack grew along the interface of the ferrite and the pearlite. So the interface was the weak position, the trend was intensified especially when the network pearlite had formed at the ferrite's boundaries.

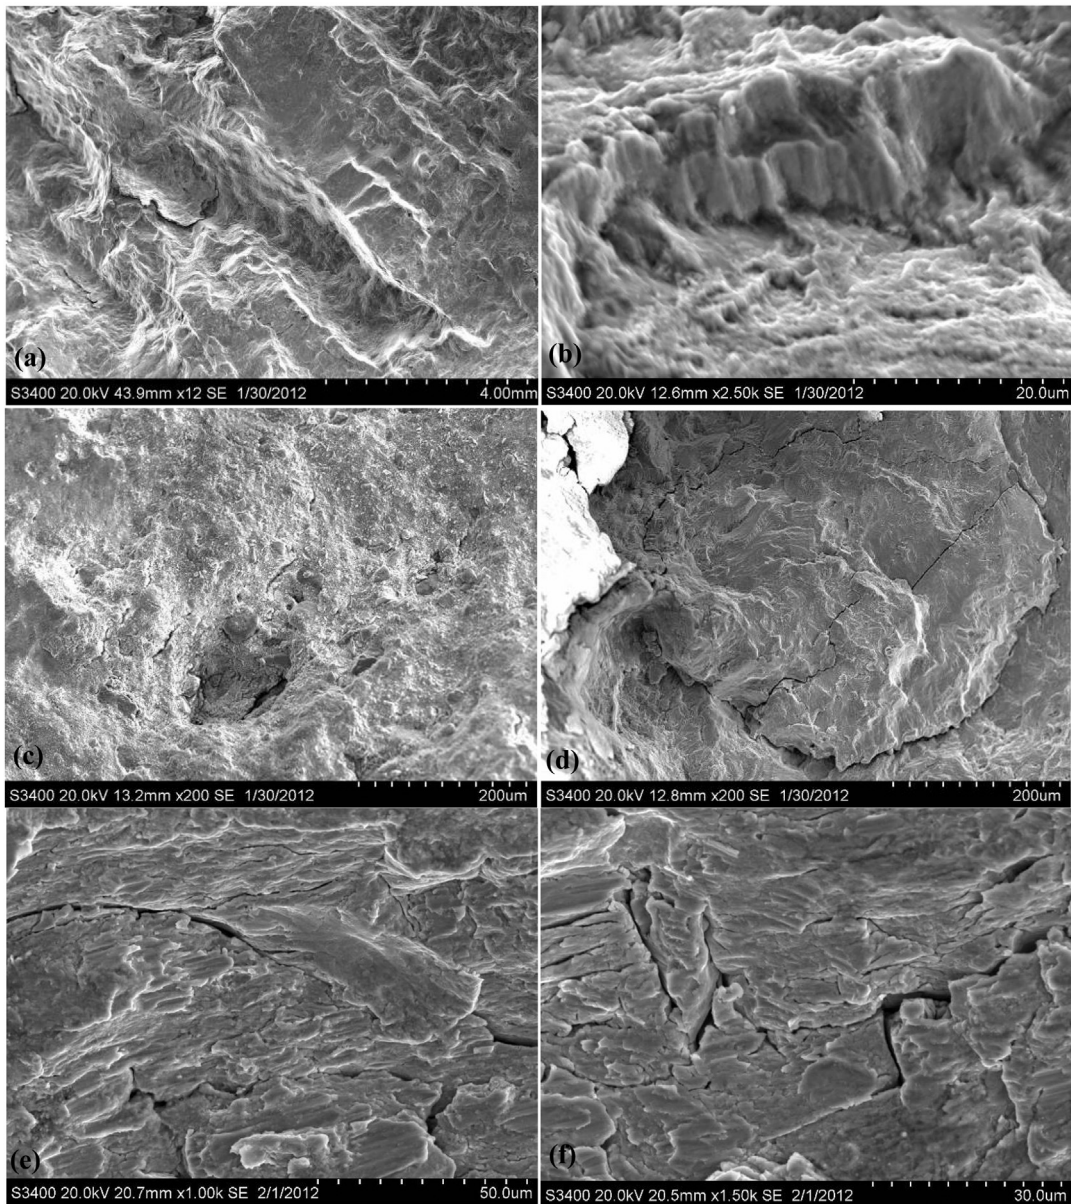
Fig. 9 showed the SEM images of the shaft's fracture. Most of fracture surface morphology were some torn edges, river pattern and small cleavage facets, so it confirmed the shaft's fracture was brittle fracture and the fracture showed the typical quasi-cleavage characteristic. The some secondary cracks appeared at the torn edge's bottom and the shallow dimple, and they was taken as the microcrack's source; some microcracks got together to form the crack, and the crack growth resulted in fracture. A large number of the multi-direction fatigue cracks were observed on the fracture's surface, and it was confirmed that the shaft underwent the fatigue damage which was caused by the vibration.

Fig. 9. The SEM images of the fracture (a) the torn edge, (b) the end of torn edge, (c) the shallow dimple, (d) the secondary crack around the shallow dimple, (e) the river pattern and (f) the fatigue crack.

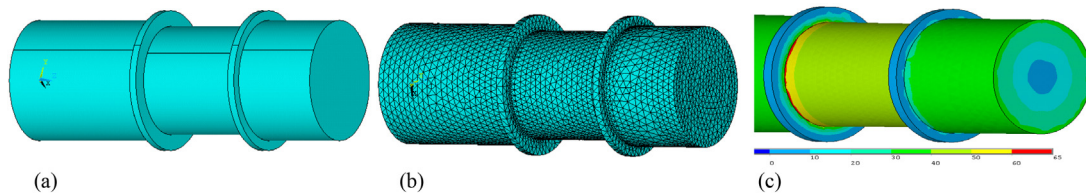
The shaft's solid model and the shaft's calculation model based on the finite element method were shown respectively in Fig. 10(a) and (b). The shaft's stress distribution obtained which is based on the induced draft fan's rated torque (58625 N m) was presented in Fig. 10(c), the stress concentration was significant at the site of the shaft shoulder's chamfer. The maximum shear stress (τ_{\max}) obtained by the ANSYS simulation was 63 MPa. The maximum allowable shear stress (τ_n) was obtained by the equation [11]

where τ_{\max} was the maximum shear stress, τ_n was the nominal maximum shear stress. Then k was 2.4 at the site of the shaft's variable diameter, and it was in a relatively high level. So this also proved that there existed the more significant stress concentration. Therefore the occurrence of fatigue failure at the shaft's variable diameter was earlier than other position.

Fig. 10. The shaft's solid model and the shaft's calculation model based on the finite element method (a) solid model, (b) calculation model, and (c) stress distribution.

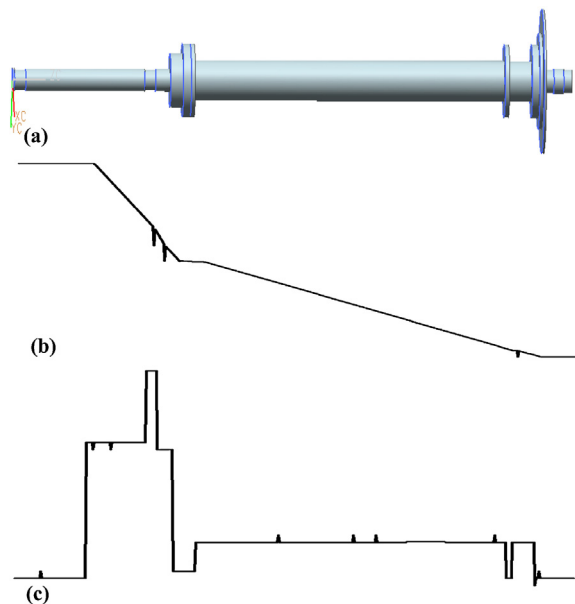
The shaft's three-dimensional model was built based on the design size, as shown in Fig. 11(a). The result calculated with applying the lumped mass method showed that the order torsional vibration was anomalous at the shaft's smallest diameter when the shaft was in the critical speed (920 rpm), and the torsional stress was maximal at the smallest diameter.

Fig. 11. The shaft's three-dimensional model and the order torsional vibration's mode and the torsional stress distribution (a) the three-dimensional model, (b) the order torsional vibration's mode, and (c) the torsional stress distribution.
