Case Studies in Engineering Failure Analysis

Stress corrosion cracking in Type.316 plates of a heat exchanger

S.H. Khodamorad^{a,*}, N. Alinezhad^a, D. Haghshenas Fatmehsari^b, K. Ghahtan^a^a Inspection Department of Jam Petrochemical Complex, Asalouyeh, Iran^b Amirkabir University of Technology, Department of Mining and Metallurgical Engineering, Tehran, Iran

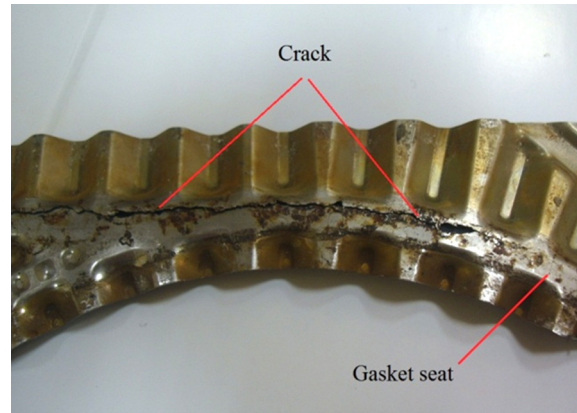
The majority of the cracks have appeared in the upper gasket seat and also some cracks have been observed under two sideward gasket seats of the PHE. In addition, the around of these cracks has been covered with a rusty layer as shown in Fig. 2.

Fig. 2. Appearance of a crack on the gasket seat of heat exchanger plates.

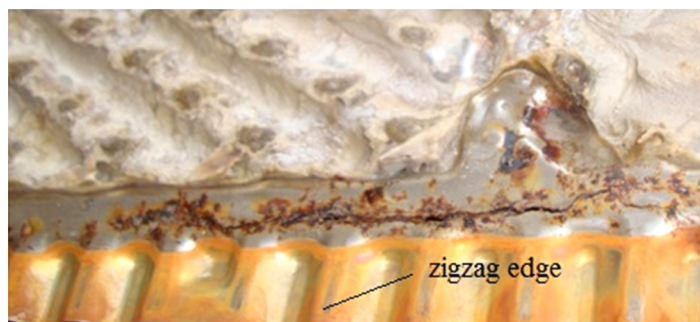
Generally the visual inspection by naked eye is the first step to roughly estimate the type and cause of failures. As it can be observed in Fig. 3, the branched cracks alongside the gasket seat grooves of plates are present and also, some corrosion pits are visible around these grooves. These pits can act as the start points for the propagating of cracks over the plates when the mechanical stress is present in the system [7]. Although the border areas of plates are not in contact with the cooling or transport water, there are many crevices between them which are subjected to the pitting by crevice corrosion. Fig. 4 shows such pits on the border areas of the plates.

Fig. 3. Presence of cracks and pits on gasket sitting groove.

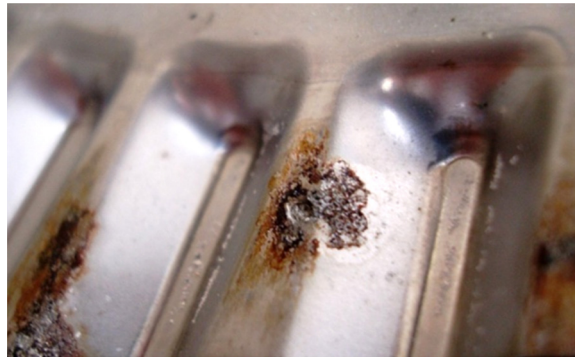
Fig. 4. Pitting corrosion on border area of failed heat exchanger plates.

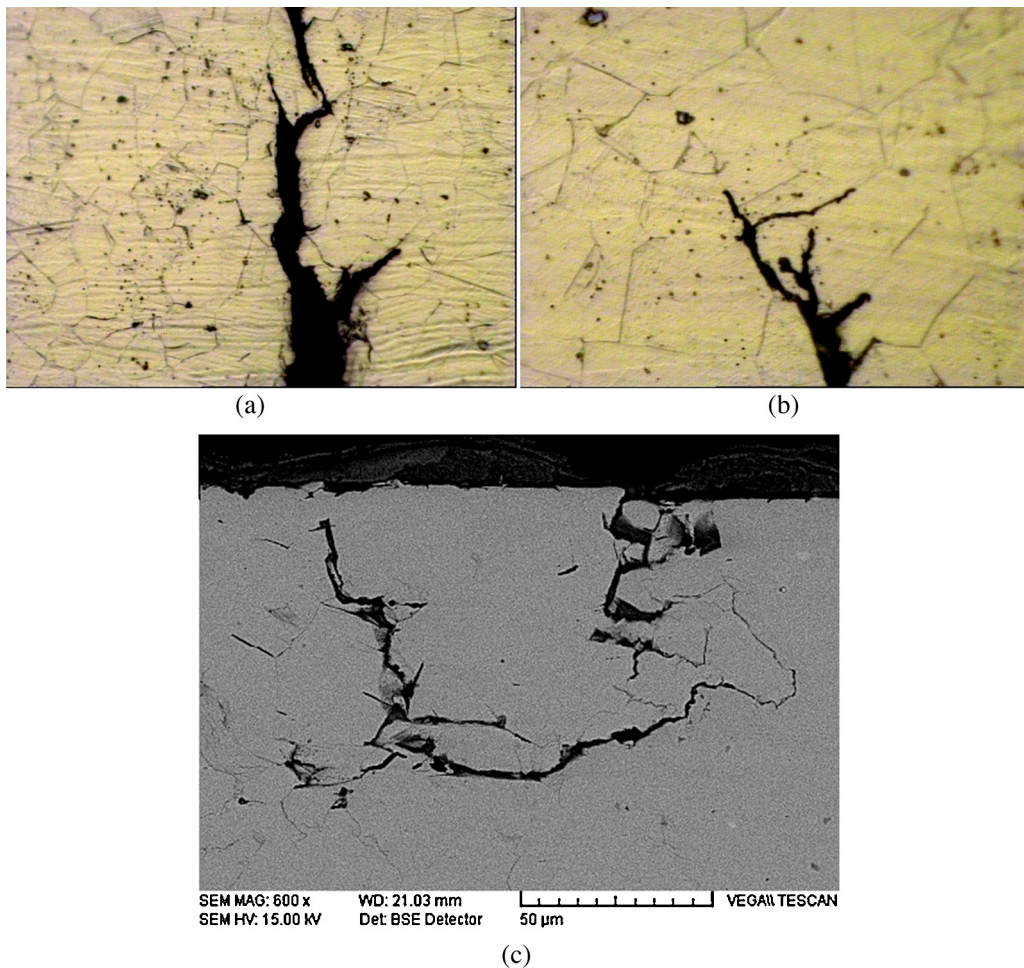
Regarding the microstructure of Sample 1 presented in Fig. 5(a) and (b), the structure includes the austenitic matrix with some intergranular and transgranular cracks. According to SEM image shown in Fig. 5(c), these cracks are relatively sharp and straight passing through the boundaries and austenitic grains. The branched cracks are typical signs of SCC [6–8].

Fig. 5. (a) and (b): Microstructure and (c) SEM of Sample 1.

Intergranular SCC also commonly indicates the contribution of corrosion process in the cracking of plates [9] and on the other hand, the appearance of transgranular SCC in the microstructure of the plates confirms the high mechanical stress conditions [10]. Garcia et al. reported that transgranular SCC susceptibility decreases at lower level of cold stress but the intergranular SCC susceptibility increases [10]. The superimposing of residual stresses leads to the cold forming of the plates and on the other hand, the stresses resulted from temperature/pressure fluctuations as well as the repair and maintenance stresses are the main sources of SCC. The small black dots observed in Fig. 5(a) and (b) are assigned to the micro-pits distributed in the microstructure.

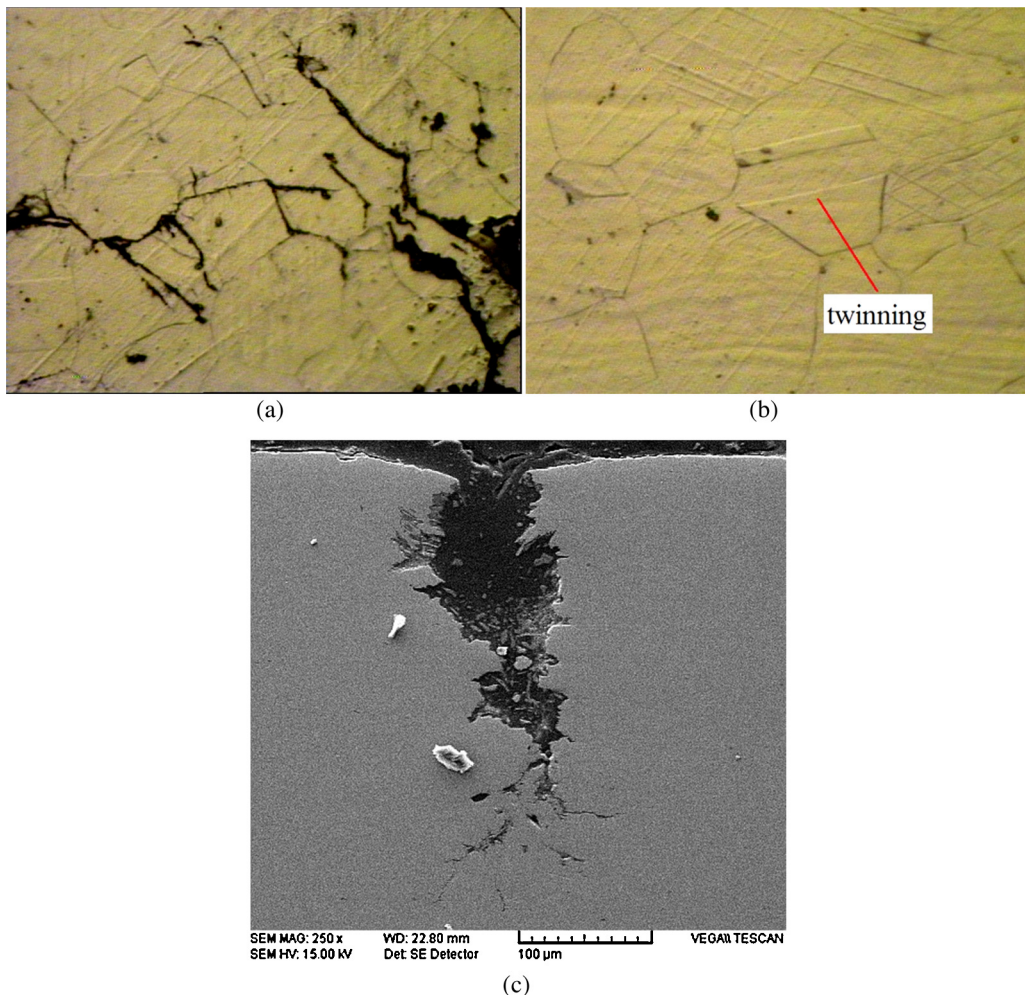
Based on the microstructure of Sample 2 shown in Fig. 6(a), the structure includes the austenitic matrix with some intergranular and transgranular cracks similar to Sample 1. Fig. 6(b) implies the presence of some twinning in the microstructure of sample. As a matter of knowledge, the twinning phenomenon requires high level of stress which can be accounted as a sign for high residual and/or applied stress in the microstructure of plates due to the plastic deformation [11]. The SEM image of Sample 2 (Fig. 6(c)) shows the growth of cracks in several directions in the tip of a primary crack. These micro-cracks are additional supportive evidences for SCC.

Fig. 6. (a) and (b): Microstructure and (c) SEM of Sample 2.

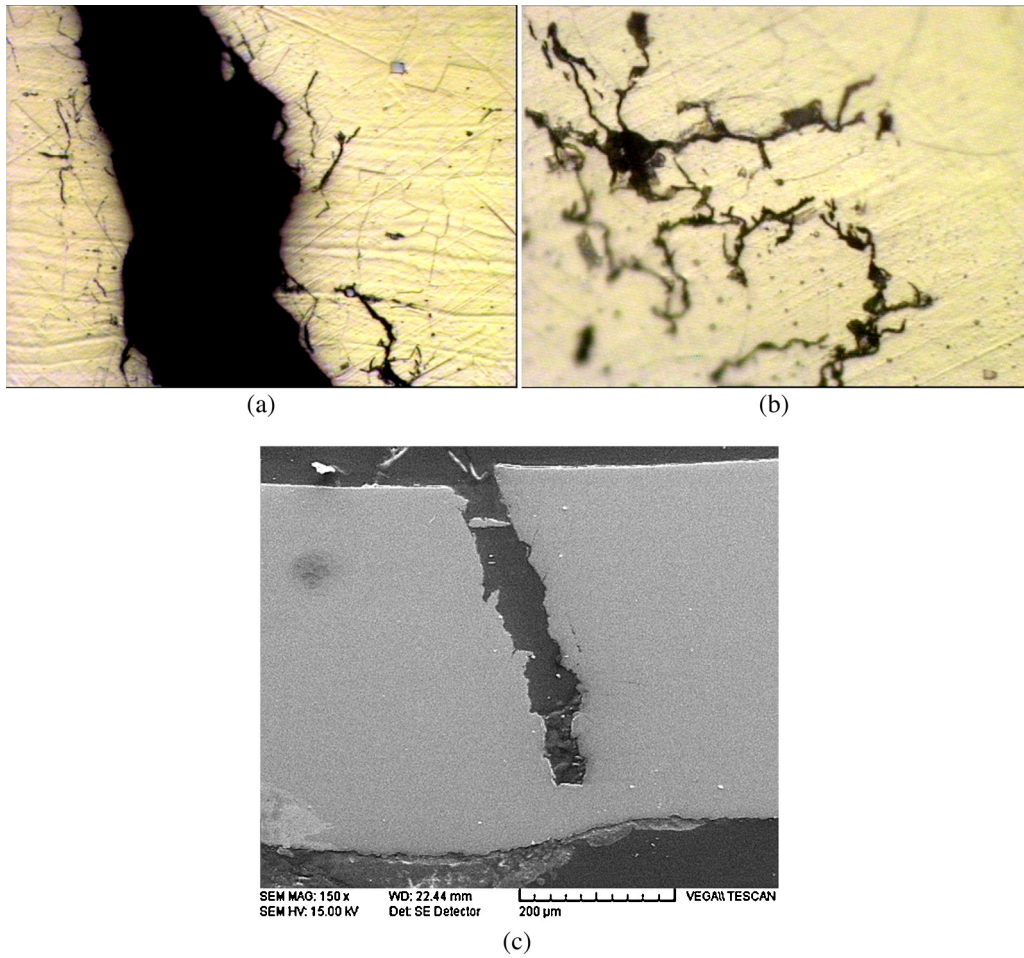
As can be seen in Fig. 7(a) and (b), the microstructural features of Sample 3 is similar to Samples 1 and 2. There is a micro-pit as a start point for SCC (Fig. 7(b)). Also, the tip of crack contains some corrosion products according to the SEM image (Fig. 7(c)). This indicates that the corrosion plays an important role in the failure of plates and the formations of cracks stems from the simultaneous occurrence of corrosion and mechanical stress.

Fig. 7. (a) and (b): Microstructure and (c) SEM of Sample 3.

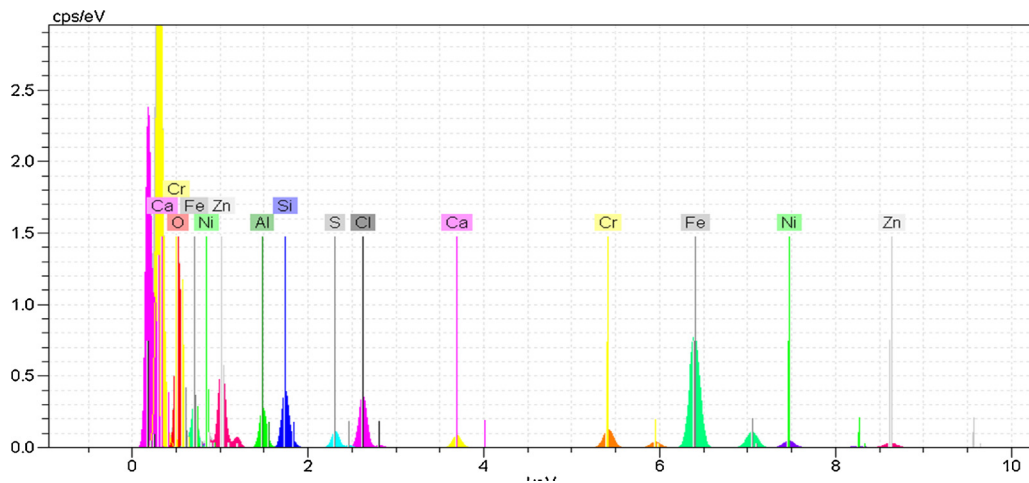
Energy dispersive X-ray spectroscopy (EDS) of the brownish (rusty) layer formed around and in the cracks is shown in Fig. 8. According to EDS spectrum, the brownish (rusty) layer contains Fe, Cr, O as well as S and Cl. Fig. 8 shows the EDS

Fig. 8. EDS analysis of corrosion products in Sample 1.

analysis of Sample 1. The presence of Fe, Cr and O can be attributed to the corrosion products of S.S 316 [11]. The presence of chloride in the EDS spectrum also confirms the contribution of Cl^- in pitting corrosion of the protective layer of 316 stainless steel plates. It can be concluded that the formation of the pits and the presence of stress can lead to Cl-SCC failure of plates. Also, sulfide ion can significantly accelerate the SCC failure of the plate [6].

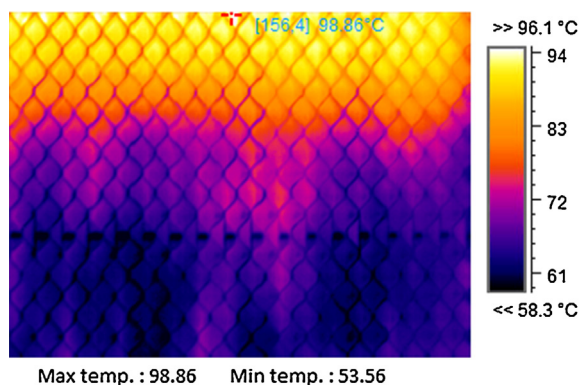
Fig. 9. Temperature profile of TW inlet.

Temperature analysis was conducted via infrared camera for the evaluation of the temperature profile of several areas of PHE. According to thermo-scan result illustrated in Fig. 9, the maximum temperature of the exchanger is around 99 °C in the top of PHE that belongs to TW inlet of exchanger. The value of temperature is higher than the design temperature of heat exchanger. The history of equipment revealed that in a period of operation around one year ago, the temperature of TW increases due to some process changes. During this period, the water that called service water (SW) was poured over the PHE to increase the cooling rate and reduce the TW outlet temperature. Moreover, as it can be seen in Fig. 3, there is a brownish layer over the zigzag edge of plates which imply the presence of suspended soil in the service water.

Since the appearance of the cracks in the heat exchangers occurs after cooling the TW outlet by the service water (SW), the use of higher number of the plates in the heat exchangers together with the higher flow rate of cooling water is strongly recommended; in this way, at a constant flow rate of transport water, not only the temperature of transport water is decreased but also the SCC cracks resulted from the direct contact of the service water (which usually contains some levels of Cl^-) can be effectively avoided.
