Case Studies in Engineering Failure Analysis

Case study

Failure analysis of a polymer centrifugal impeller

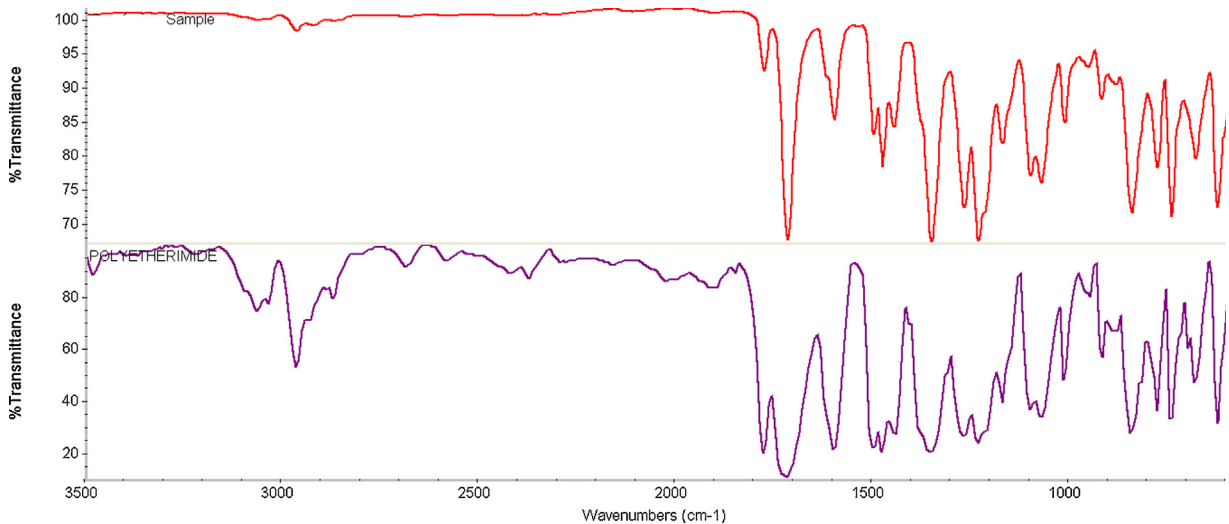
Fig. 1. Fourier transform infrared spectroscopy of impeller provides a spectrum match with library database that indicated a polyetherimide material.

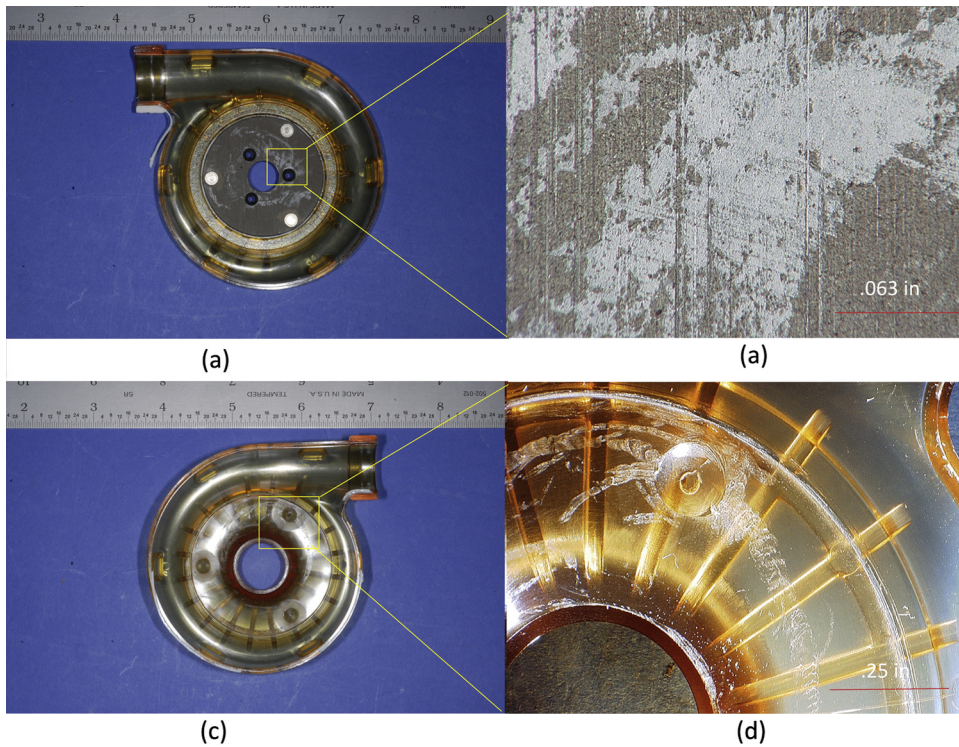
Macroscopic inspection (Hirox Digital Microscope) of the impeller casing showed signs of wear on both the inner surfaces as shown in Fig. 2. Fig. 2a is an overall view of the inner casing surface where the motor is fixed in place with the mounting holes within the casing where the impeller spins. Signs of discoloration, material removal, and wear marks are shown in Fig. 2b on the alloy surface. Fig. 2c and d shows the opposite surface of the impeller casing. Visual examination showed signs of rotational wear marks and material removal of the polymer surface. While these features do indicate an imbalance condition of the impeller, it is unknown if these features were produced before or after catastrophic failure of the impeller.

Fig. 2. (a) Overall view of impeller casing reveals signs of wear on motor mount surface. (b) High magnification view of surface shows discoloration and wear marks. (c) Polymer side of impeller casing shows rotational wear marks. (d) High magnification view of polymer casing surface shows wear evidence and material removal.

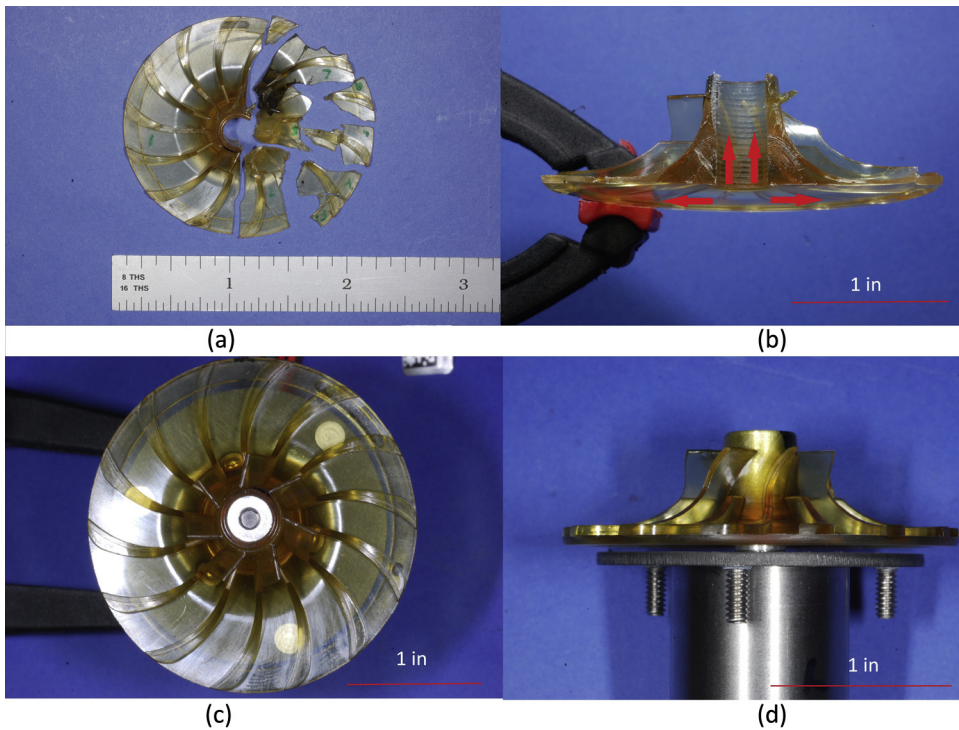
Initial stereomicroscope examination of the polymer impeller indicated there were no surface defects or porosity on the exterior surface of the impeller or along the fluid vanes. The main fracture of the impeller was a radial split along a centerline, with half of the impeller remaining intact as a single piece, and the other half fracturing into multiple pieces, as shown in Fig. 3a and b. The mating fracture surfaces and the fractured remnant pieces were identified and organized to reconstruct the shape of the impeller as shown in Fig. 3a. Two symmetric fracture planes are observed in Fig. 2b. Failure of the impeller was brittle and catastrophic, showing no signs of gross plastic deformation or changes in shape when compared to a non-failed impeller as shown in Fig. 2c and d. While this polymer can elongate extensively under quasi-static loading conditions, the polymer can undergo brittle fracture, especially at elevated velocities and under high strain rate conditions in the presence of a notch/crack. The top view and side view of the non-failed impeller show a cylindrical aluminum shaft press-fit into the bore of the impeller (used to transfer the rotational motion created by the motor), and the clearance spacing between the mounting plate and bottom face of the impeller.

Fig. 3. (a) Overall top view of impeller fragments reconstructed for observation. (b) Image of symmetric fracture faces along the radial split of the impeller, red arrows indicate direction of crack propagation. (c) Overall top view of non-fractured impeller with aluminum shaft press fit into bore. (d) Side profile view of non-fractured impeller.

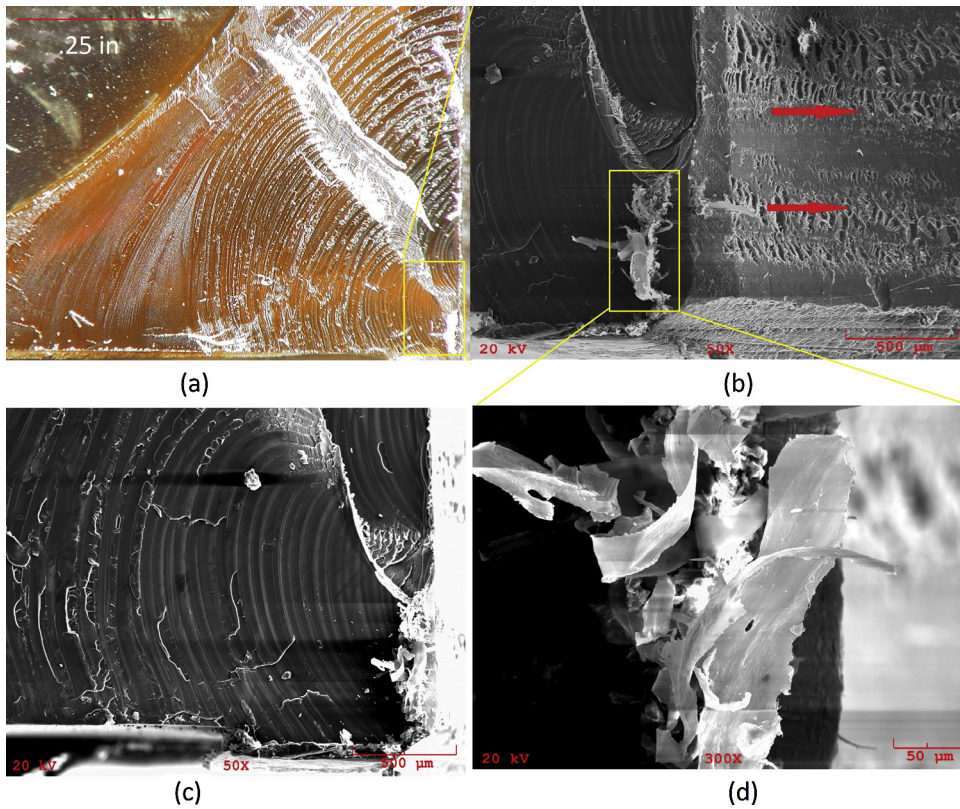
Microscopic examination was performed on the intact impeller half as shown in Fig. 4 using light microscopy (Hirox Digital Microscope) and scanning electron microscopy (JEOL JSM 820) techniques. Fig. 4a shows faint ridged patterns on the left half of the symmetric fracture face, curved markings that indicated the location of the fracture origin near the bottom corner, where the impeller bore was press fit against the aluminum shaft. These curved markings are identified as Wallner lines that occur under brittle fracture conditions of polymers, which can resemble fatigue striations but differ in that they represent the interaction of a stress wave with a propagating crack front [7]. The Wallner lines indicate that the nature of the

Fig. 4. (a) High magnification light microscopy image of left side fracture face reveals Wallner lines emanating from bottom corner. (b) Scanning electron microscopy image of corner shows fibril development, and defects along inner diameter bore of impeller. (c) Scanning electron microscopy image reveals transition from smooth to rough Wallner lines signifying accelerating crack front. (d) High magnification SEM image of fibril development.

failure was brittle, occurring over an extremely short time span where the curved markings were a result of an accelerating crack front interacting with a stress wave. Fig. 4b–d are high resolution SEM images of the origin, and both show multiple crack/wave interaction markings, as well as the formation of slow drawn fibrils where crazing initiated.

Drawn fibrils observed near the bottom edge of the impeller on the left half side of the fracture as shown in Fig. 4b and d. While no gross plastic deformation was observed for the impeller bulk (yielding, tearing, necking), brittle fractures of polyetherimide involve highly localized plastic flow processes that involve crazes. A craze contains an interpenetrating network of voids among polymer fibrils that bridge the craze faces [7]. The craze initiation zone shows the location of ruptured fibrils (see Fig. 4b and d) along with multiple craze fronts. As the nucleated crack grows, it forms a smooth region with signs of stress waves interacting with a propagating crack front (see Fig. 4a and c). A critical crack size is reached at which point the crack becomes unstable and propagates at a rapid rate, and this can be described by an initial mirror like region (smooth Wallner lines) as shown in Fig. 5 that transitions to portions with surface texture.

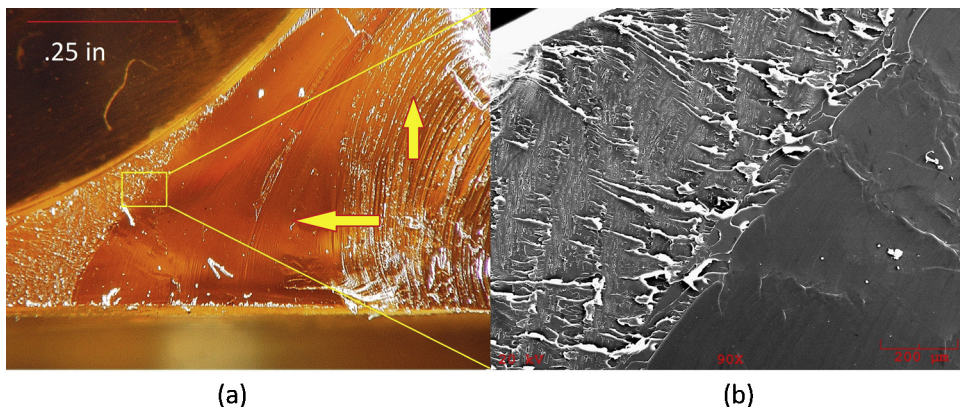
Fig. 5. (a) Light microscopy image reveals transition from Wallner lines to (b) mirror, mist and hackle morphology as crack accelerates along radial path.

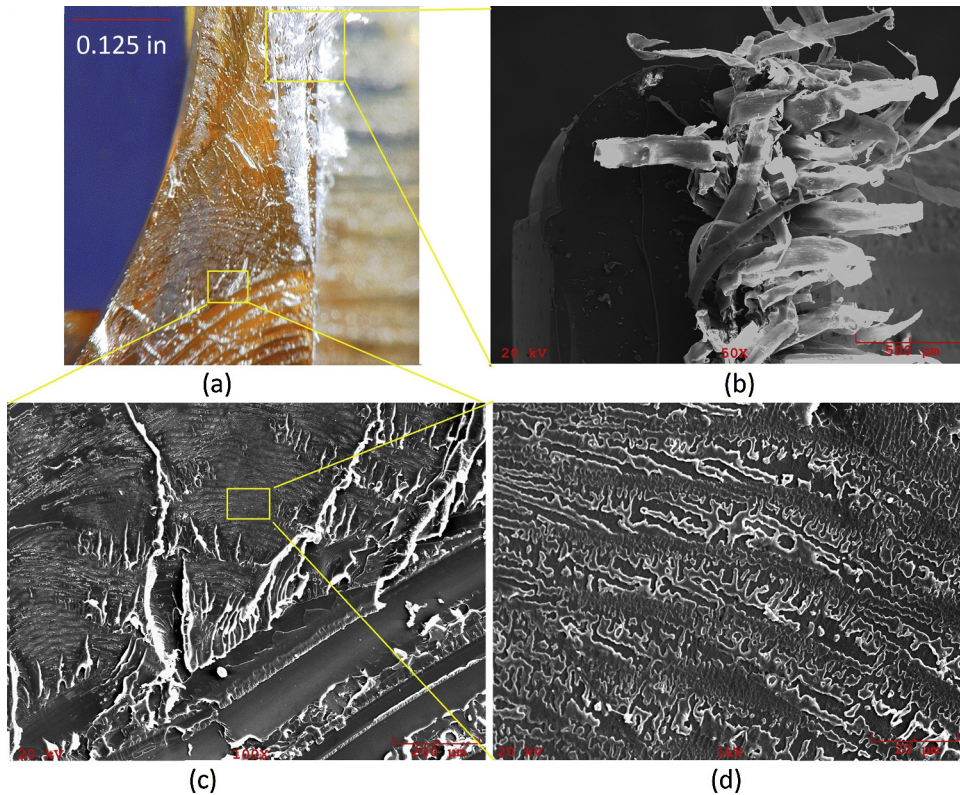
Fig. 6. (a) Light microscopy image reveals transition from Wallner lines to mist and hackle morphology and (b) formation of long fibrils. (c) Scanning electron microscopy image of transition zone shows fracture features consistent with hackles. (d) Higher magnification SEM image within hackle region shows mist formation in the form of surface undulations.

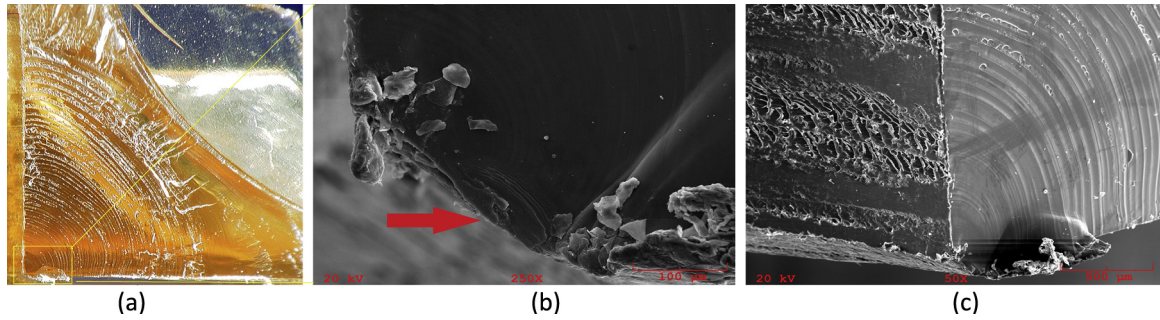
The symmetric fracture faces about the impeller bore as shown in [Fig. 2](#) revealed that on both faces, the fracture morphology exhibited distinct brittle fracture features: Wallner lines, a mirror-like featureless region, and rough fracture regions. [Fig. 7a and b](#) shows the right face of the impeller half revealing these features. High resolution inspection of the failure surfaces showed Wallner lines along with mirror, mist, and hackle regions which represent the history and location of crazes that turned into an accelerating crack as a function of time. Because the impeller underwent strenuous and intermittent cyclic loading conditions, fatigue induced striations may have also play a role in the failure of this impeller. [Fig. 7b](#) shows faint striations (see red arrow) near the bottom lip which appear different from the macroscopic Wallner lines observed in [Fig. 7a](#). No slow drawn fibrils were observed on the right fracture face, as observed on the left fracture face discussed previously.

Further investigation of the impeller showed significant signs of wear on the diameter of the impeller bore as shown in [Figs. 4b](#) (red arrows) and [7c](#). The morphology observed here is an indication of wear induced defects caused by a reaming operation used to press fit the aluminum shaft with the bore of the impeller. Defect size and control are important factors in preventing premature failure of polymer components under various loading conditions. Critical defects may interact concurrently with shaft misalignment, resonance, or impact situations that can lead to fatigue crack growth, inducing catastrophic failure of such polymer impellers.

Fig. 7. (a) Light microscopy image of right side fracture face reveals macroscopic Wallner lines and location of fracture origin. (b) High magnification SEM image of fracture origin shows faint fatigue striations. (c) Oblique view of fracture origin reveals bore defects along inner diameter which could contribute to premature failure.

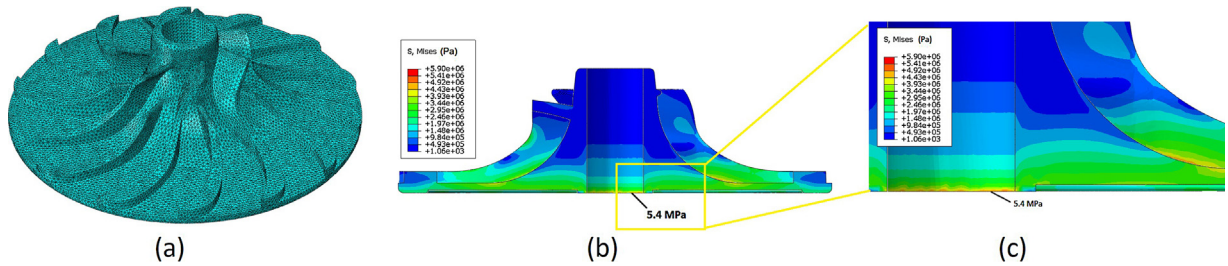
Fig. 8. (a) High density three dimensional mesh applied to impeller model. (b) Cross sectional view of impeller reveals von mises stress distribution. (c) Close up view of impeller lip reveals concentrated stresses along circumference of lip, conditions created due to flexing condition of impeller.

Fig. 8b and c shows the von Mises stress distribution at the cross-section under both gravity and centrifugal load. The bottom lip location within the bore shows stress concentration up to 5.4 MPa, however this stress level is much lower than the yield strength of this material (~110 MPa). The results indicate that elevated von Mises stresses exist near the bore of the impeller where the bottom lip meets the rotating shaft. Because of the bore constraint against the aluminum shaft, the bottom corners appear to act as stress concentration sites as the impeller rotates and displaces under flexural conditions. The stress concentrations coincide with the craze and fatigue initiation sites described in the previous figures. The elevated stress region combined with inner bore defects near the bottom lip increase the probability of craze/crack initiation which may have induced premature failure of the impeller.
