Case Studies in Engineering Failure Analysis

Failure analysis of edge discoloration of galvanized fuel tank

R&D and Scientific Services, Tata Steel Ltd., Jamshedpur 831001, India

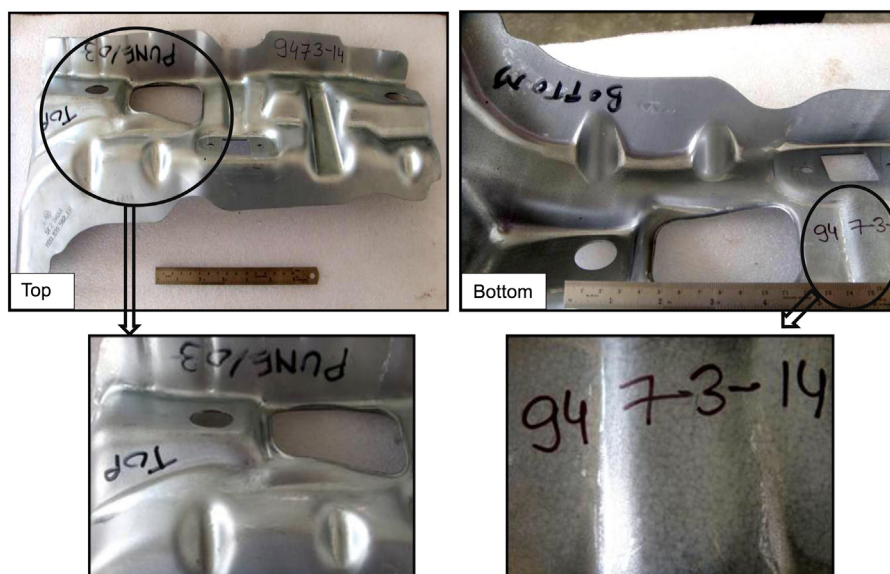
The photograph of the fuel tank made from galvanized steel sheet consisting of peculiar shade difference is shown in Fig. 1. These defects are readily observed by naked eye. From the photograph it can be seen that the top surface sheet have bright appearance whereas bottom surface of sheet have dull appearance as shown by the arrows. At some location, grain structure like appearance is also observed.

Fig. 1. Photograph of the galvanized fuel tank consisting of peculiar shade difference problem.

Visual observation of the defective fuel tank confirms that there are three regions bright, dull and grain structure like appearance on the surface. This grain structure like appearance is result of transition of galvanizing and galvannealing process. SEM microphotographs and EDS analysis shows the presence of zeta crystals and high amount of Fe in dull surface, it confirms that galvannealing take place at bottom surface. Amount of Fe in top surface is low which resulted into bright surface. Optical microscopy study confirms the presence of brittle coating layer at bottom surface.

Due to lower bath aluminium content ($\sim 0.13\%$ as compared to 0.185% regular) during galvanizing process, lower speed and thicker section combination resulted in formation of partial Galvannealed surface in the coil owing to the internal heat content of the coil. It is recommended that coils for automotive galvanizing grade are not to be scheduled during unstable zinc condition (like run down).

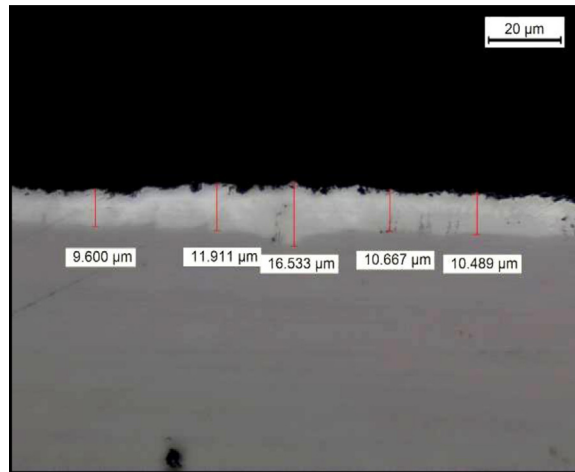
Fig. 2. Optical microphotograph of the top surface of Galvanized fuel tank.

is shown in Fig. 2; whereas bottom surface is shown in Fig. 3. Uniform coating is observed on top surface with an average thickness of $11.84 \mu\text{m}$; whereas bottom coating appeared as brittle in nature. Average coating thickness at bottom surface was $10.58 \mu\text{m}$. Coating thickness of top surface having bright appearance is more than the coating of bottom surface.

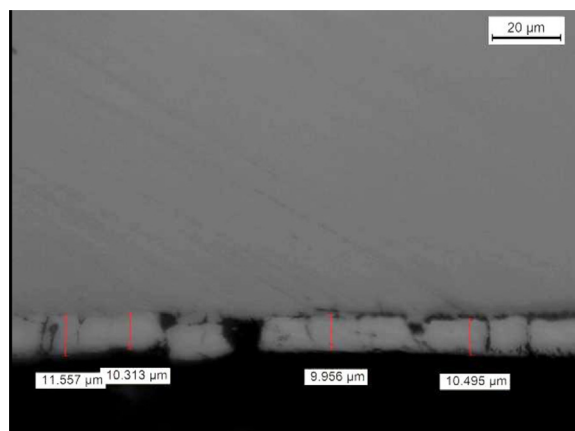
Fig. 3. Optical microphotograph of the bottom surface of Galvanized fuel tank.

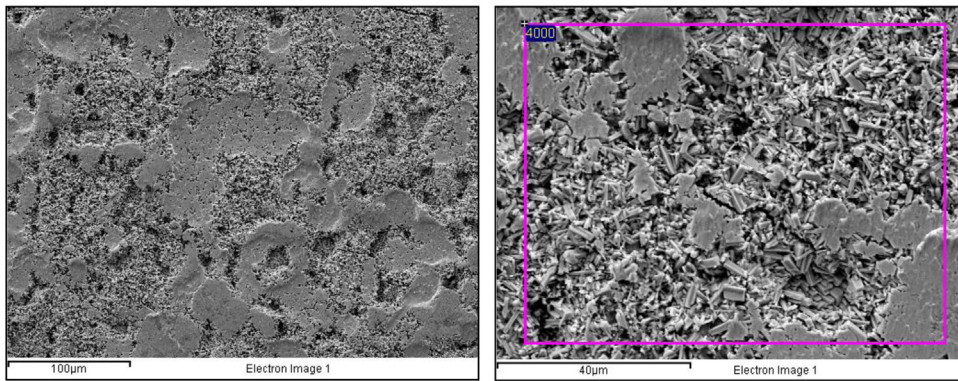
The SEM microphotograph from the defect region, having dull appearance on the galvanized fuel tank is shown in Fig. 4a. Fig. 4a shows two distinct regions, viz. Region A is the zeta crystals, region B is the skin pass marks. Fig. 4b is the high magnification SEM micrograph of region A and B in Fig. 4a. From Fig. 4b we can see that the zeta crystals are clearly visible indicating Galvannealing take place at this region. EDS analysis was carried out on Galvannealed region showing the concentration in wt.% of Zn, Fe and Al in these regions as mentioned in Table 1.

Fig. 4. (a) SEM microphotograph of Galvannealed surface at 1000 \times magnification. (b) High magnification (4000 \times) SEM microphotograph of Galvannealed surface.

Based on the preliminary results, the following hypothesis was made: The dull appearance of the bottom surface is due to the partial Galvannealing (GA) formation. The metallographic analysis shows the partial GA formation on both bottom and top surfaces though the extent of GA formation is greater on the bottom surface due to which the appearance is darker as compare to top surface. The complaint coil was processed during galvanizing to galvannealing transition when the zinc bath aluminium run down was going on. There was thickness and width transition and the coil was processed at a lower line speed on account of its thicker section.

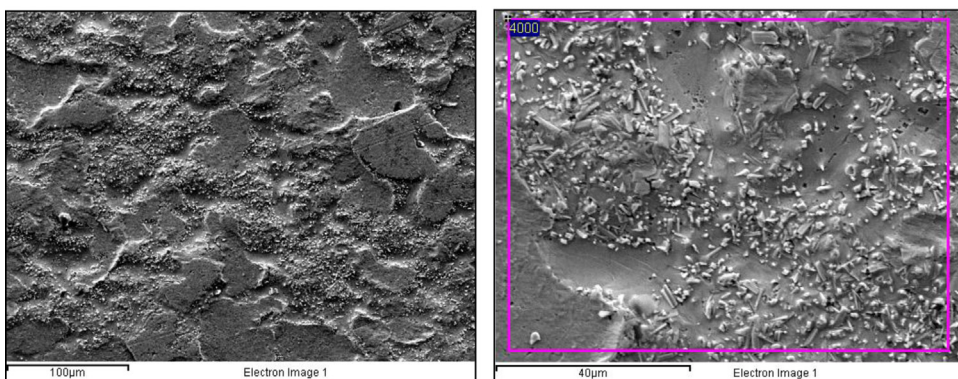
The SEM microphotograph from the defect region, having grain structure like appearance on the galvanized fuel tank is shown in Fig. 5a. Fig. 5a shows two distinct regions, viz. Region A is the partially zeta crystals, region B is the skin pass marks. Fig. 5b is the high magnification SEM micrograph of region A and B in Fig. 5a. From Fig. 5b we can see that the zeta crystals are partially appeared over the surface indicating transition zone of Galvannealing and Galvanizing at this region. EDS analysis was carried out at this transition region showing the concentration in wt.% of Zn, Fe and Al in these regions as mentioned in Table 2.

Fig. 5. (a) SEM Microphotograph of transition region of Galvannealing and Galvanizing at 1000 \times magnification. (b) High magnification (4000 \times) SEM microphotograph of transition region.

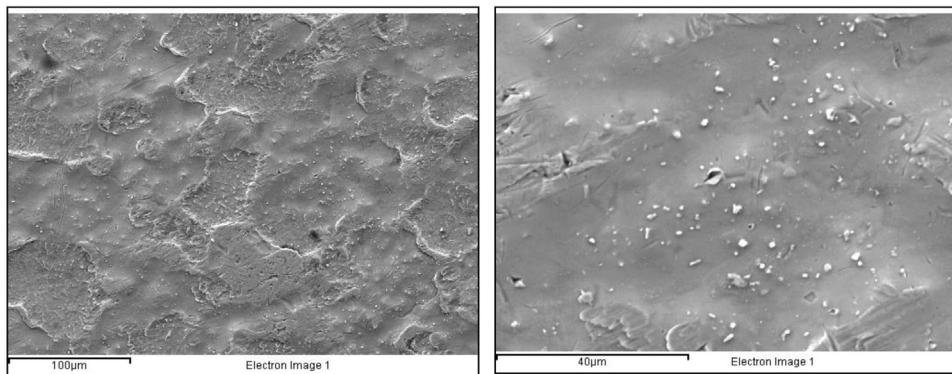
The SEM microphotograph from the non-defect region having bright appearance shows Galvanized surface appearance along with skin pass mark as shown in Fig. 6a. Fig. 6b is the high magnification SEM microphotograph of Galvanized surface. EDS analysis was carried out at this bright region showing the concentration in wt.% of Zn, Fe and Al in these regions as mentioned in Table 3.

Fig. 6. (a) SEM microphotograph of Galvanized surface at 1000 \times magnification. (b) High magnification (4000 \times) SEM microphotograph of Galvanized surface.
