Case Studies in Engineering Failure Analysis

Failure study of a cracked speed boat steering wheel

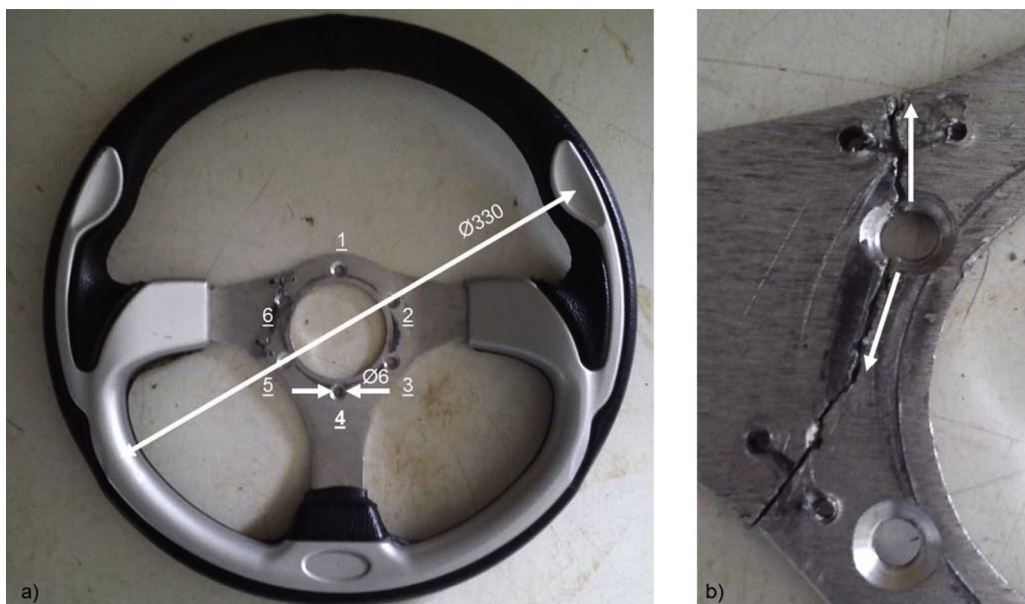
Double crack occurrence was noticed on the speed boat steering wheel after about nine years of regular marine service conditions. Particular steering wheel uses an adapter to connect with steering column and it is fastened to the adapter by six fasteners. Two cracks started emanating from one of the fastener holes causing the final fracture of the wheel, Fig. 1. Four small holes are a result of clamping; a poor try of maintaining the wheel in function after the crack was noticed. General dimensions of wheel skeleton (when plastic lining removed) are also given in Fig. 1 with thickness of the central part being 5 mm. Fastener holes are numbered from 1 to 6 to identify the one with the cracks.

It can be noticed that the fastener mounted in the hole at the position 6 had relatively high torque value comparing to other five. The excessive torque value could be from initial mounting which could help in crack growth, but also a result of retightening the fastener after the cracks were noticed.

Fig. 1. (a) Cracked steering wheel with dimensions in mm. (b) Detail of the fastener hole with cracks; arrows showing direction of crack growth.

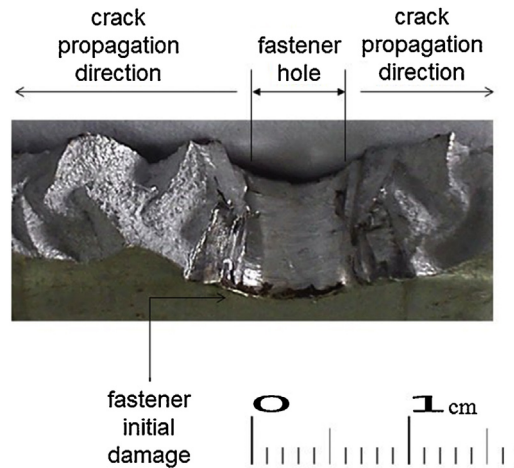
Detail of the crack surface can be seen in Fig. 2 where the area of fastener hole is marked. Crack propagation in both directions can be noticed.

Visual examination revealed surface marks resulting from a poor machining process along with fretting marks that came from contact of steel fastener and steering wheel. These initial damages probably served as potential crack initiation points.

Fig. 2. Crack surface.

Visual examination of cracked steering wheel revealed machining and fretting marks on the surface of fastener hole from which cracks emanated. These marks served as initiation points for crack growth.

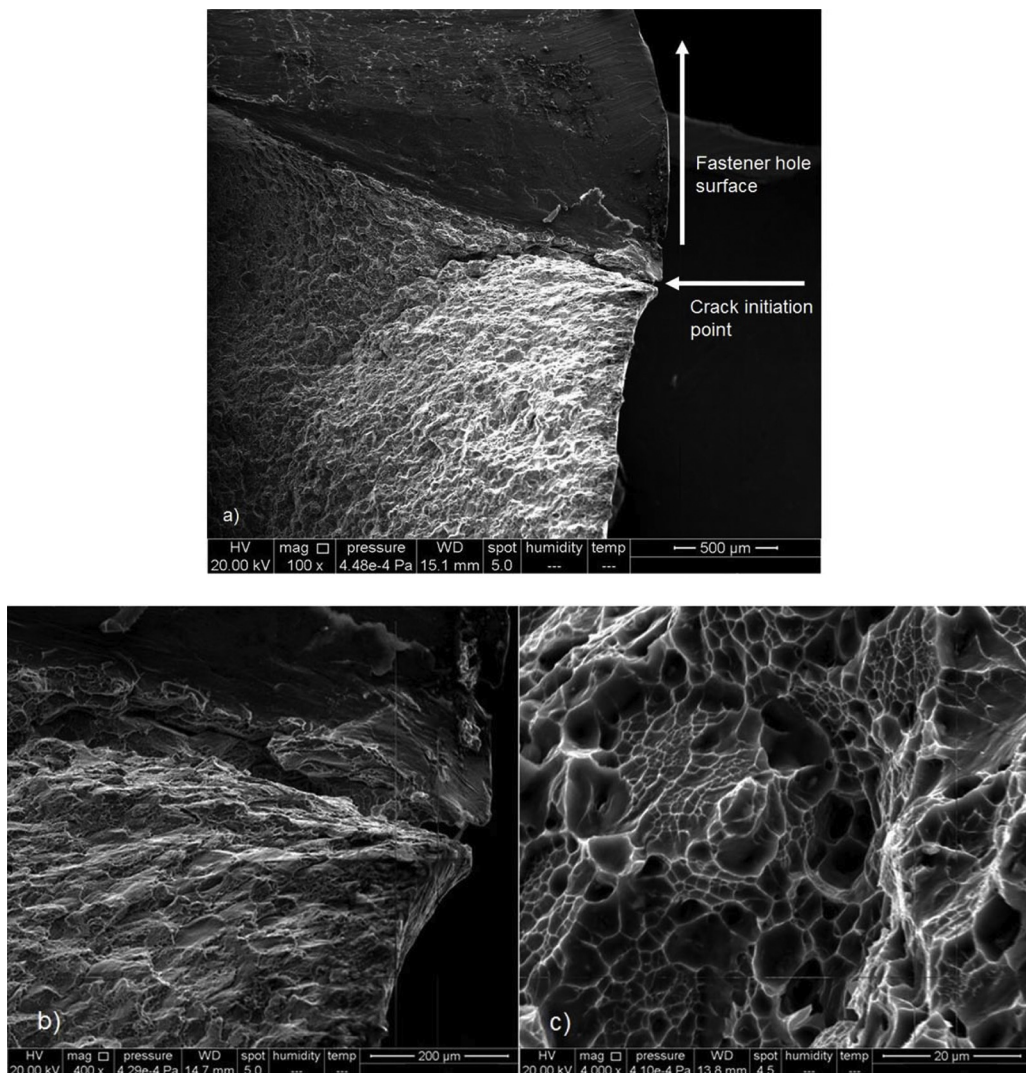
Fig. 3a brings typical SEM image of fractured surface near hole opening. Crack initiation zone can be observed and it is probably caused by machining or fretting damage. Direction of crack propagation is through the thickness of steering wheel (horizontal cleavage in Fig. 3b), then toward the outer edges. Fracture area consists of dimple fracture (Fig. 3c) and transgranular cleavage, separated by crack gaps. Fracture surface can be attributed mostly as transcrystal, with scarce areas of intercrystal fracture.

Fig. 3. (a) Crack surface. (b) Magnified crack surface. (c) Spherical dimples.

Detailed SEM examination of the fractured surface confirmed cracks growing from the mentioned marks and showed direction of crack propagation to be through the thickness of steering wheel and toward the outer edges. Fracture area consists of dimple fracture and transgranular cleavage separated by crack gaps in the vicinity of the fastener hole. Surface consists of some cleavage step pattern that reminds of Wallner lines. Cracks between flat surfaces and cleavage suggest possible fracture initiation point.

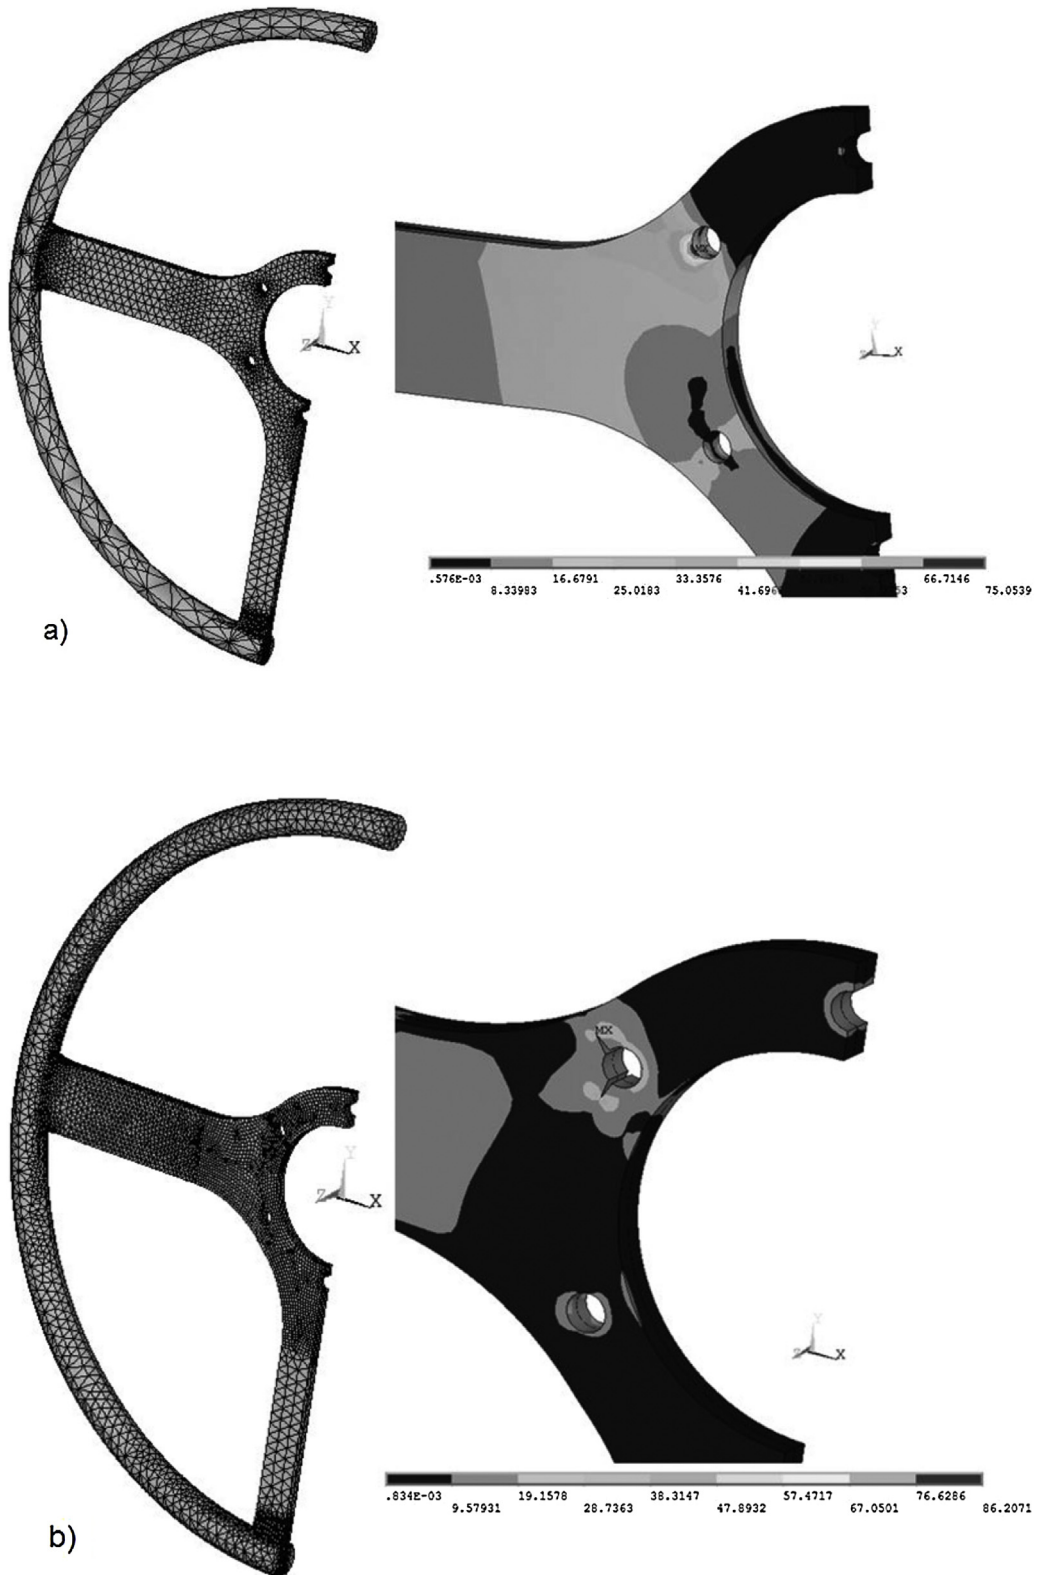
Fig. 4. Von Mises stress distribution on FE model of steering wheel. (a) Without cracks. (b) With cracks.

Fig. 4 shows Von Mises stress levels on FE model with and without cracks. Observing the example without cracks, maximum stress level can clearly be seen on the outer edge of fastener hole no. 6 with level of about 75 MPa. With two cracks incorporated into the model, stress level rises and shifts from hole to crack tip following the propagation of the crack tip, in accordance with the fracture mechanics principles.

In addition, numerical analysis showed maximum stress level at the point of crack initiation on the outer edge of fastener hole. Same load produced higher stress level when the cracks were added to the FE model shifting them to the crack tips making way for propagation of the cracks. Joint stresses produced in the local stress concentration point at the fastener holes further enhance the fracture evolution.

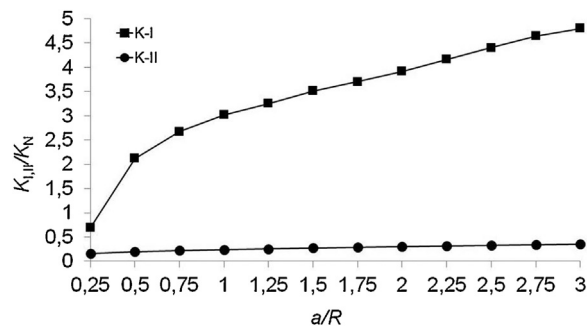
Fig. 5. Calculated normalized mode I and II stress intensity factors.

Results are given in Fig. 5. It can be noted that mode I SIFs dominate over mode II values. Also, there is a considerable growth of SIF with the crack changing length between $a/R = 0.25$ and 0.5; after that SIF values grow steadily.
