Metallurgical investigation of wire breakage of tyre bead grade

Piyas Palit*, Souvik Das, Jitendra Mathur

R&D and Scientific Services, Tata Steel Limited, Jamshedpur 831 001, India

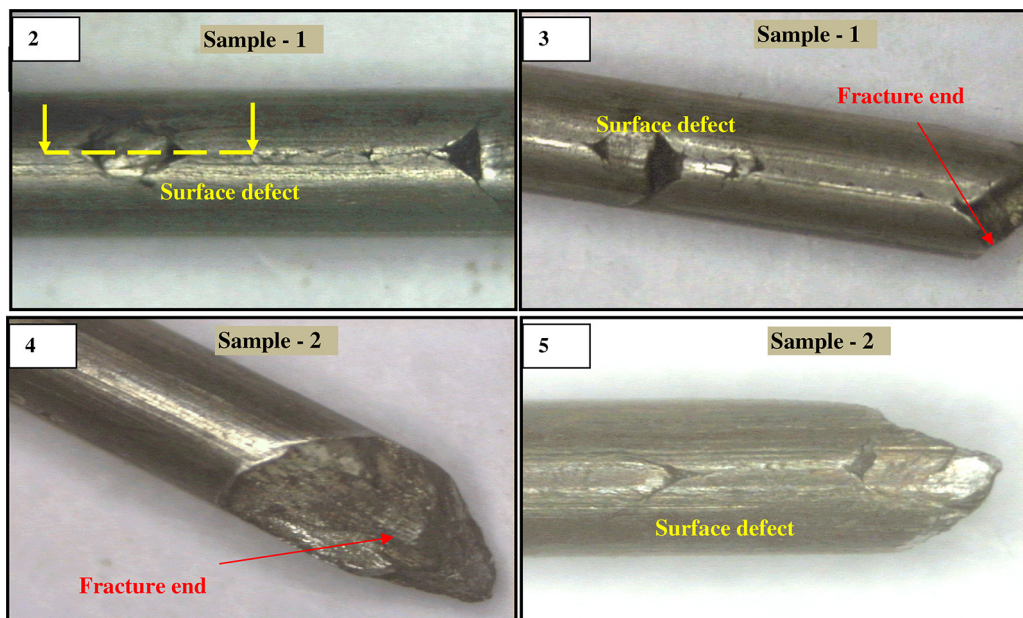
Two pieces of breakage wire samples were collected from the drawing mill for investigations. The samples were cleaned with acetone to remove dirt for visual examination prior to metallographic sample preparation. Visual examination is carried out in stereoscope. Surface appearance of the defects in all wire samples was of similar in nature. The fracture surface revealed finger nail type (Figs. 4 and 5). Crow feet like defects including button like surface abnormalities were observed on

the broken wire samples. The defect was observed near the fracture end and which was very much localized in nature (Figs. 2 and 3).

Figs. 2–5. (2, 3) Closer view of surface defects of failed wire samples #1. (4, 5) Closer view of surface defects of failed wire samples #2.

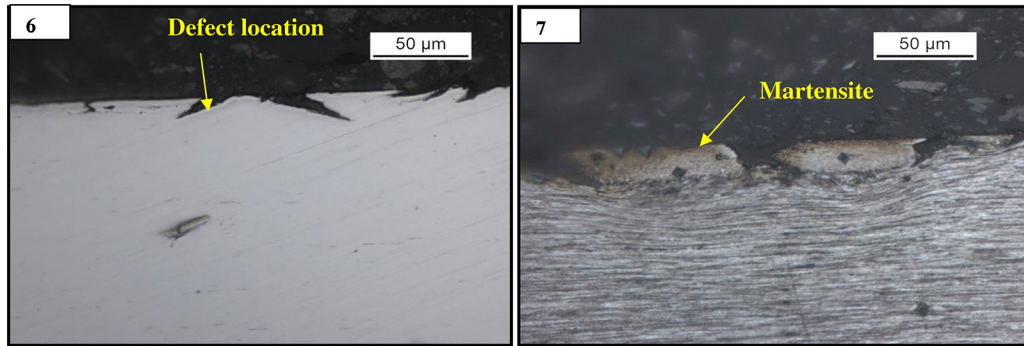
Figs. 6 and 7. (6) Un-etched micrograph of the cross section of the defect location in longitudinal micro specimen. (7) Etched microstructure of the same.

fracture end and in localized manner. Etched microstructure of the longitudinal samples revealed presence of brown layer near the defect location. The thickness of the brown layer is around 30–40 μm . From microstructure analysis the brown layer appeared to be of martensite (which was further verified by micro hardness value and SEM analysis). Severe grain flow was observed along the defect location. The microstructure of the matrix revealed cold drawn pearlite structure. The average hardness of the matrix is about 460 HV, and the average hardness value of the brown phase is around 650 HV. This type of layer is generated during wire drawing due to lack of lubrication as no segregation was observed [4]. The martensite layer which forms a brown layer in the surface is very brittle in nature (high hardness). This surface martensite helps to propagate cracks from the pearlite–martensite interface and which leads to failure during drawing or its successive operations. The martensite formed in the surface is a thermal phenomenon generated during friction causes surface temperature rise followed by rapid cooling due to mass effect of bulk. EDS analysis reveals presence of tungsten (W) in the martensite region in concentration of more than 2% as the element is not contained in bulk, which indicates that the material transfers between

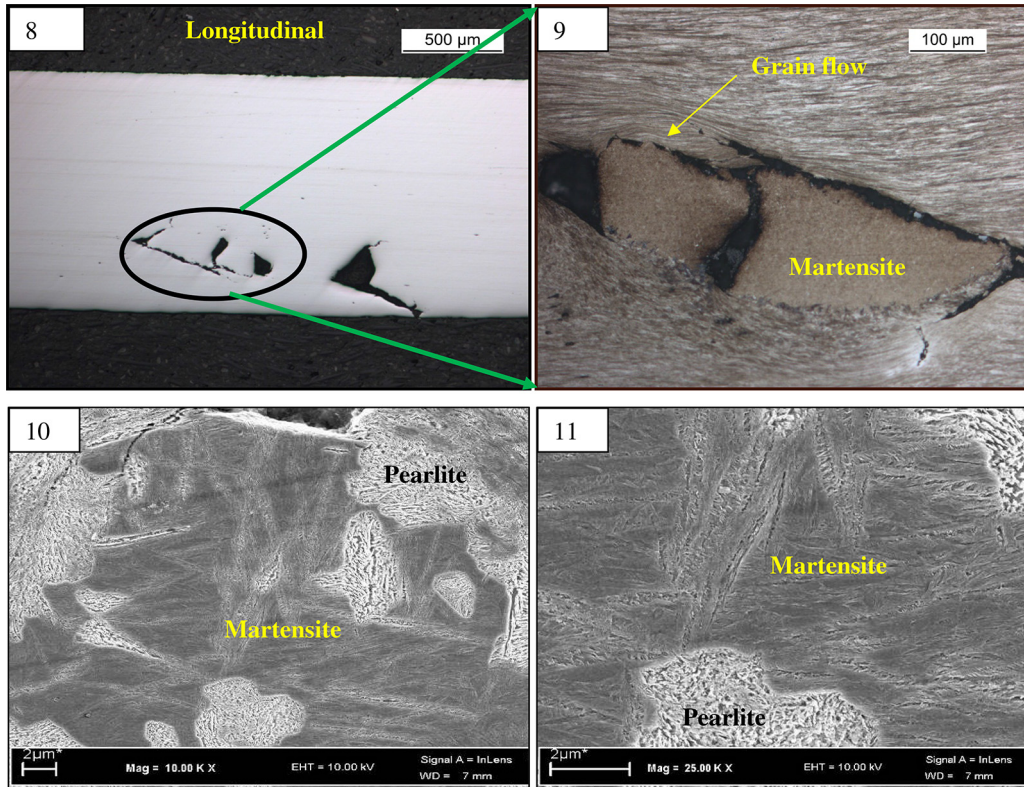
Micro specimens were prepared from the fractured end as well as defect location of wire samples for conducting light optical microscopic examination and scanning electron microscopy (SEM). These samples were individually mounted in conductive mounting and polished by conventional metallographic techniques for scratch free surface. The polished samples were etched in 3% nital solution (3 mL HNO₃ in 97 mL ethyl alcohol), and both un-etched and etched samples were examined in a light microscope to observe microstructural constituents. Un-etched sample shows surface defect in longitudinal as well in transverse direction (Figs. 6 and 8). Etched microstructure of the longitudinal samples revealed presence of brown layer near the defect location. The thickness of the brown layer is around 30–40 μm (Fig. 7). From microstructure analysis the brown layer appeared to be of martensite (which was further verified by micro hardness value and SEM analysis; Table 2). Severe grain flow was observed along the defect location. The microstructure of the matrix revealed cold drawn pearlite structure (Figs. 9–11).

Figs. 8–11. (8) Un-etched micrograph of the top view of the defect in longitudinal micro specimen at 50× magnification. (9) Etched microstructure of the same at 200× magnification revealed martensite at the defect location. (Top view of the defect; etched after marginal polishing of surface.) (10, 11) Martensite at higher magnification under SEM.

Presence of martensite (hard phase) in the surface of the wire samples caused breakage during drawing. It could be envisaged from the surface characteristics and microstructure vis-à-vis the occurrence of failure that the hard-phase generated during drawing due to improper lubrication.

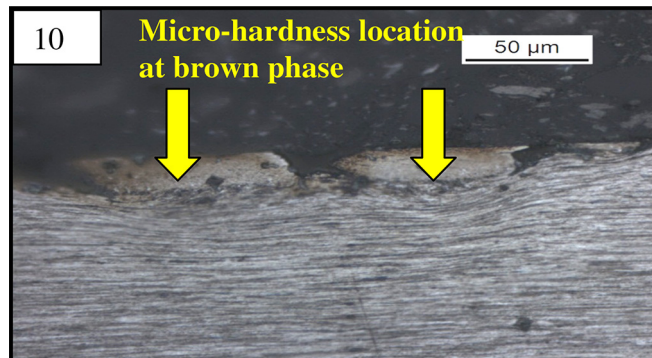
The micro hardness of different phases observed in the broken wire samples was determined in a pneumatically controlled automatic micro hardness tester (Leco-LM247AT). An applied load of 50 gf was used during testing, and several indentations were made to determine the hardness of different phases (Fig. 12). The average hardness of the matrix is about 461 HV, and the average hardness value of the brown phase is about 624 HV (Table 2).

Fig. 12. Etched microstructure of the defect location showing indentation in the brown layer (surface martensite) and the drawn pearlite matrix.

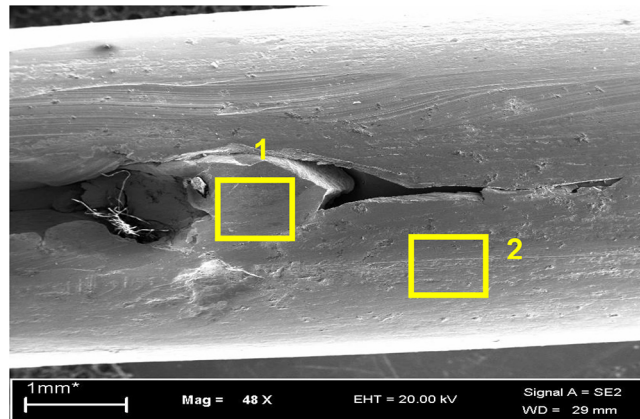
EDS analysis was carried out in the as received sample to find out the elemental difference between parent and the defect region (Fig. 13). EDS analysis reveals presence of tungsten (W) in the martensite region in concentration of more than 2% as shown in Table 3. As the element is not contained in bulk, which indicates that the material transfers between the mating bodies i.e. an intense adhesive sliding wear. Other elements remains almost constant indicate that martensitic transformation took place due to thermal effect with rapid quenching of local austenite produced by friction [4].

Fig. 13. SEM image of defect sample in as received condition.

the mating bodies i.e. an intense adhesive sliding wear. The martensite formed in the surface was generated during drawing process probably due to lack of localized lubrication [5]. Due to improper lubrication, during drawing of high carbon wires sometimes temperature reaches up to austenitic range due to heat generated, because of plastic deformation and friction between wire and die [6].
