## Case study

## Failure analysis of a leaked oil pipeline

En-Na Yang<sup>\*</sup>, Chang-Ming Fu, Chen Dong, Shen Qu<sup>\*</sup>, Ji-Feng Tian,  
Zhe-Feng Zhang

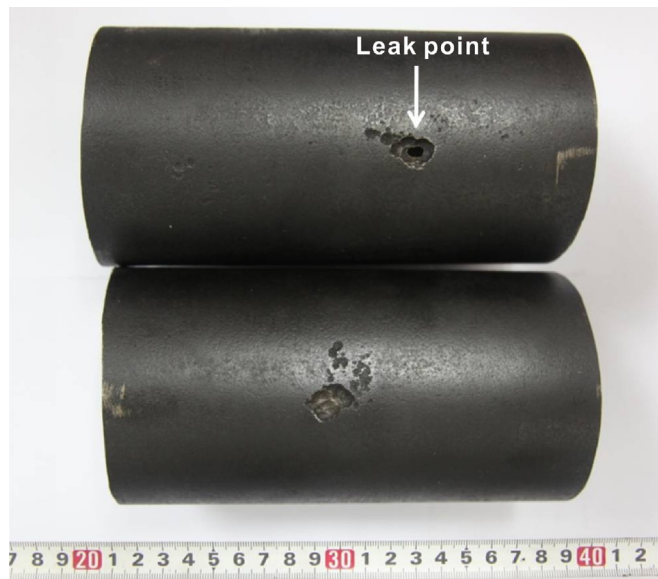
Two pipe samples cutting from the failed pipeline are shown in Fig. 1. Apparently, it can be found that some pits locate on the exterior surface of the both two pipes. Furthermore, in one pipe sample, a perforation can be found inside one large

Fig. 1. Examples of the failed pipes. The leak point is indicated by the white arrow.

pit, which is also one leak point of the pipeline, as indicated by the white arrow. No perforation was observed in another pipe.

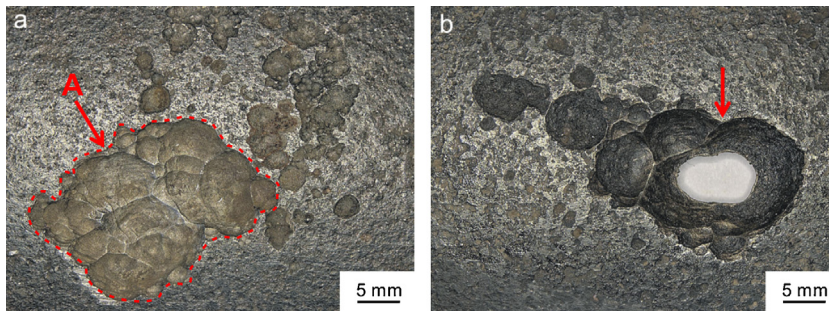
The macroscopic morphology of the pits and the perforation were observed by the stereoscope, as shown in Fig. 2. Comparing Fig. 2a with Fig. 2b, three common features can be found. First, both two damaged sites show the aggregation of pits. Second, in each pit-aggregation, there is always a large pit, as indicated by the red arrows. Third, around and inside the large pit, many small pits with different size can be observed. However, the differences between the morphologies of two damaged sites are also evident. For example, for the pipe sample showed in Fig. 2b, all pits seem to be

Fig. 2. Macroscopic morphology of two pipe samples observed by stereoscope, showing the pits and the perforation. The large pit in each sample is indicated by the red arrow.

deeper than those pits in Fig. 2a, and the largest pit had already penetrated through the wall of pipe, resulting in an obvious perforation, while no perforation can be observed in Fig. 2a.

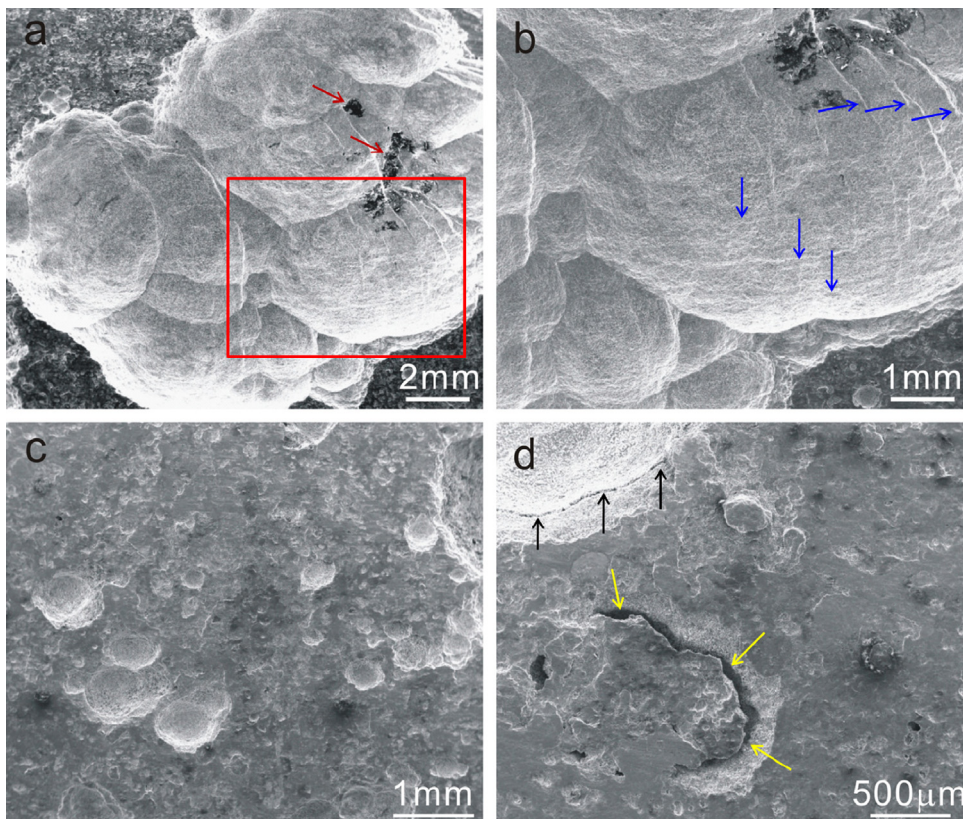
The sample with pits shown in Fig. 2a, especially the large pit marked as “A”, was further observed by SEM. The results are displayed in Fig. 3. Fig. 3a shows that inside the large pit “A” there are multiple small pits. These small pits contact or even overlap each other, and collectively form the large pit. Note that the black patches indicated by the red arrows should be adhesive dirt that was supposed to be cleared away. Fig. 3b presents the local amplification of the boxed area in Fig. 3a. Convex ridges are obviously visible, indicated by the blue arrows. Furthermore, near the large pit “A”, many smaller pits can also be observed (Fig. 3c), well agreeing with the above macroscopic observation. In addition, a crack with approximately circular shape was found, as indicated by the yellow arrows in Fig. 3d. Thus it can be deduced that a new pit would be formed if this crack extended to be closed along the ring and the materials surrounded by the crack peeled off. Also, a circumferential

Fig. 3. SEM observations on the pits in the pipeline: (a) the low-magnification observation; (b) local enlarged image of the red boxed area in (a); (c) small pits near the large pit; and (d) circumferential cracks as indicated by the arrows.

crack was found at the boundary of the pit “A”, as indicated by the black arrows in Fig. 3d, implying that a small pit might probably be formed inside this pit “A” when this crack were closed circumferentially.

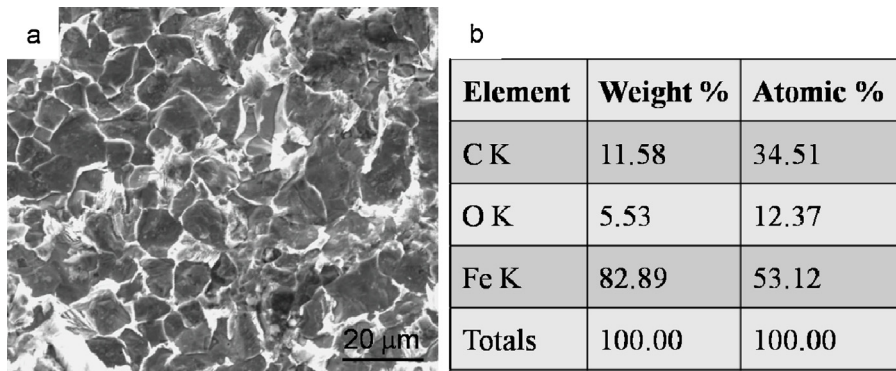
Fig. 4. Results of EDS analysis on the large pit: (a) the SEM image showing the zone for analysis; and (b) the corresponding EDS results.

In order to find out inside the pits whether there are some other elements besides the original ones of the material, the composition at the location shown in Fig. 3b was analyzed by EDS. Fig. 4a shows an enlarged image of Fig. 3b, at which the EDS analysis was performed. The corresponding numerical results of element content are shown in Fig. 4b. No corrosive elements, yet a small amount of oxygen, were detected. In other words, the pipe should have experienced slight oxidation, but no corrosion.

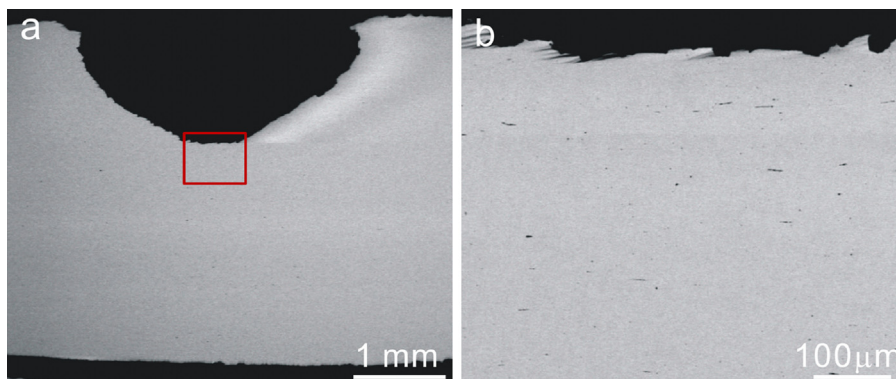
To further observe the internal morphology of the large pit “A”, a metallographic section plane was made, and then observed by SEM. Fig. 5a shows the low-magnification image of the metallographic section plane. One can see that the internal surface of the pit is not smooth, but rather uneven, as can also be more clearly seen in the enlarged local image (see Fig. 5b). Further examination of the internal surface shown in Fig. 5b reveals many small pits with size ranging from micro scale to sub-millimeter scale, which is in good accordance with the SEM observations in Section 3.3.

Fig. 5. SEM observations on the metallographic section plane of the pit “A” in Fig. 2a: (a) low-magnification observation; (b) local enlarged image of the red boxed area in (a).

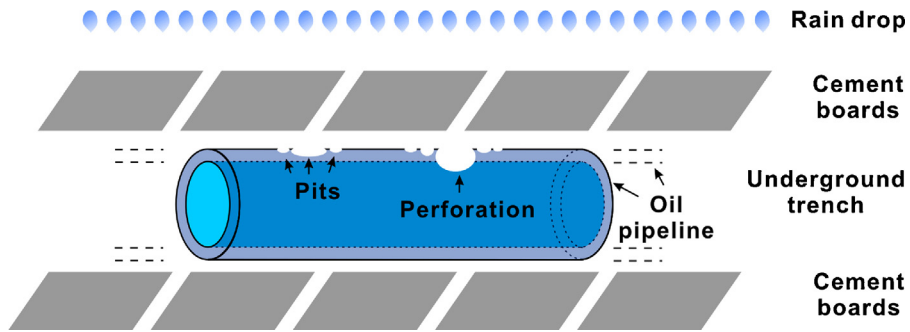
According to the introduction of the accident, the local weather was rainy heavily for a few days before the finding of the leak. The investigation in the scene of the accident also found rainwater in the underground trench, where the failed pipeline was placed. It implies that there should be some holes or gaps at the joints between two adjacent cement boards. This can

Fig. 6. Schematic diagram of the failure locations and the surrounding environment of the failed oil pipeline.

probably cause the direct impact from the raindrops on the exterior surface of the pipeline, and consequently resulting in the formation of the pits and perforation, as illustrated in Fig. 6. These situations demonstrate that the leak of the pipeline should be attributed to the liquid impingement erosion induced by falling raindrop.

Based on the experimental observations and the analysis above, it can be concluded that the failure of the oil pipeline should be originated from the liquid impingement erosion induced by falling raindrop. Thus, suggestions to prevent the recurrent of the accident may include: (1) Adding water-proof coating or cover to avoid the direct exposure of the external surface of the pipeline, which may be also beneficial for averting other types of erosion and corrosion; (2) keeping the underground trench always dry; (3) periodically checking the covered cement boards, and ensuring no locally large holes. The present work provides sufficient experimental evidences for liquid impingement erosion, which may be helpful for future engineering failure analysis.
