Case Studies in Engineering Failure Analysis

Case study

Failure analysis of a motor-car coil spring[☆]

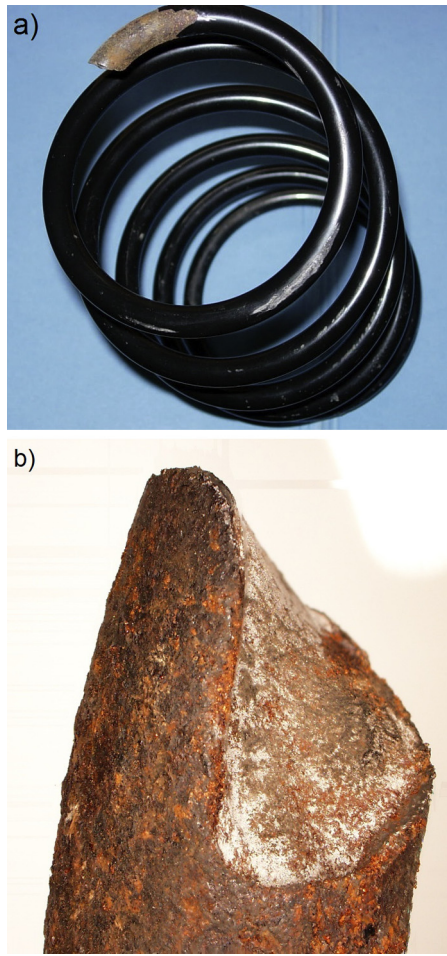
A motor car coil spring of a rear shock absorber has been ruptured during car operation. The surface of a spring was protected against corrosion with a thick layer of paint on polymer basis. Around the fracture surface, a protective layer was damaged and removed over a length of several centimeters. In this area, spring has long been exposed to corrosion attack and thus surface heavily corroded and wrinkled (Fig. 1).

Fig. 1. Damaged motor-car coil surface (a) and corroded fracture surface (b).

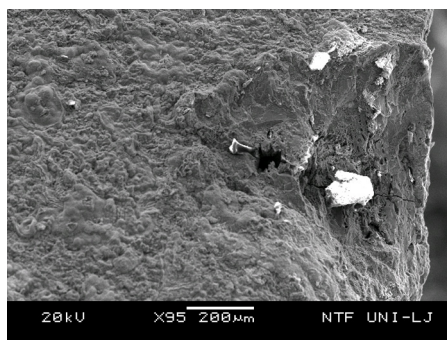
The fracture surface of a spring is discontinuous and in major part of it covered with fresh rust. On a minor portion of a fracture surface, a compact, dark brown rust (like on the circumference of the spring) is visible, which was formed substantially (months) before the final rupture of the spring (Fig. 2). From this part of the fracture surface, crack gradually propagated (the “arrest lines” are clearly visible), due to the combination of corrosion attack and cyclic loading during the car operation (Fig. 3), until the length of the crack reached its critical value, and the spring broke instantly (Fig. 4).

Fig. 2. The fracture initiation surface of a coil spring, covered with corrosion products and secondary cracks.

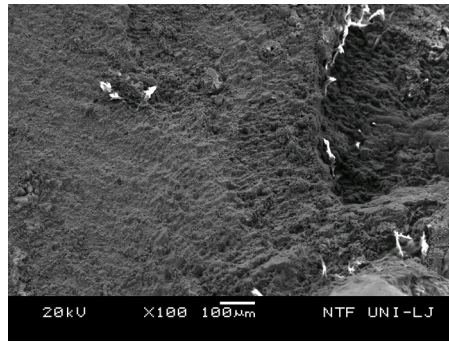
Fig. 3. Part of the fracture surface with a gradual crack propagation (corrosion induced fatigue).

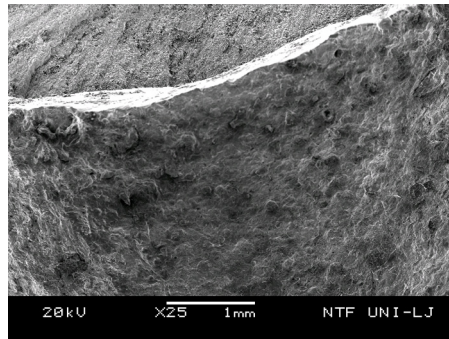
Fig. 4. Upper part of a fracture surface represents a termination stage of a fatigue where spring broke instantly and lower area corroded surface of the spring.

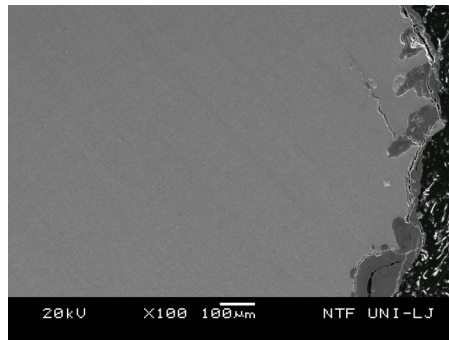
Part of the fracture surface, covered with thick, compact and dark rust is the primary crack, which was exposed to corrosion attack for months. Part of the fracture surface (Fig. 5), where a layer of compact surface rust and indentations of rust into the material are clearly visible represents a propagating stage of a fatigue and part of a surface (Fig. 6), which is covered with thin fresh rust (formed in a few days after final rupture) the terminating stage of the fatigue.

Fig. 5. Axial cross-section through fracture surface. Corrosion products are at the circumference and the fracture surface as in the indentations (secondary cracks).

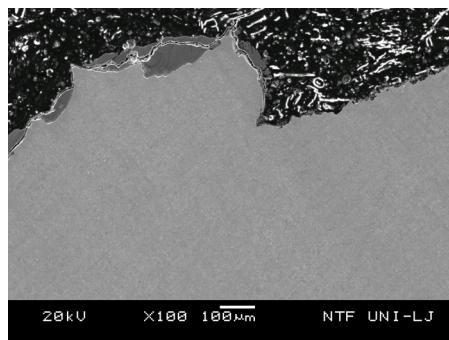
Fig. 6. The micrograph shows the boundary between propagating stage, with visible corrosion products and terminating stage of the fatigue fracture. Opposite side of the primary crack.

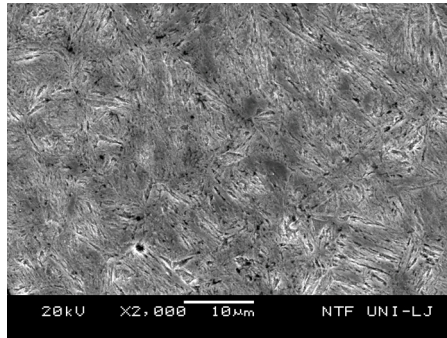
**Fig. 7.** Martensitic microstructure of the spring.

Steel was quenched and tempered to obtain martensitic microstructure with hardness of 520 HV–560 HV (49 HRC–51 HRC). There was found no evidence of any imperfection in the steel, which could be the cause of failure of the spring (Fig. 7).
