Experimental investigation on structural collapse of a large composite wind turbine blade under combined bending and torsion

Xiao Chen

National Laboratory of Wind Turbine Blade Research & Development Center, Institute of Engineering Thermophysics (IET-Wind), Chinese Academy of Sciences, Beijing 100190, China

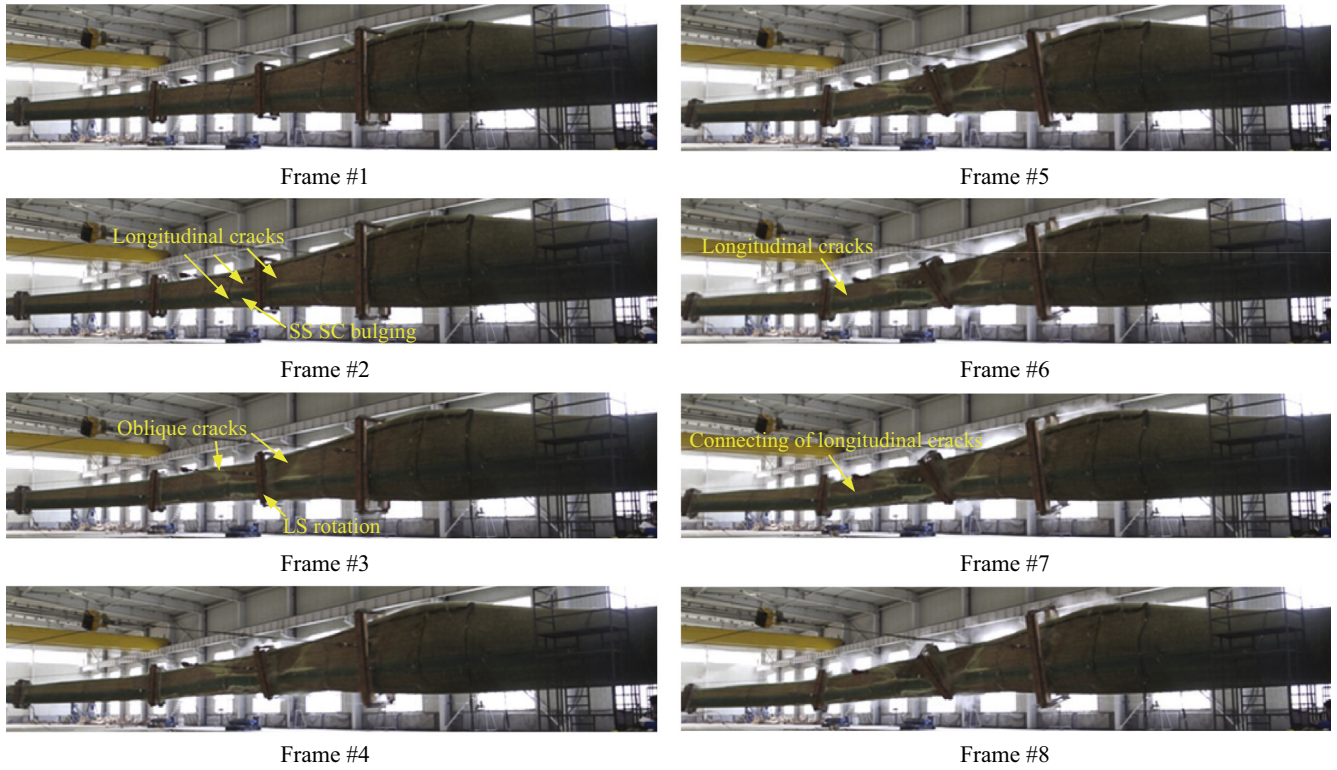
(a) Collapse process captured by camera #1

Frame #1 captured by camera #1 shows no obvious visual damage in the blade just before the collapse process starts. In Frame #2, longitudinal cracks occur in the intersectional region between SS SC and sandwich panels around the 19-m section where the LS is mounted on. Noting that at this frame, the SS SC exhibits significant local buckling in the form of bulging around the 22-m section. In Frame #3, oblique cracks occur in aft panel (AP) together with the rotation of the LS. The cracks around the 19-m section start to propagate as recoded in the following video frames. In Frame #6, longitudinal cracks are observed near the 28-m section and they further connect to the previous cracks initiated from the 19-m section as shown in Frame #7. The blade collapses in the region from the 15- to 28-m section as shown in Frame #8.

According to the observation presented, several findings can be ascertained. First, a series of progressive chain events occur in the collapse process of the blade. Among them, local buckling of the SS SC in the form of bulging is the phenomenon initiating the collapse process of the blade. Second, debonding of adhesive joints between the SC and the SW accompanies the significant bulging of the blade shell. Third, torsion loads due to the applied twisting moment significantly affect the collapse process of the blade after the occurrence of local buckling.

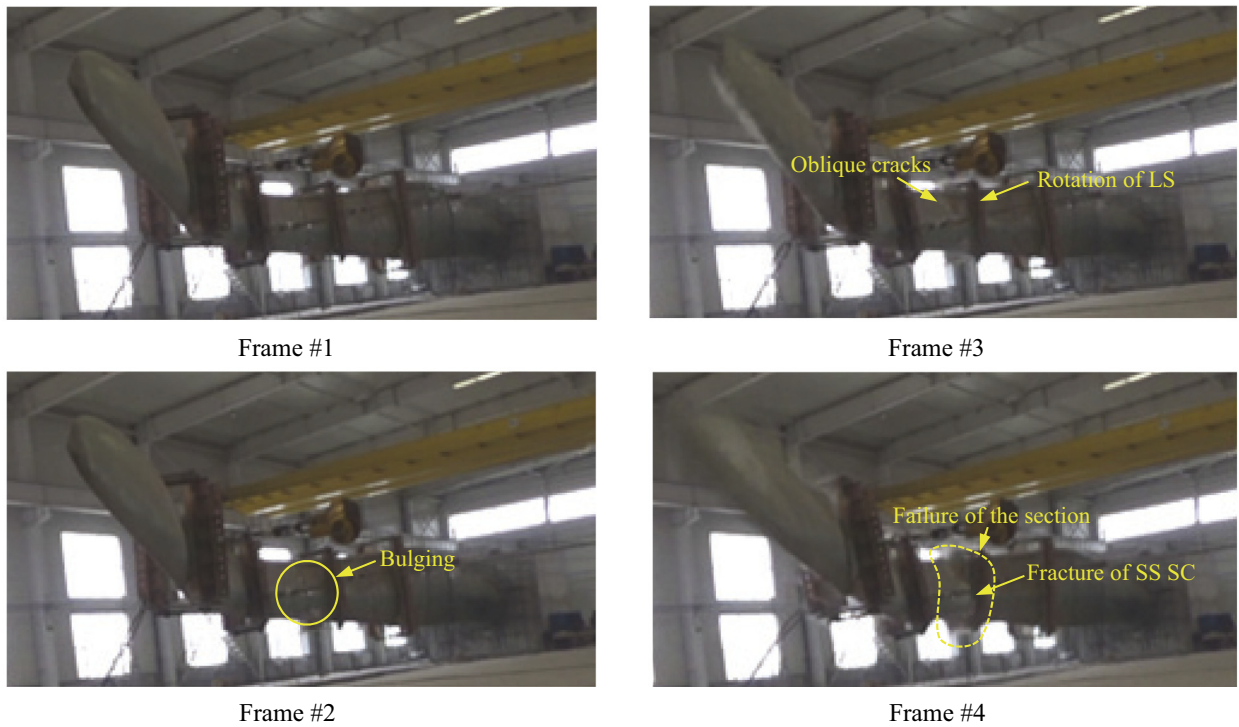
(b) Collapse process captured by camera #2

Video records from camera #2 provide clearer images of collapse response of the 22-m section at the beginning of the incident. It is worth noting that significant bulging occurs not only in the SC but also in sandwich panels in the blade cross section as shown in Frame #2. This observation indicates that the entire blade shell, which consists of both SC and sandwich panels, deforms without constraint in the out-of-plane direction at this time instance. Considering that the SC is originally adhesively bonded to the SW, it is impossible for the SC to exhibit large out-of-plane deformation together with the adjacent sandwich panels if the adhesive joints are intact. Therefore, it can be deduced that the significant bulging of the entire blade shell in the SS side is an indication of the failure of adhesive joints in the blade section. Frame #3 shows the same observation of oblique cracks and rotation of the LS as the one captured by camera #1. Furthermore, Frame #4 provides a better view of the fracture of the SS SC and the failure of the blade section near

the LS compared with the observation from camera #1. It can be seen that the blade exhibits drastic deformation at this time instance, indicating the loss of the load-carrying capacity of this blade section.

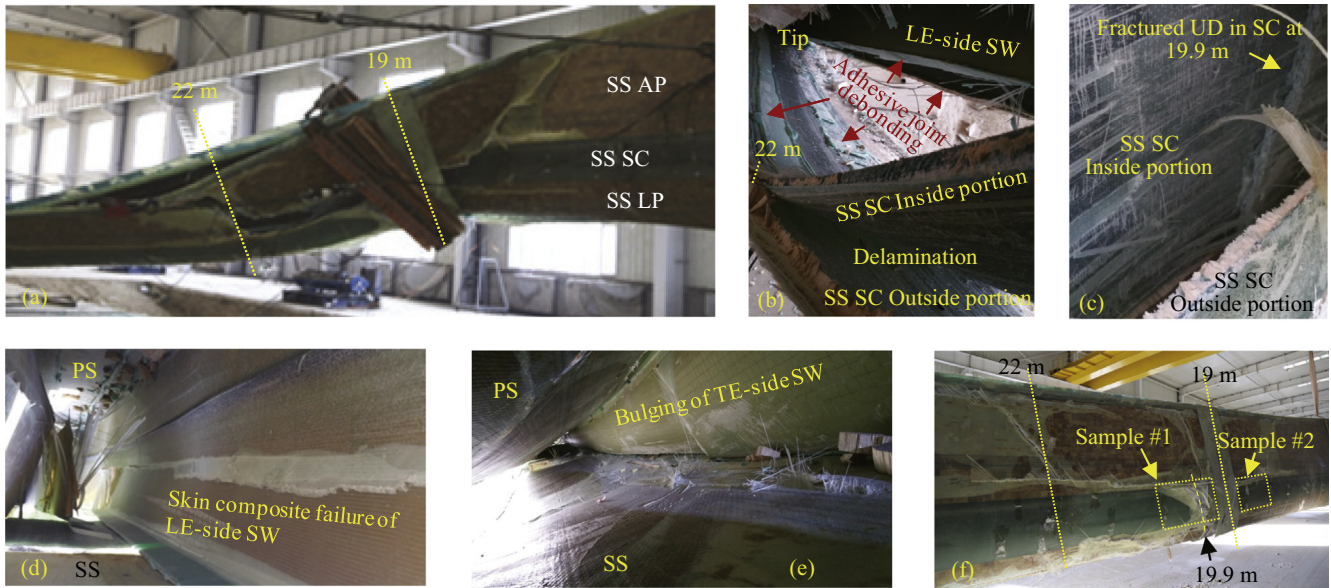
Fig. 5. In situ post-collapse characteristics of the blade.

A close-up of the blade after the collapse test is shown in Fig. 5 (a). It can be seen that the primary failure of the blade ranges approximately from 15 to 28 m from the blade root. The SS SC is separated from AP which exhibits significant fracture near the 19-m section with oblique cracks caused by torsion as previously discussed. Debonding of adhesive joint is observed along trailing edge (TE), leading to the separation of two blade shells. The LS at the 19-m section is dislocated from its original location probably due to the drastic impact load during the blade collapse.

Taking advantage of large openings at various fracture locations, it is possible to examine the interior of the blade. If looking towards the blade tip direction from the blade section around 21 m, one can find that adhesive joints between the SS SC and the SW are completely debonded. Furthermore, the SS SC is delaminated from unidirectional (UD) composites and separated into two portions as shown in Fig. 5(b). If looking towards the blade root direction, one can find that the outside portion of the delaminated SS SC is completely fractured at the 19.9-m section as indicated in Fig. 5(c). The location of fracture correlates well with the one observed in Frame #4 of camera #2. Since the SC is the structural

component primarily responsible for load-carrying, the fracture and the delamination are two critical failure modes which significantly damage the load-carrying capacity of the blade. It should be

noted that the PS of the blade was also inspected and there is no failure observed in the SC.

Inspection on SW shows that skin laminates of the leading edge (LE) side SW is fractured with longitudinal cracks at the middle

height of the SW as shown in Fig. 5(d). The TE-side SW is found to undergo significant bulging towards TE with minor cracks in skin laminates as shown in Fig. 5(e). These failure modes in the SW indicate that the cross section of the blade has sustained considerable crushing pressure which imposes transverse compressive forces to the SW. It is deduced that the crushing pressure was caused by the overall flattening, or ovalization, of the blade cross sections, which is also known as the Brazier effect for thin-walled structures under bending. The Brazier effect causes the SC to flatten while the SW inside the blade intends to resist this flattening and is therefore subject to transverse compressive forces, which eventually fail the SW with the failure modes as observed in the blade.

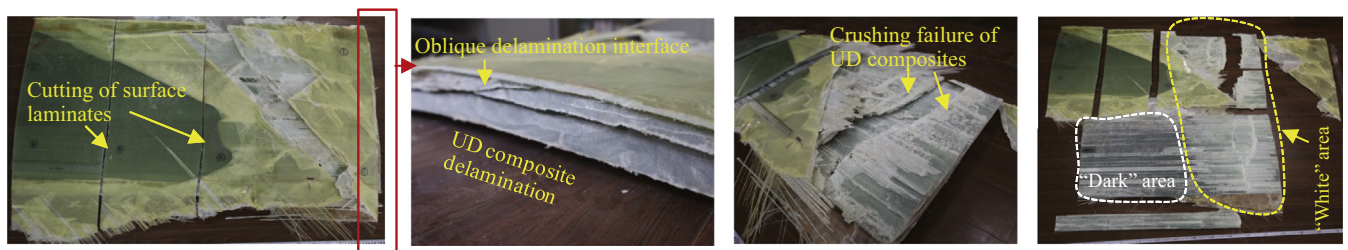
Fig. 6. Laboratory examination on SC sample #1.

SC sample #1, as shown in Fig. 6(a), shows oblique cracks in skin composites. These cracks are regarded to be caused by the tearing force when the blade section is twisted during the blade collapse. Noting that the outside laminates of the sample are transversely cut for the ease of removing to facilitate inspection on the interior. It can be found that multiple delamination exists in the thickness direction of the SC primarily consisted of UD composites,

see Fig. 6(b). It is interesting to note that oblique delamination is also found in the middle portion of the SC.

After removing one of the outside laminates, it is found that UD composites of the outside portion of the delaminated SC exhibit significant compressive crushing failure at the fracture location as shown in Fig. 6(c). This failure mode is regarded to be caused by the longitudinal compressive forces sustained by the SS SC. The explosive view of the sample reveals two distinct colors in the delamination surface as shown in Fig. 6(d). The region near the location of UD composite fracture shows a white and bright color while the other region shows a relative dark and green color. This finding implies a possible failure sequence that UD composites at the outside portion of the SS is first subject to longitudinal compressive crushing failure, which initiates delamination at the location of UD composite fracture. After that the delamination further propagates along the SC, creating a dark green color in the delamination surface.

(a) Sample #1 to be examined (b) Delamination (c) Crushing failure (d) Explosive view of the sample

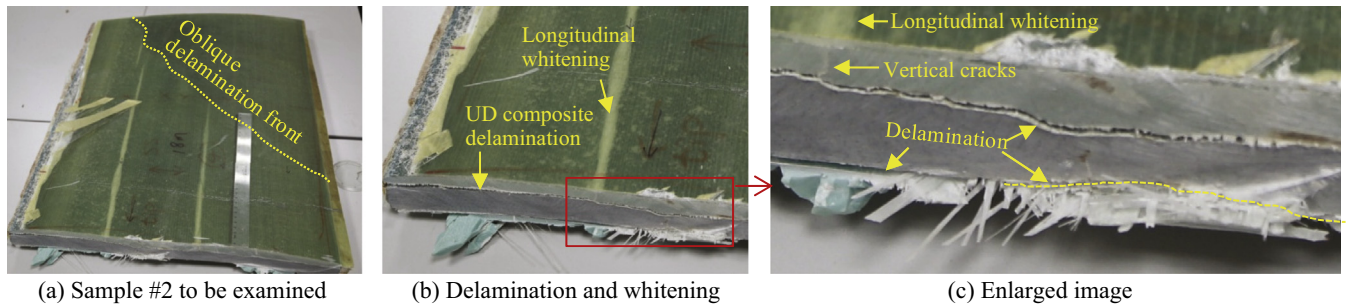
Fig. 7. Laboratory examination on SC sample #2.

SC sample #2, as shown in Fig. 7, exhibits several interesting failure modes. The first one is delamination of UD composites, which vanishes at the oblique delamination front in the in-plane direction of the SC as indicated in Fig. 7(a). This oblique delamination front is regarded to be caused by the twisting moment as the direction of the delamination front is similar to that of the oblique cracks of AP in this blade section. The second failure mode is the compressive crushing failure of epoxy resin matrix of the outside skin composites characterized by two lines of longitudinal whitening due to transverse compressive forces, see Fig. 7(b). When atten-

tion is paid to the cross section, it can be found that there are vertical cracks underneath longitudinal whitening lines and they run along the thickness direction of the SC laminates as indicated in Fig. 7(c). The vertical cracks are considered to be caused by transverse tensile forces as they are found to start at the delamination surface of SC and propagate up to the outside skin composites. Moreover, the enlarged image also reveals that delamination does not only occur in the middle but also in the region near the inside surface of the SC as indicated in the figure, implying the existence of transverse tensile stress/strain at the inside surface of the SC.

These failure modes provide important information on the blade collapse. On the one hand, it can be known that the Brazier effect exists in the blade and it is the reason for the longitudinal whitening lines, the underneath vertical cracks and the delamination of the inside portion laminates when the blade cross section is subject to flattening. On the other hand, it can be deduced that three failure modes of UD composite delamination, longitudinal whitening and vertical cracks do not occur simultaneously but in a certain sequence. Considering there is no vertical cracks in the inside portion of the delaminated SC due to the existing delamination surface which stops the further progress of vertical cracks, it can be known that the vertical cracks occur after the UD composite delamination.

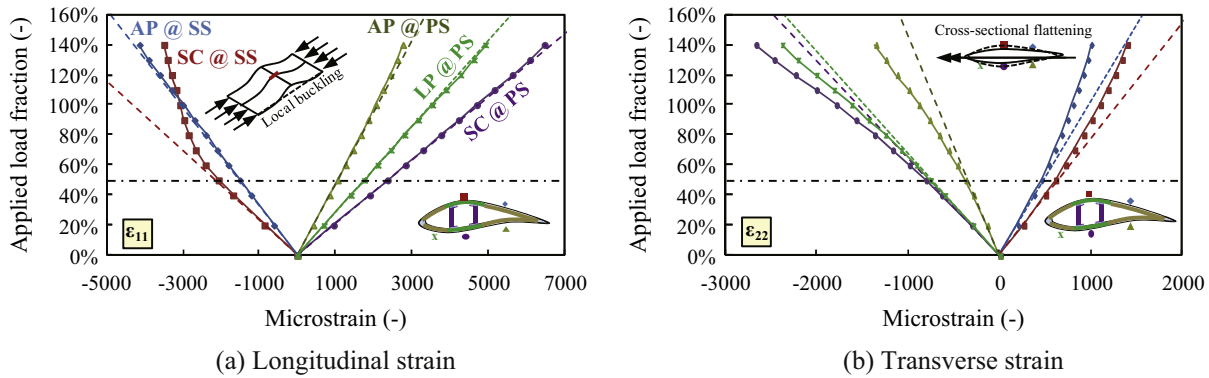
Fig. 8. Longitudinal and transverse strain response of the 22-m section of the blade.

It can be found that all longitudinal strains respond to applied loads in a linear fashion except the one of SC at SS, which exhibits significant nonlinearity starting from 50% test loads as shown in Fig. 8(a). In general, nonlinear behavior of a structure can be categorized into three types from a structural mechanics point of view. The first type is geometric nonlinearity due to large deformation in either global or local structure, the second type is material nonlinearity associated with intrinsic properties of materials used in the structure, and the third type is boundary nonlinearity which involves the change of boundary condition, contact status, etc. For this case, it is not possible for the composite material to undergo nonlinear response due to the low strain level in the longitudinal direction. In addition, there is no detachment between the SG and the blade surface according to post-collapse investigation. It can be concluded that the geometric nonlinearity is the only source contributing to nonlinear strain response of the SC.

Considering that the strain curve is bent towards the positive side with the increase of the applied loads, it can be known that geometric nonlinearity of the SC is developed as local buckling in the form of bulging outward, which leads to the reduction of longitudinal compressive strain of the outside surface of the SC. This finding is important as it provides a strong quantitative evidence to confirm the cause of the SC bulging observed in the video records. It can be known that the development of local buckling of the SS SC during the loading history is a driving factor leading to the bulging of the blade shell and eventually the blade collapse.

When attention is paid to transverse strains of the blade cross section as shown in Fig. 8(b), it is found that transverse strains exhibit nonlinearity. All strain curves bent towards the negative side regardless of the locations of SG. This bent pattern indicates that the outside surface of the blade shell at this cross section is subject to additional transverse compressive strains in addition to its intended transverse strains which are tensile at SS and compressive at PS due to Poisson effect when the blade is primarily under bending. The only explanation to the cause of this bent pattern is the overall flattening of the cross section. This finding provides direct evidence which indicates the existence of the Brazier effect which although has been discussed previously according to post-collapse investigation.

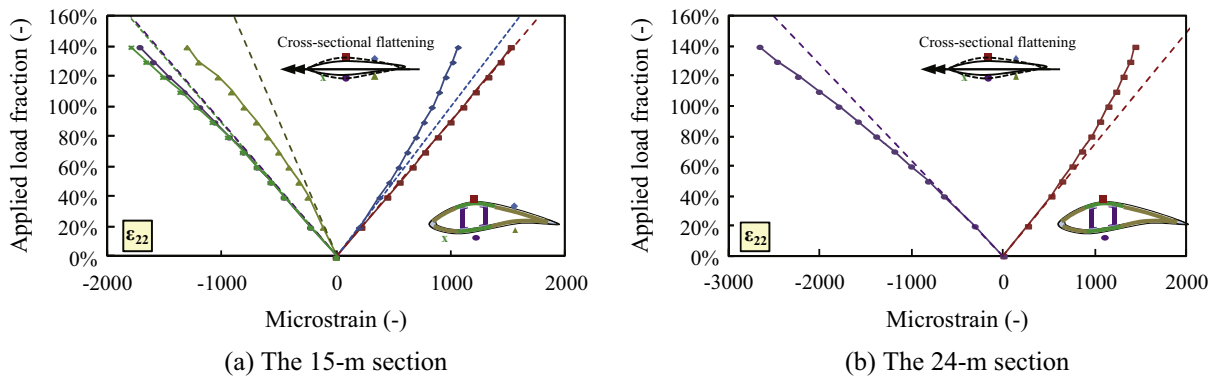
Fig. 9. Transverse strain response of the 15- and 24-m section of the blade.

It should be noted that the Brazier effect does not only occur in the 22-m section but also in the 15-m section and the 24-m section. As shown in Fig. 9, two blade cross sections exhibit a bent pattern of transverse strain response similar to that observed in the 22-m section despite difference in the starting load level. Nevertheless, neither SC nor sandwich panels in these two blade sections is found to experience local buckling as all longitudinal strains

respond to applied loads in a linear fashion up to the collapse loads.

From the observation on transverse strain response, it is deduced that the overall flattening, or the Brazier effect, of the blade cross sections is not the reason for the blade collapse. Indeed, the cross-sectional flattening is the intrinsic nonlinear geometric behavior of thin-wall structures under bending and this phenomenon can be observed in the blade cross sections which do not fail. According to the investigation on collapse process of the blade using video records, it has been found that the blade collapse is initiated in the cross section around 22 m which is identified to undergo significant local buckling. It can be therefore concluded that local buckling of the SC is the dominating phenomenon in the loading process leading to the blade collapse.

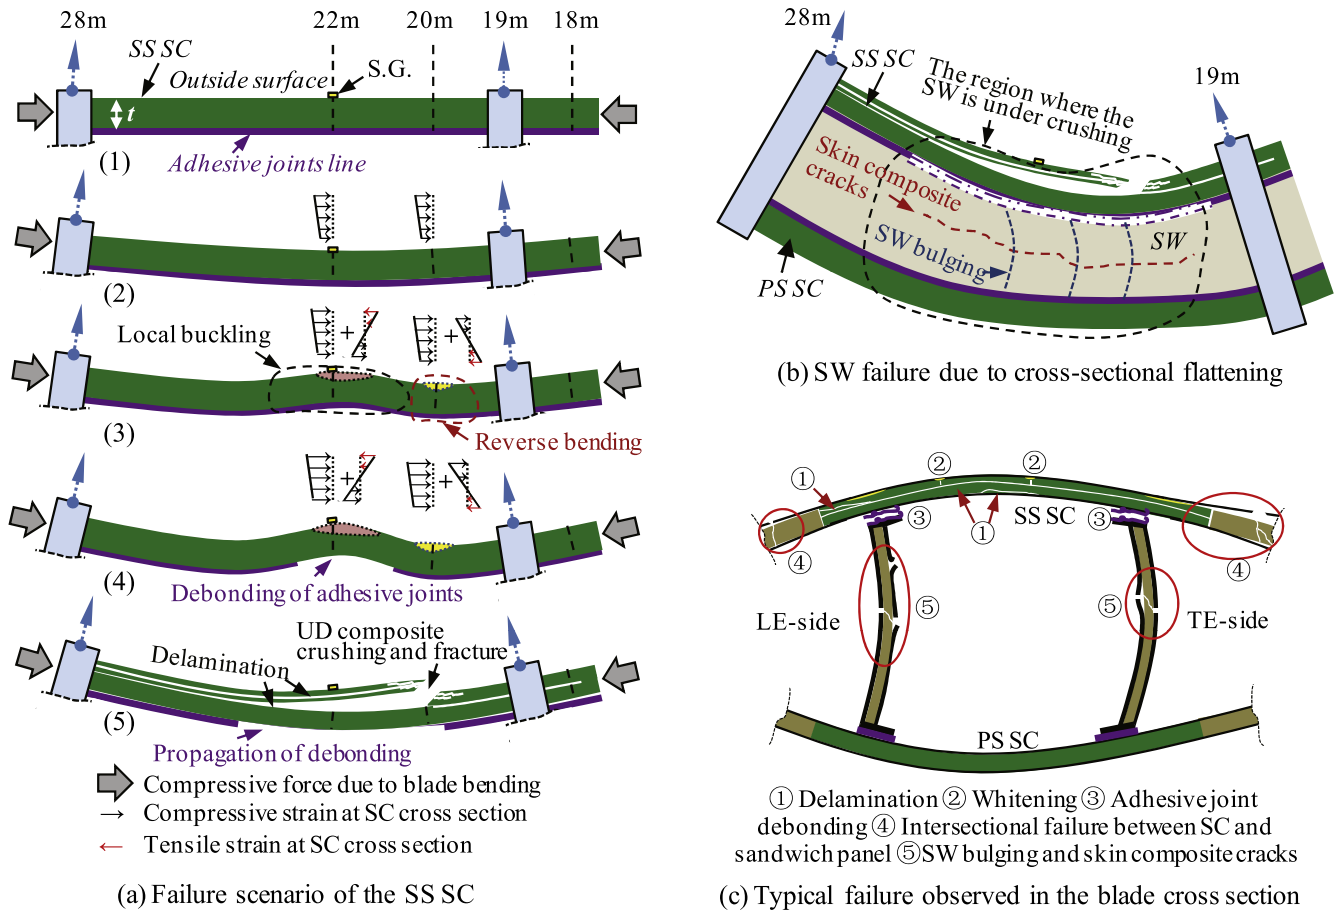
Fig. 10. Illustration of the plausible failure mechanism of the blade collapse.

Recall that applied loads are introduced to the blade through LSs, which are built to have enough stiffness to avoid their excessive deformation during the test. Meanwhile, the blade sections at the LS locations are reinforced by wet layups to prevent the blade from local damage. The LS and the local reinforcement are two measures widely used to introduce test loads to the blades. However, they implicitly impose additional constraint to the degree of freedom of the blade cross sections especially in their outward direction. Taking this constraint effect and the previous findings into account, the most likely failure scenario of the load-carrying member, i.e., the SC, can be schematically illustrated in Fig. 10(a), and it is elaborated as follows:

tion. Therefore, a reverse bending exists in the SS SC from 19 to 22 m. The reverse bending results in additional compressive strain and causes the outside surface of the SS SC to sustain even more compressive strain. Furthermore, the local buckling also leads to the increase of through-thickness tensile stress/strain in adhesive joints which intend to constrain the out-of-plane deformation of the buckled SC.

- (5) The significant bulging, or local buckling, of the SC generates considerable compressive strain in the outside surface of the 20-m section. As a result, the laminates experience longitudinal crushing failure due to excessive compressive strain and laminate fracture occurs consequently. The failure of the outside portion of the SC initiates delamination which further propagates along the SC, resulting in the loss of the load-carrying capacity of the blade.

- (6) Because the test loads are still applied to the blade, the damaged blade bends and twists drastically due to its loss of the load-carrying capacity as observed in the video image of Frame #3. The bending loads cause the blade cross sections, which at the present have much less stiffness than when they are intact due to the SC failure, to undergo considerable flattening and sustain large transverse crushing pressure induced by the Brazier effect as shown in Fig. 10(b). This leads to post-collapse characteristics of longitudinal cracks and bulging deformation in SW, longitudinal whitening lines and the underneath vertical cracks, and delamination of the inside portion of laminates in the SS SC as previously discussed. The torsion loads, on the other hand, also come into play when the blade loses its strength and cause post-collapse characteristics in the form of oblique cracks in AP and oblique delamination in the through-thickness direction and in the in-plane direction of the SC. Typical failure observed in the blade cross section is schematically shown in Fig. 10(c).

On the basis of all the information presented, it is evident to deduce the plausible failure mechanism of the blade collapse. When the blade is loaded with the offset loading lines, it bends in the flap-wise direction with minor torsion due to the small twisting moment introduced to the blade. The SS of the blade is primarily under compression and experiences local buckling at 22 m starting at 50% test loads. Due to the constraint from the LS and local reinforcement at the 19-m section, the SS SC at 20 m is
