Paper No: 05-IAGT-2.1

MEASURES EMPLOYED AT UNION GAS TO ADDRESS HIGH CYCLE FATIGUE IN THE AVON HP TURBINE

Rick Wintjes

**Union Gas Ltd
A Division of Duke Energy Gas Transmission
Chatham, Ontario**

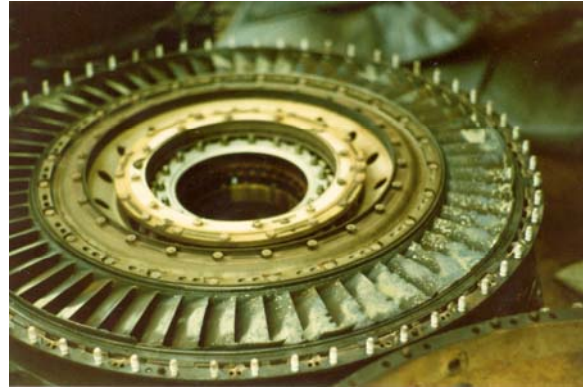
Following the first HP Turbine failure in 1981, it was concluded that the damage was a direct result of liquids formation between the filter separator and the fuel gas manifold on the GG. Evidence of this fuel contamination is shown in the photographs below. Irregular burn patterns can be seen on the trailing edges of the HP NGV's (right) and were thought to be typical of combustible liquids being ingested by the engine.

Figure 6 – HP NGV Damage

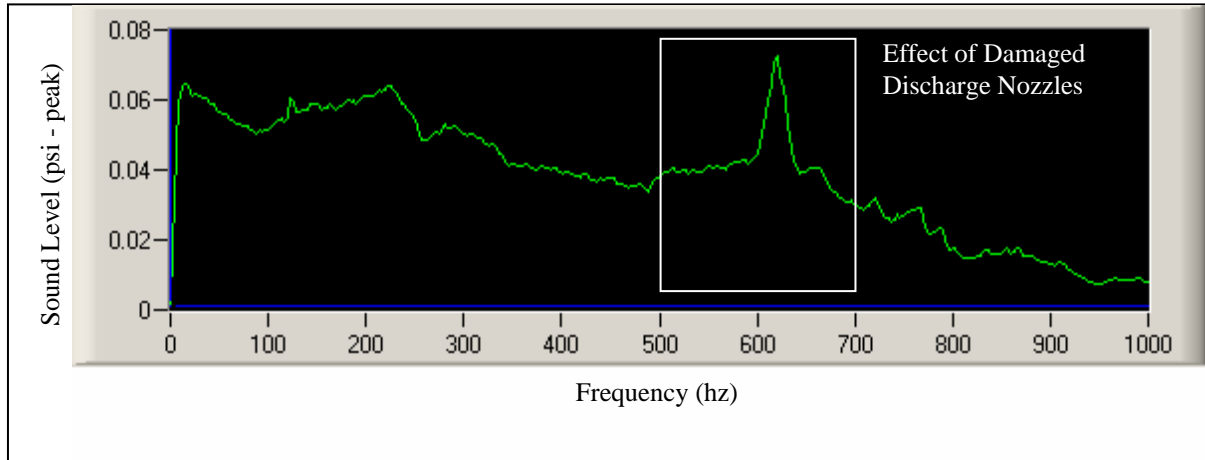
Figure 23 – Bright A1 (Engine 37433): May 6th, 2005

1534 AVON – c/w Broken Discharge Nozzle Bracket and Broken Chin Strap

During the hot end inspection of engine 37433 (June 6th, 2005), it was discovered that the discharge nozzles had suffered from a broken chin strap at discharge nozzle #8, and a broken bracket joining discharge nozzles #6 and #7. Comparison between the CP103 traces of a healthy 1534 engine (see Figure 22) and an engine with damaged discharge nozzles (Figure 23), shows that the failed discharge nozzles generate elevated combustion noise levels in the 500 to 700 hz range, with a strong peak at around 600 hz.

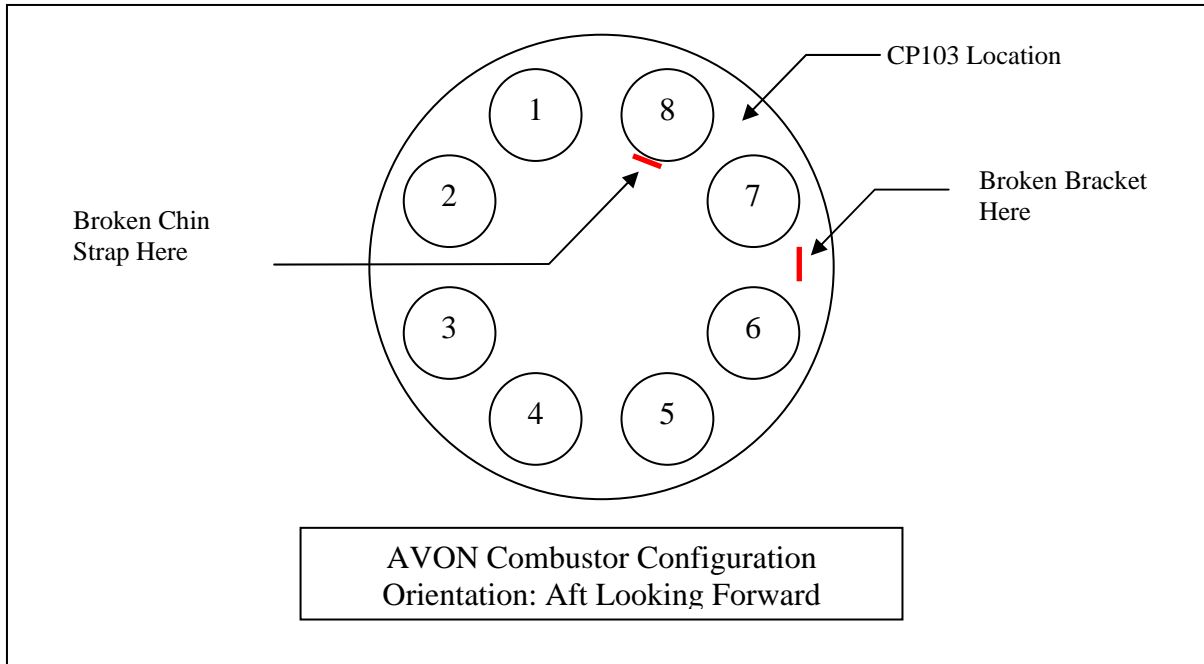
Figure 24 – Discharge Nozzle Damage Location (Engine 37433)

The exact location of the damaged components, relative to the CP103 transmitter location, is shown above (Figure 24).

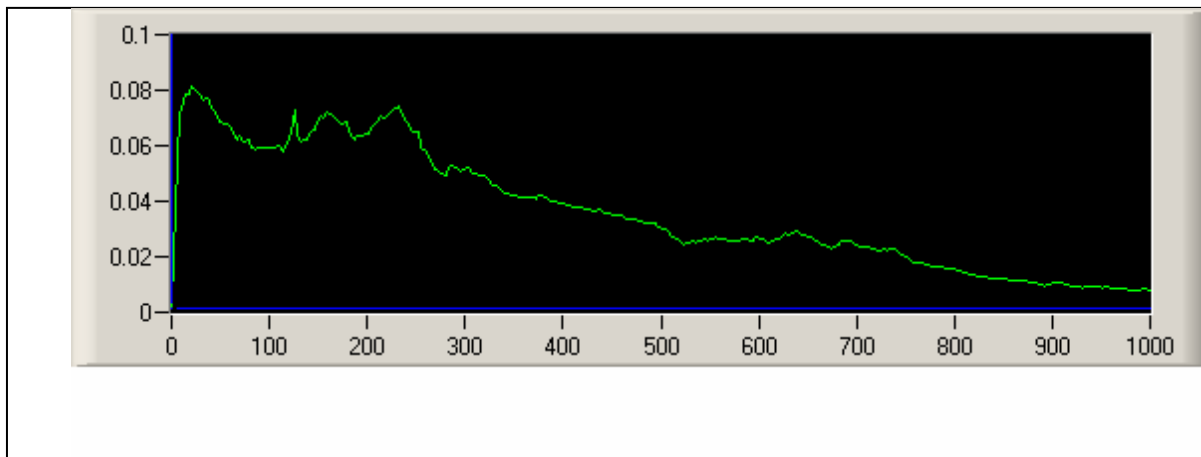
Figure 26 – Lobo A1 (Engine 38425): April 12th, 2005

Although the hot-end inspection of engine 38425 revealed yet another broken chin strap (at discharge nozzle #1), there appears to be no significant indication of this problem by the CP103 Transmitter. Note that only the chin strap failed, all 8 brackets remained intact. Several possible explanations could account for the lack of CP103 signal:

- CP103 Transmitter location. The location of the transmitter (relative to the failed chin strap) may affect the signal strength.
- Chin strap failure may have occurred at the very end of the operating season and was not captured by the CP103 transmitter. This possibility cannot be ruled out since there was very little fretting wear found on the damaged discharge nozzle.
- Chin strap failure is not detectable. The affect of the chin strap may be far less severe than that of the bracket.
- Swirler burners may have a lower tendency to make the discharge nozzles fret when the supports fail.

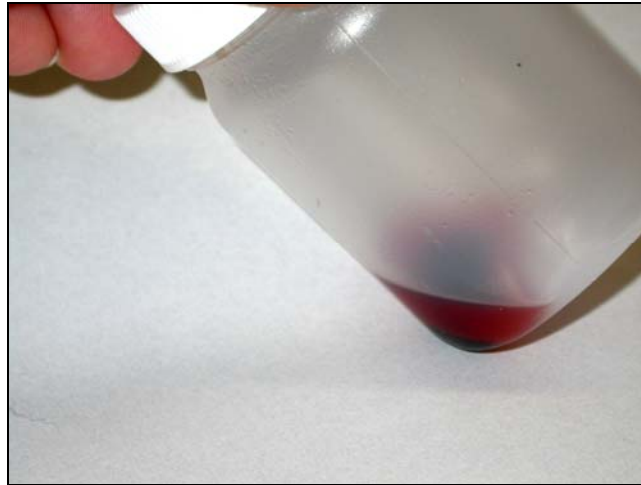
Figure 28 – Liquids Removed From Lobo A2 Coalescing Filter

Installation of this process design and operation through the 2004/2005 winter yielded a small quantity of unexpected liquids. Liquids were found in the sump of the Lobo A2 coalescer and were characterized as being two immiscible liquids, the primary being “kerosene like” and the other being “glycol based”. Sample quantities were insufficient for a detailed chemical analysis – see Figure 28 below. The suspected source of these liquids is either pipeline cleaning fluids or naturally occurring “kerosene” from storage pools.

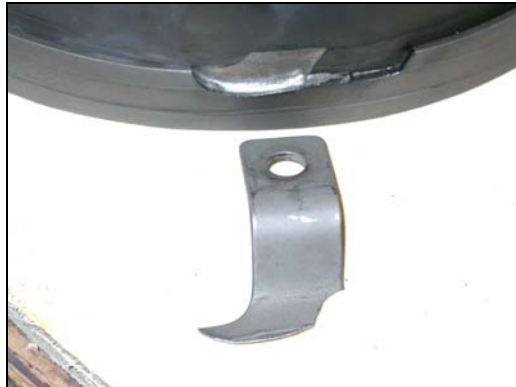
1. Engine 37433. Failed chin strap at discharge nozzle #8. Failed bracket connecting discharge nozzles #6 and #7. Four HP NGV's were damaged by a small piece of the chin strap that was released into the HP Turbine. Scored rear bearing. All other indications were normal. Damaged components had only 900 hours since repair or replacement.

Figure 29 – Failed Chin Strap

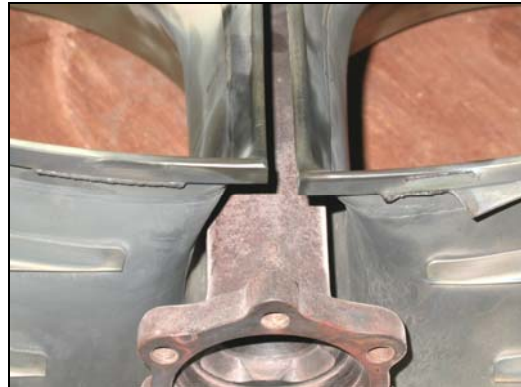
Figure 30 – Failed Nozzle Bracket

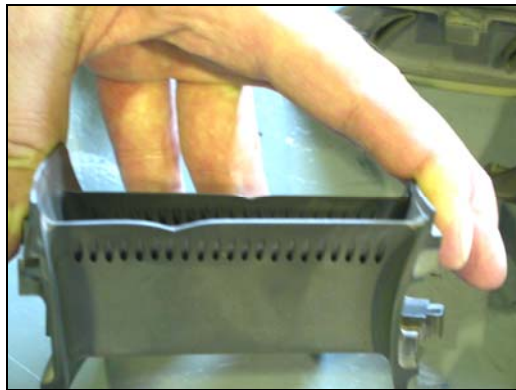
Figure 31 – Damaged HP NGV

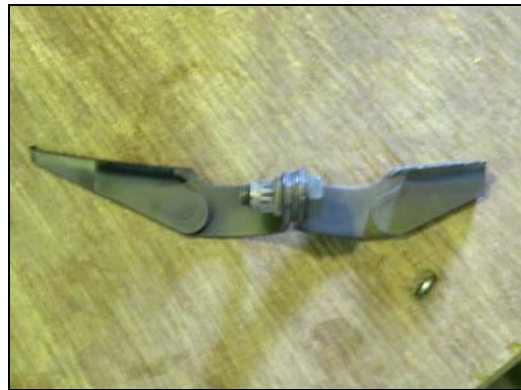
Figure 32- Failed Nozzle Bracket

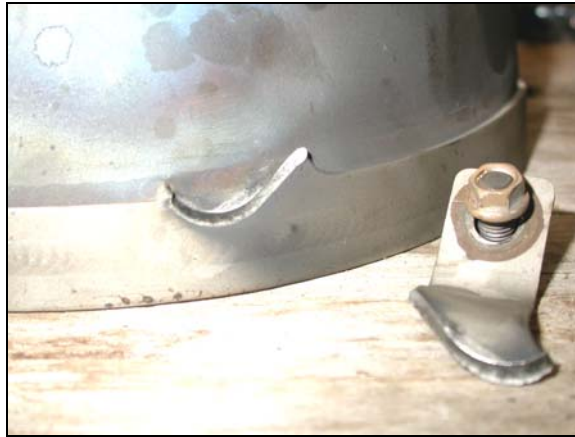
2. Engine 38425. Failed chin strap at discharge nozzle #1. Four additional discharge nozzles were found to be cracked and in need of repair. All other indications were normal. Unit had 1300 hours of operation – approximately 10% were peak operating hours.

Figure 33 – Failed Chin Strap

While the failure of this chin strap is a disappointment, it should be noted that there was very little fretting wear around the discharge nozzle. This suggests that the chin strap failure was either very recent or that the remaining supports were sufficient to keep the nozzle from vibrating. This is consistent with the CP103 signal data, which showed no significant indication of a problem.
