Multi-hazard vulnerability of structures and lifelines due to the 2015 Gorkha earthquake and 2017 central Nepal flash flood

Dipendra Gautam, You Dong

To appear in: *Journal of Building Engineering*

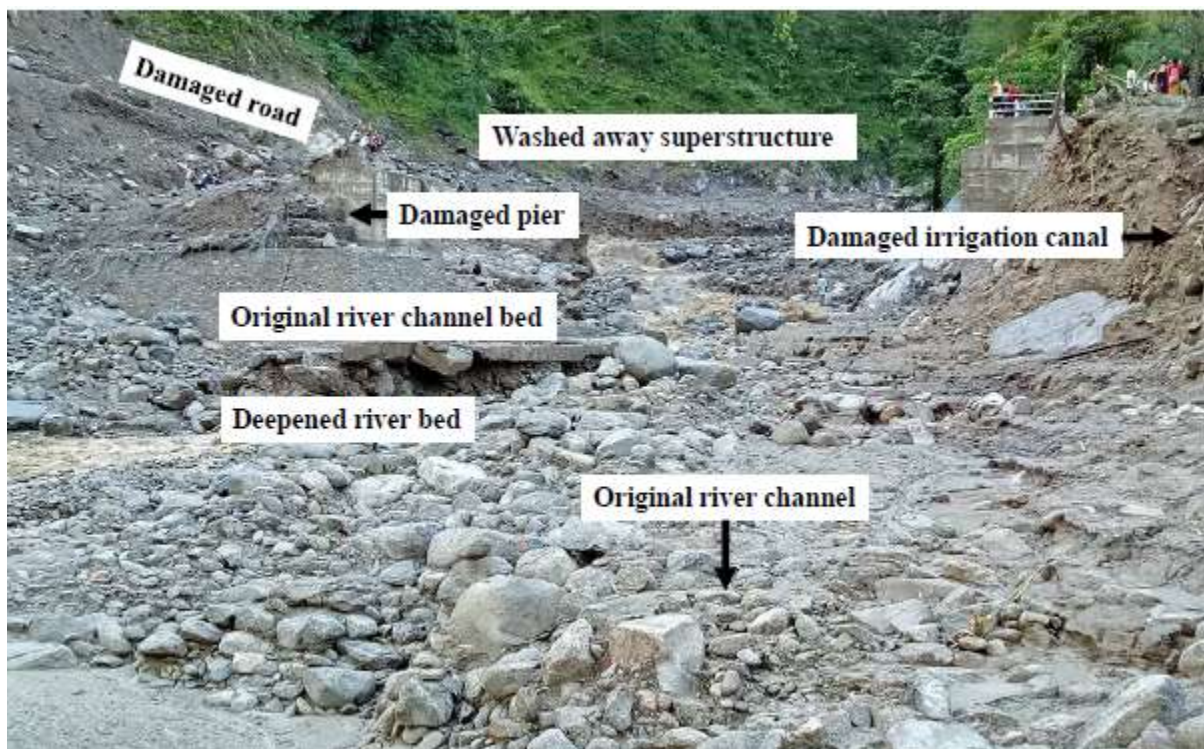
Chhatiune Khola bridge was reinforced concrete single span bridge. The bridge span was 30 m with 10 m height from the previous river bed. Due to the July 2017 flood, the river channel was ~3 m deepened whereas the bridge was destroyed with no indication of parts of the superstructure (Fig. 3).

Fig. 3 Debris flood from the stream due to flash flood in the bridge site

The river channel was shifted ~10 m and the river is currently flowing through previous rice fields. Per the local people, flash floods of such extent were not observed in the last hundred years. Forensic interpretation depicts that there were no concerns of structural deficiencies, however, the hydrodynamic force arising from the turbulent water flow in the steep river channel could have destroyed the superstructure since superstructures are designed providing freeboard per the discharge without due consideration of hydrodynamic forces. In the case of piers, again due to the low discharge scenario, the forces considered during design would not have been

adequate to assure the performance during turbulent flows as in the case of July 2017 flash floods.

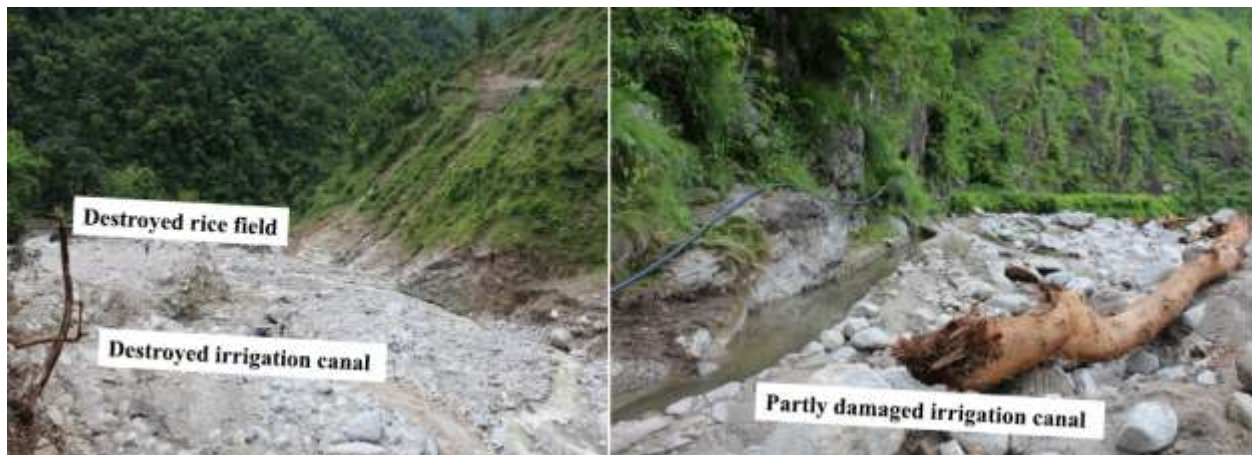
Performance of lifelines during multi-hazards is a seldom discussed topic in Nepal. We observed the damages in irrigation canals, water supply pipeline and electric poles, road network, and roadway sign posts due to the recent flash flood of 2017 which were exposed to Gorkha earthquake too. The damage in lifelines due to the 2015 Gorkha earthquake has been thoroughly reported by the National Planning Commission, Nepal (NPC 2015). To the best of authors' knowledge, limited reports and documents are available for the 2017 flash flood (e.g. Gautam et al. 2017). As shown in Fig. 4, one of the irrigation canal supplying water to nearest rice field was washed away by the flood, meanwhile, local people confirmed that there was no significant damage during Gorkha earthquake.

Fig. 4 Damage to the irrigation canals due to 2017 flash flood

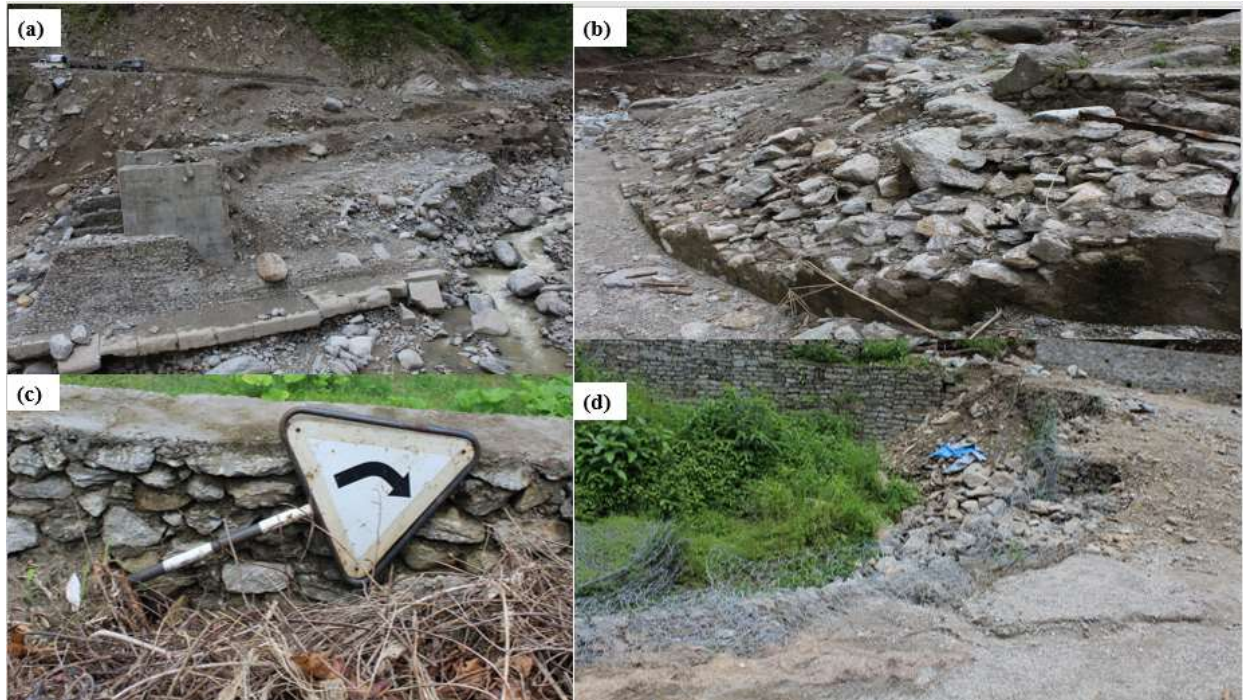
Similarly, ~2 km long feeder road, that connects the neighborhood with the nearest highway, was damaged due to the flash flood as shown in Figs. 5a, 5b. The sign post (Fig. 5c) and slope protection structure (gabion wall) (Fig. 5d) were also damaged due to the flash flood. The damage extent was spread over nearly 200 m territory from the river channel. The feeder road

was single lane unmetalled track along the river bank and no indication of the road was visible during the field visit. In the case of gabion wall, the damage occurred nearly 300 m from the river course.

Fig. 5 a) Road damage due to flash flood; ~2 km long stretch was washed away with no indication of road alignment; b) exposed subgrade of the road; c) damaged sign post along the road; and d) damage to the gabion wall

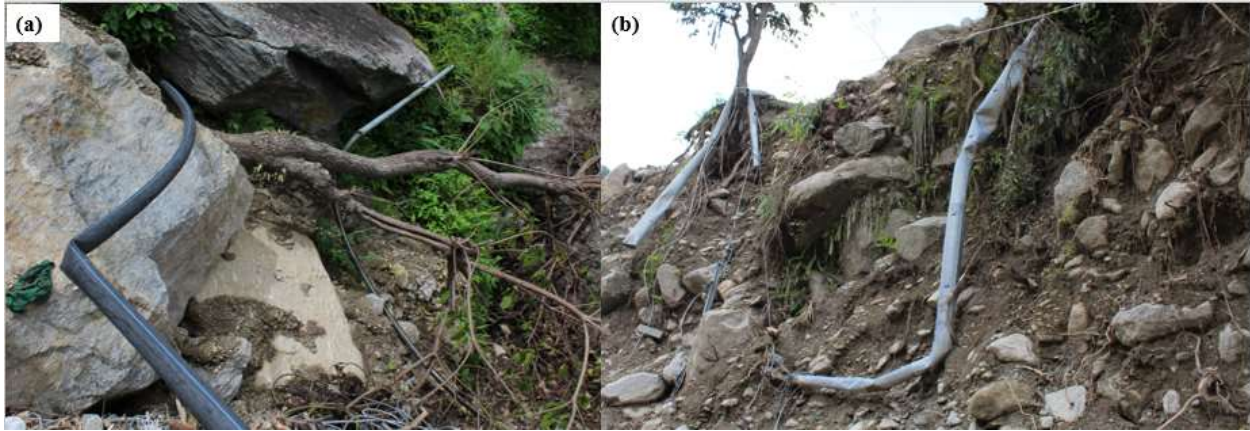
The water supply system was also destroyed by the flash flood as well (Fig. 6a); leading the affected families out of water supply for many days. The water supply pipes were found to be displaced and in many cases destroyed by the cobbles carried by flash floods. The electrical poles throughout the settlement were destroyed due to the flash flood (Fig. 6b). At least five electrical poles were observed to be washed away and the electricity supply was not resumed until the first week of August 2017.

Fig. 6 a) Damage water supply pipeline and b) damaged to the electrical poles

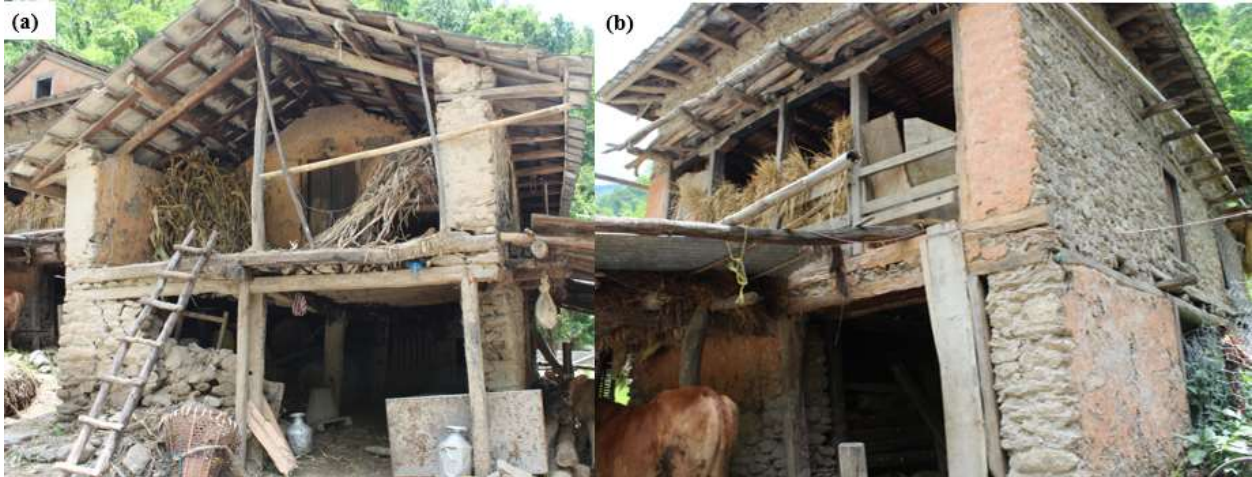
In the Khimti settlement buildings constructed some 40 years ago were affected due to the Gorkha earthquake as well as the 2017 flash flood. Damage to the vernacular buildings due to the Gorkha earthquake is reported by Gautam et al. (2016), Gautam and Chaulagain (2016), and others. On the other hand, flash flood damage to the vernacular buildings has not been reported yet in Nepal to the best of authors' knowledge. Seismic vulnerability of vernacular buildings in Nepal is partly addressed by the work of Chaulagain et al. (2016); however, vulnerability due to multi-hazards is not found in existing literature. On the contrary, this study presents a reconnaissance based multi-hazard vulnerability scenario of vernacular stone masonry buildings in the middle mountains of Nepal. All the five buildings in the neighborhood were two storied vernacular stone masonry constructions with rectangular plans. Moreover, the buildings were non-engineered houses constructed as owner-built constructions using local resources and manpower. One of the buildings was destroyed with no remains left on the field due to the flood whereas all the surveyed buildings including the collapsed one were observed to be sustaining minor damage state ($\leq 25\%$ damage) due to the 2015 Gorkha earthquake. For this study, a generic damage classification considering the damage ratio obtained from the visual inspection was

adopted as: minor damage ($\leq 25\%$); major damage (26-50%); severe damage (51-75%); collapse ($>75\%$). All the buildings were continued to use after the earthquake without any repair. The flow height for the destroyed building was estimated to be 3.5 m through the peak flood level measurement at the nearest point. All the four side walls were inundated in the case of the destroyed building thus the building should have been washed away. One of the buildings that sustained severe damage state (Fig. 7a) had dislocated wooden pillars and part of the wall was collapsed. Meanwhile, the building that sustained major damage had cracks on masonry walls (Fig. 7b). The building that sustained minor damage was not exposed to hydrodynamic forces (Fig. 8) thus the minor cracks due to the earthquake were not extended; unlike the building that sustained major damage. The building that sustained severe damage was exposed to the flow height of 3 m whereas the building that sustained major damage was exposed to the flow height of 1.5 m. The sum of observations concluded that hydrodynamic force was the major factor in damage aggravation and the extent of damage depended on the exposure percentage. In the case of collapse, severe damage, and major damage, the hydrodynamic forces along with boulders and cobbles may have played the vital role in damage aggravation if not collapse of the building. The collapsed structure was in the immediate vicinity of the flow thus the water current should have washed away the building.

Fig. 7 a) severe damage and b) major damage to vernacular buildings

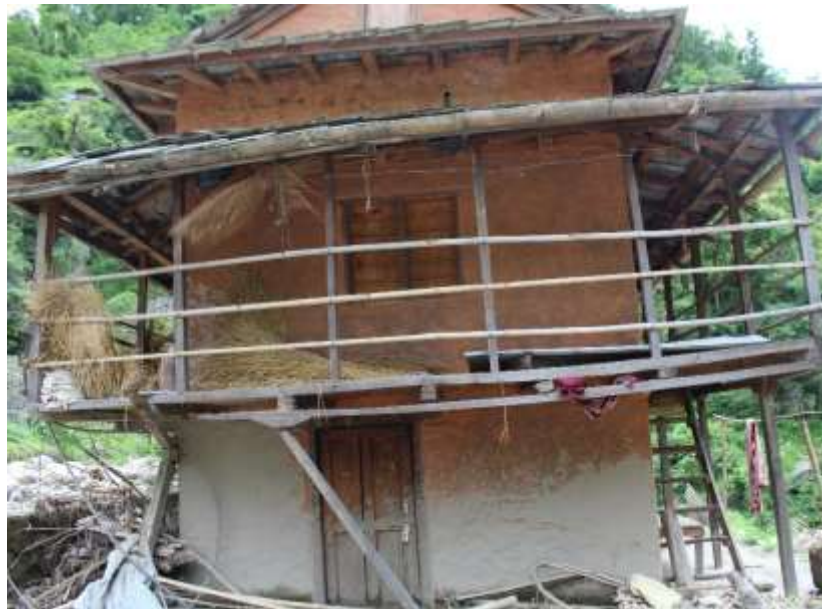
Fig. 8 The flood unaffected but earthquake damaged (minor) vernacular building

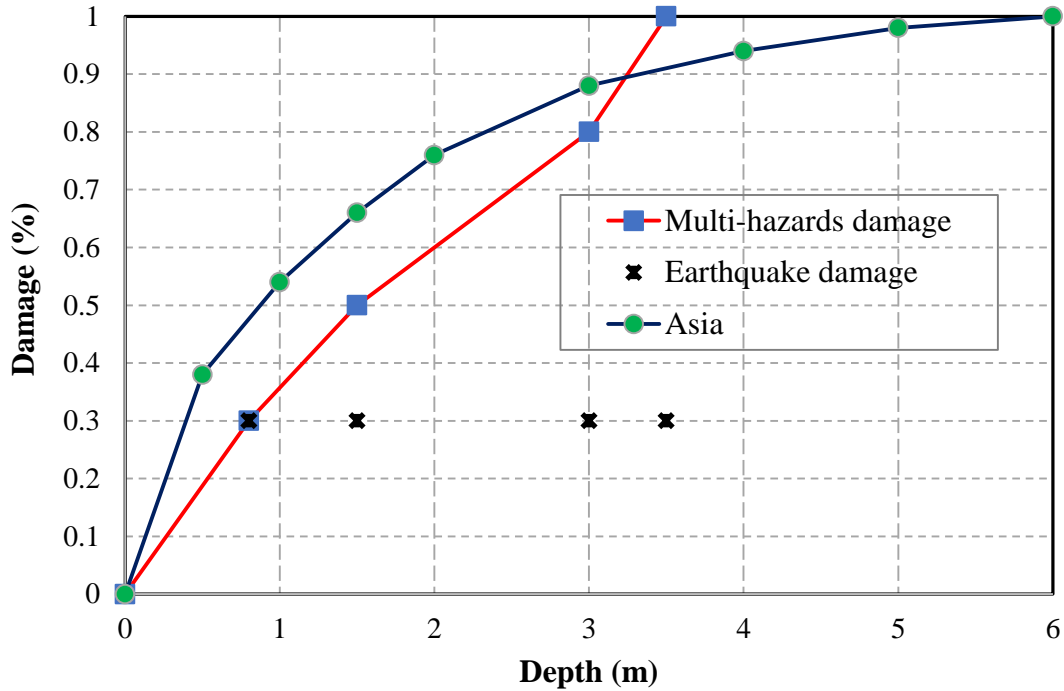
damage curves for vernacular buildings are particularly important in Nepal as most of the river settlements in the river banks have the vernacular mud-mortar stone masonry buildings and no flood and seismic countermeasures are provided. Moreover, consideration of multi-hazards is relatively new for Nepal, thus the changing context would be highlighting the need of depth-damage curves especially for the settlements near rivers and streams. A new approach of multi-hazards vulnerability depiction is presented in this study. This approach incorporates a plot showing both earthquake and flash flood vulnerability in the same depth-damage curve and one can easily distinguish the damage level and aggravation scenario due to individual event (Fig. 9). The percentage of damage as observed in the field are plotted along with the flow height in Fig. 8 to obtain the empirical depth-damage curve. Meanwhile, the depth-damage curve for vernacular Nepali residential buildings is compared with the existing depth damage curve proposed by Huizinga et al. (2017). As all buildings were sustaining minor damage state during the earthquake, exposure to flash flood led damage aggravation to each building that was exposed to flash flood. For instance, the building with minor damage state ($\leq 25\%$ damage) during earthquake was not exposed to the flood directly thus no further damage was occurred whereas the collapsed building was exposed to the hydrodynamic forces to all four facades during the flood event; hence got washed away. The flood damage was increased by 300% in the case of full inundation as observed during the field reconnaissance. The damage increment is calculated based on the existing damage level in all buildings (25%). For instance, if the building was now determined to have major damage level (50% damage), then the increment was obtained to be 100%. In the case of majority of inundation (3 m), the building damage was increased by 200% due to flash flood and in the case of half inundation, the damage was increased by 100% due to the flash flood in earthquake damaged building.

Fig. 9 Depth damage curve and earthquake damage scenario for vernacular buildings in Nepal

As shown in Fig. 9, the depth-damage curve due to the flash flood in Nepal shows the damage in terms of residential buildings is slightly lower than the depth-damage curve for Asia (Huizinga et al. 2017). For example, at a depth of 1 m, 35% damage is expected in residential buildings, whereas in the case of the depth-damage curve for Asia, the damage is nearly 55%. It should be noted that the depth-damage curve depicted in this study is the one that incorporates multi-hazards damage scenario thus the actual damage in terms of a single event may be lower than 35%. Similarly, in the case of a higher depth, Nepali vernacular residential buildings sustain severer damage than the Asian depth-damage curve suggested by Huizinga et al. (2017). For example, Nepali residential buildings are expected to collapse at a depth of 3.5 m, whereas the depth-damage curve for Asia shows that the damage extent would be 90% only for the same inundation depth. Similarly, at a depth of around 3.2 m, the curves are intersected leading to similar damage state in the case of Nepal and Asia. It is worthy to note that unlike Europe and North America, local construction practices are greatly varied and such variation can be even grave within a country so exact comparison needs similar building types. Meanwhile, the confinement of collapse at the lower depth than the Asian collapse scenario should be attributed to the poor construction practice in Nepal wherein buildings usually do not consist lateral load resisting members and both the seismic and hydrodynamic forces may cause severe damage.
