Case Studies in Nondestructive Testing and Evaluation

# Application of microCT to the non-destructive testing of an additive manufactured titanium component

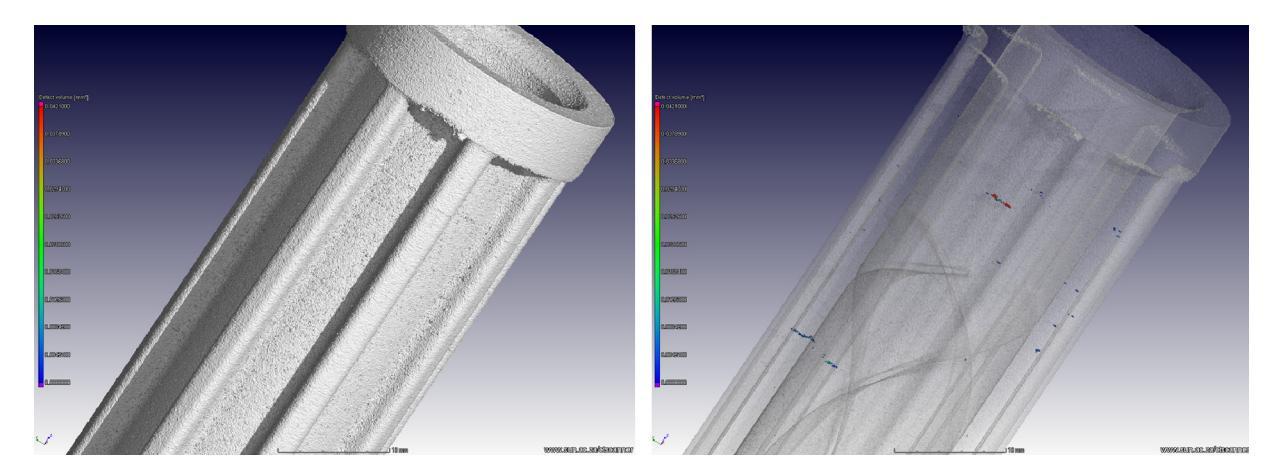
Fig. 1. A 3D view of the sample showing the surface (left) and the defects (right).

The defects are clearly layered or flattened in shape as seen in the 3D image in Fig. 1. In this image, the defects are colour-coded with the largest void in red and smallest in blue. Slice images in Fig. 2 show more clearly the largest void region from top and side views. Clearly, the defects are found in a layered or flattened structure, with the defects in the plane of the laser melting process. This type of defect can be explained by imperfect melting on specific layers as explained in the previous section. This type of defect is difficult to detect by other means such as traditional radiographic testing, due to its size and geometry and the complexity of the object. The average porosity was measured using the automated defect

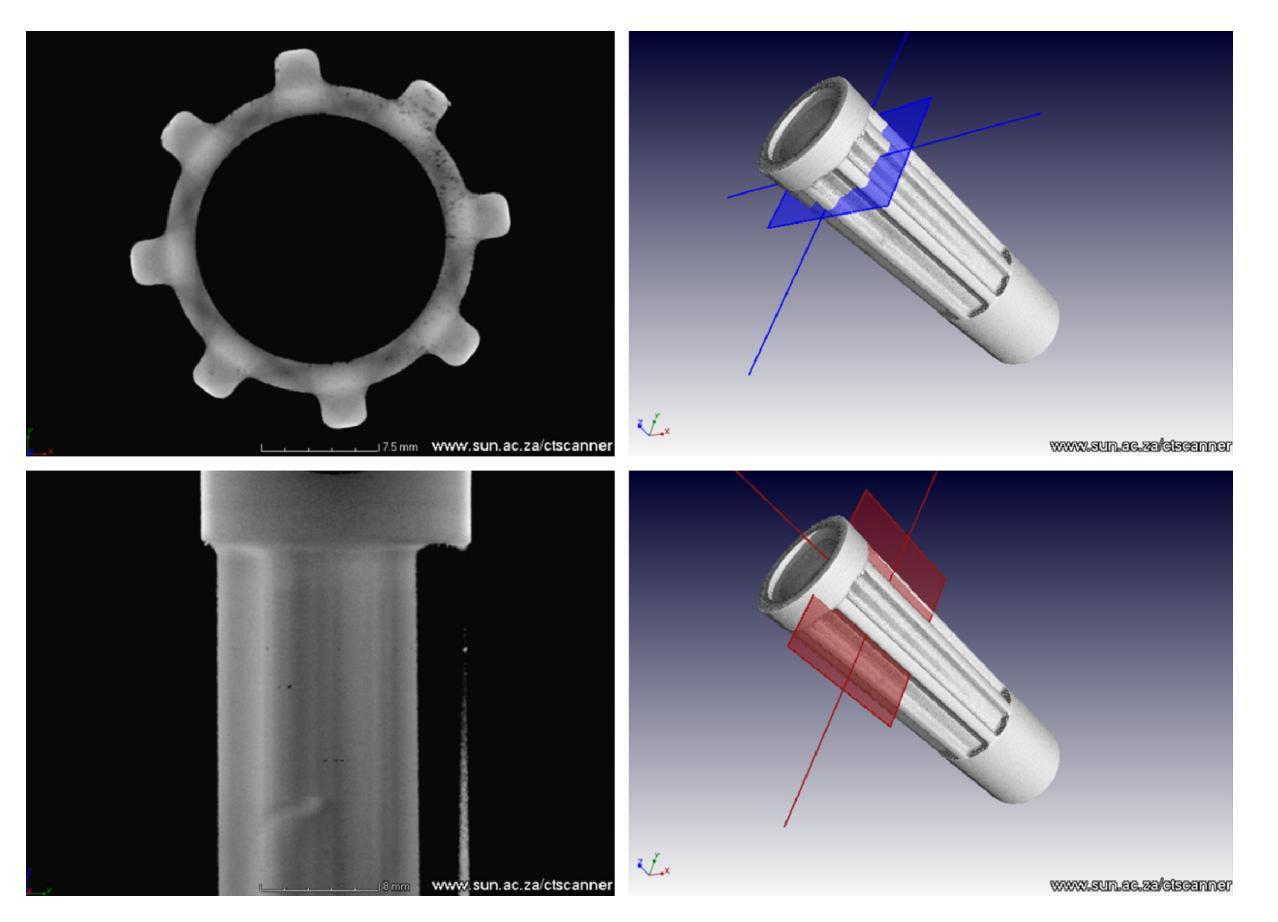
Fig. 2. Slice images from the top and side indicate the layered nature of the porosity.

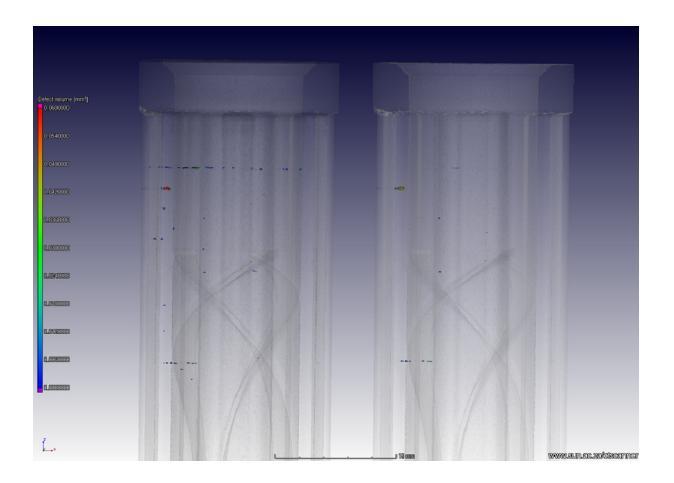
Fig. 3. Transparent 3D views before (left) and after (right) HIP treatment indicates qualitatively the lower average porosity after treatment.

Analysis of scans from before and after HIP treatment, using identical scan and analysis settings, indicates a reduced average porosity from 0.005% before HIP to 0.002% after HIP treatment. An automated defect analysis conducted on both samples shows this qualitatively in Fig. 3 in 3D.

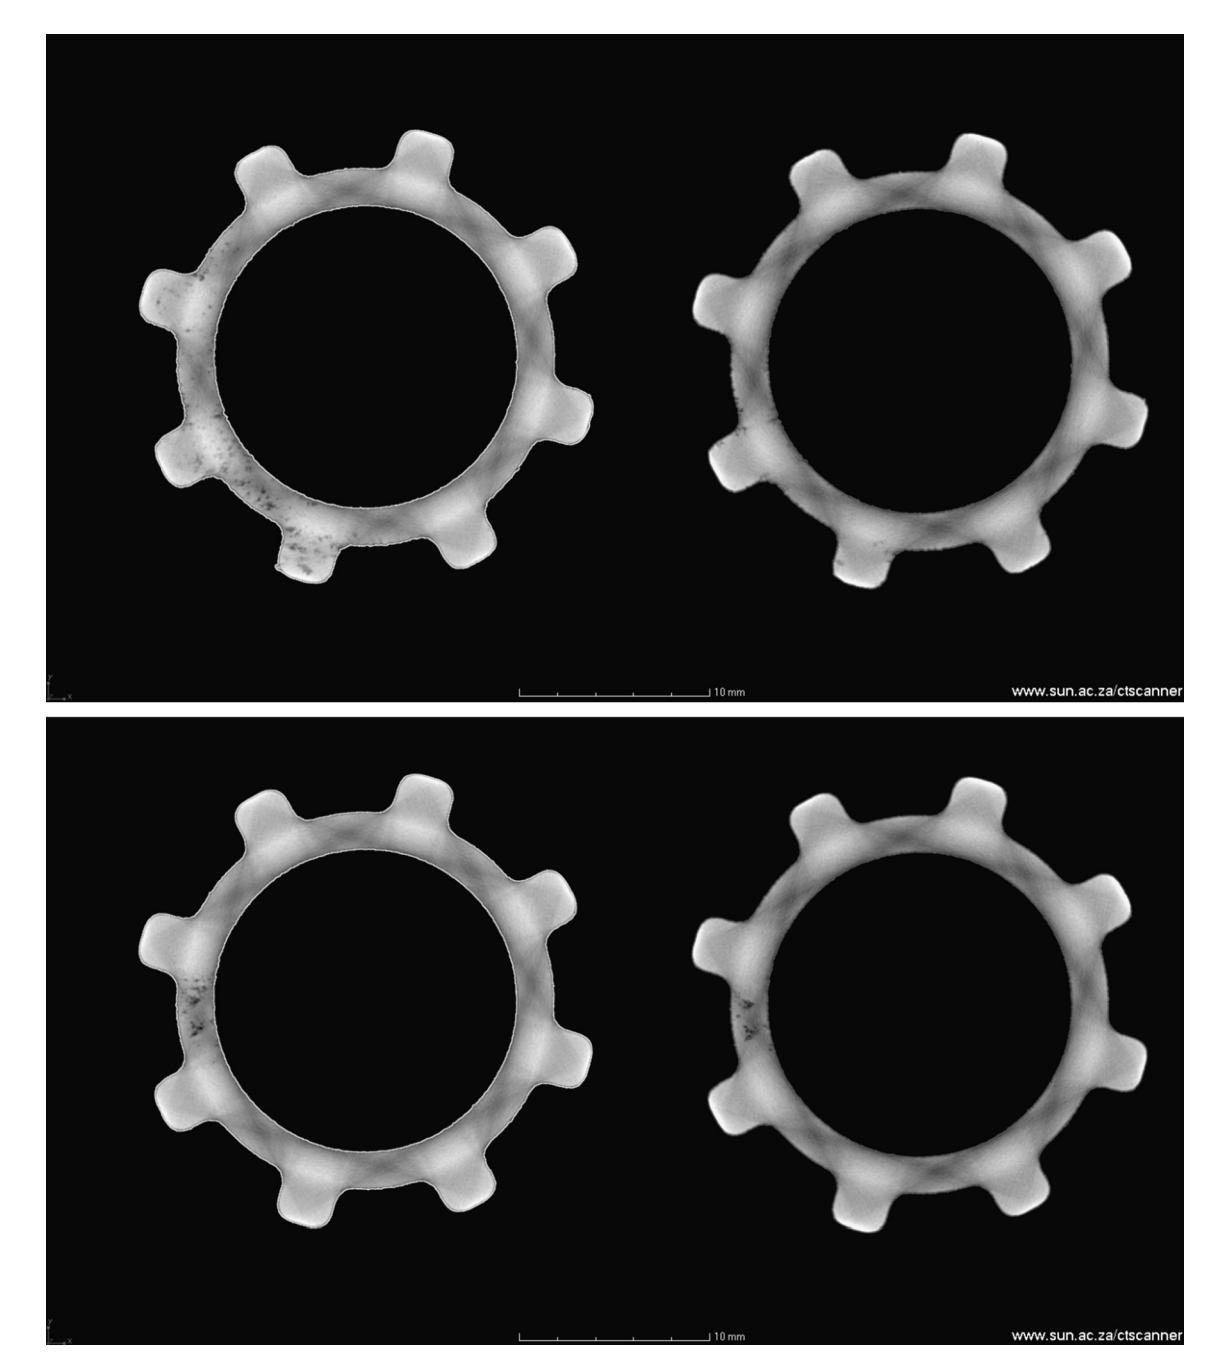
Fig. 4. Two examples of slice images side-by-side before and after HIP treatment, for which alignment is crucial. The first example shows porosity that is reduced while the second example shows one which remains unchanged.

In Fig. 4, two examples are shown at different heights along the sample. The first one is where the porosity reduces considerably due to HIPing, except for some pores near the edge of the object, most likely open pores connected to the surface. The second is an example where the pore structure remains effectively unchanged. This is unexpected and could be explained by the pore being connected to the surface via small porosity undetectable at this scan resolution.

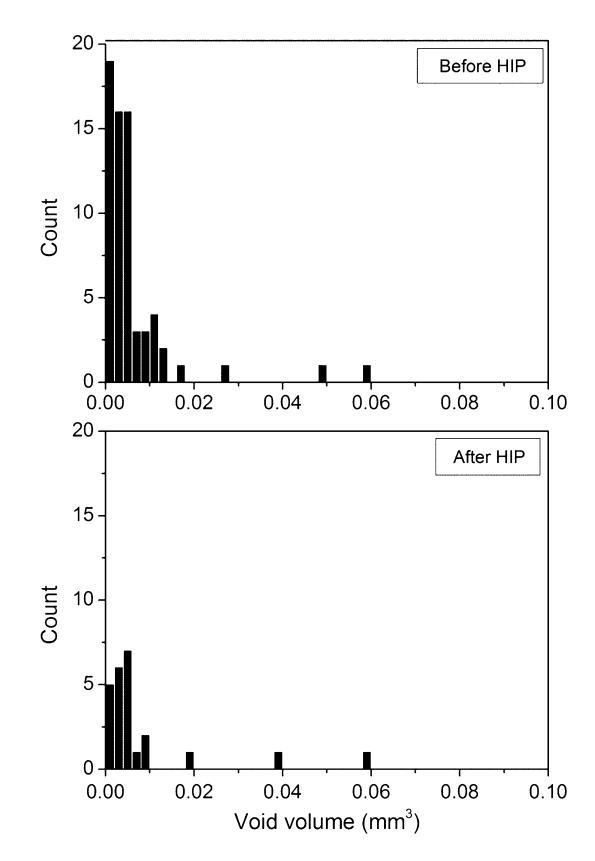
An automated defect analysis can provide statistical information on the pore size distribution before and after HIP treatment. This is shown in Fig. 5, with counts scaled for direct comparison. The total number of pores reduced due to HIP treatment, as expected. The number of the smallest pores reduced considerably, while the largest pores are almost unchanged or only slightly reduced in size.

Fig. 5. Void size distribution before (top) and after (bottom) HIP treatment.

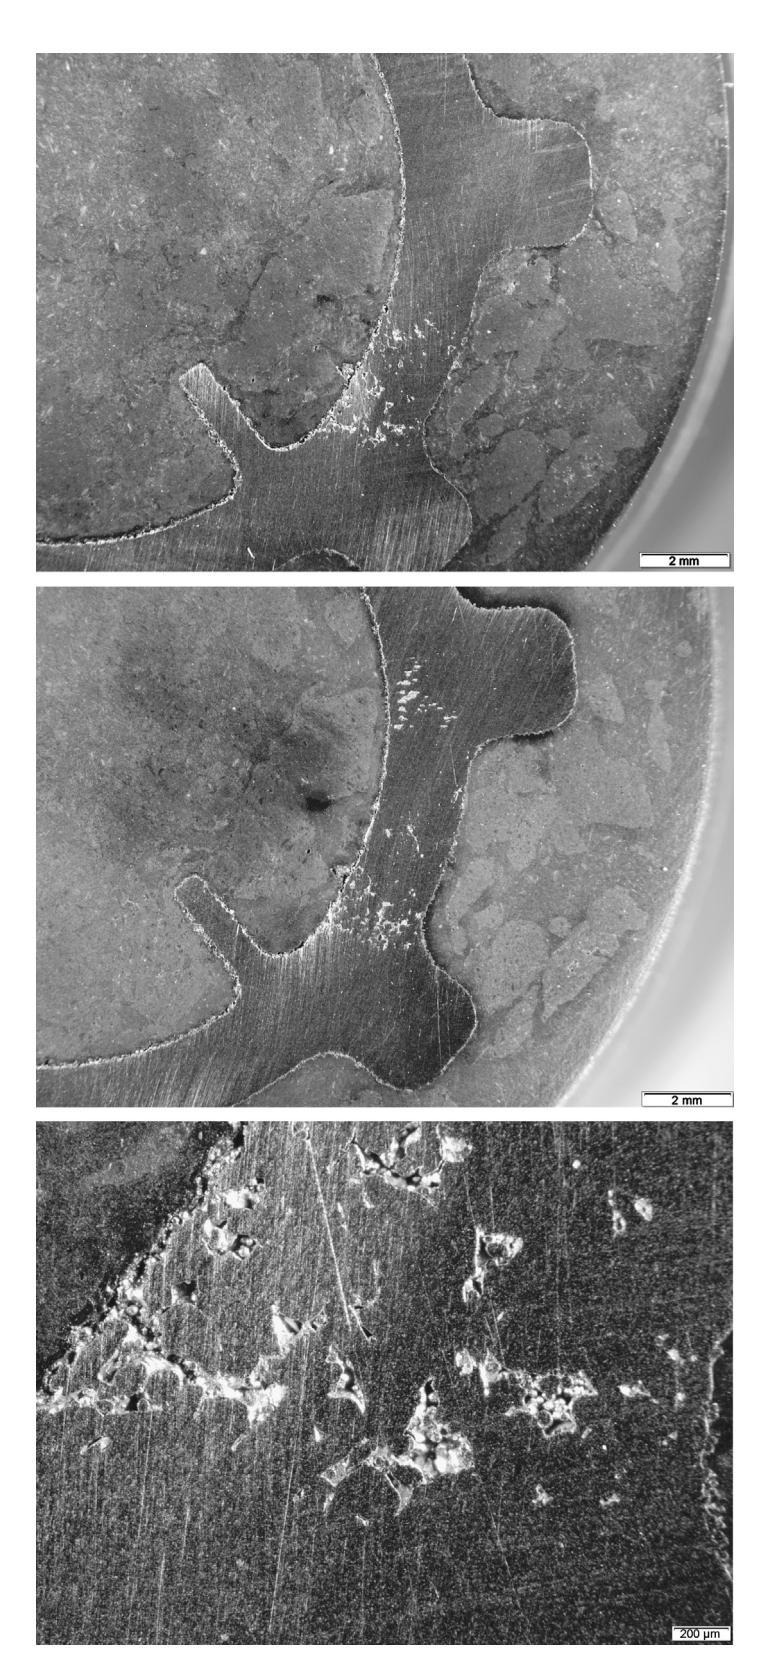
As additional proof of the porosity presence, a physical sectioning of the sample was done. The approximate location of the largest pore region from the CT scan data was used as a guide and physical sectioning and polishing was used producing optical micrographs as shown for two subsequent layers in Fig. 6 top and middle images. A higher resolution closeup view of the porosity region is shown in Fig. 6 as well, confirming the presence of pores indicated by CT scans. Additionally the shapes of the pores are seen to be very irregular.

Fig. 6. Sectioning at the location indicated by the CT scans confirmed the presence of porosity in these micrograph images, where top and middle images show subsequent polished layers and the bottom image is a close-up view of the region of porosity in the middle image.
