Behavior of X60 Line Pipe Subjected to Axial and Lateral Deformations

Buried pipelines may be subjected to various complicated combinations of forces and deformations. This may result in localized curvature, strains, and associated deformations in the pipe wall. As a result, wrinkle may form. The wrinkled pipeline may then develop a rupture in the pipe wall and lose its structural integrity if it is subjected to further sustained loads or deformations. Recently, laboratory tests on NPS6 steel pipes were undertaken at the University of Windsor to study the wrinkling and post-wrinkling behaviors of this NPS6 pipe when subjected to lateral load in addition to internal pressure and axial load. Four full-scale laboratory tests were conducted, and it was found that the application of lateral load on wrinkled pipe produces a wrinkle shape similar to that occurred in a field NPS10 line pipe. Complex test setup was designed and built for successful loading and completion of these tests. This paper makes a detailed discussion on the test setup, test method, loading and boundary conditions, instruments used, and test results obtained from this study. [DOI: 10.1115/1.4001426]

Keywords: line

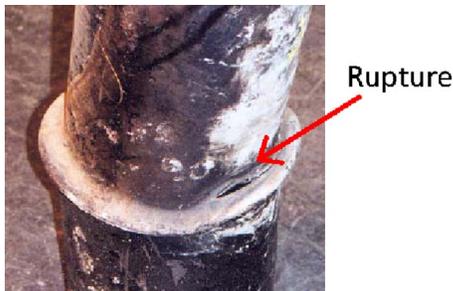
Fig. 3 Shape of the wrinkle in the field NPS10 line pipe

The objective for the current study is to investigate the wrinkling behavior and failure mode in the wrinkle under combined lateral and axial loadings. The motivation of this study was due to the diagnosis and exposure of a wrinkle shape that looks like a cowboy hat, and the rupture that occurred in the wrinkle location of a field X60 grade NPS10 (line pipe with nominal diameter of 10 in. or 254 mm) energy pipeline with a wall thickness of 7.9 mm, as shown in Fig. 3. This field specimen was obtained from a segment on of the pipeline on an unstable slope. The operating pressure in that segment of the line pipe ranges from $0.3p_y$ to $0.35p_y$. The physical inspection of the NPS10 field line pipe showed physical marks of soil thrust and rubbing in the portion of the pipe just above the wrinkle, and therefore, it was felt that the pipe wall in that region was subjected to a lateral load (load not aligned to the longitudinal axis of the pipeline). However, the real load combination was not known. Das et al. [13] conducted one laboratory test on a X52 grade pipe to understand the possible load combination that may have caused the rupture in the field NPS10 line pipe. The test load and specimen end conditions could not be controlled systematically in that test though the final deformed shape showed some similarities with the field NPS10 pipeline. Thus, a detailed and carefully designed experimental research program was undertaken at the University of Windsor for better understanding of the load and boundary conditions that possibly produced a wrinkle and the rupture in the wrinkle region that look similar to the field NPS10 line pipe. Four full-scale laboratory tests on NPS6 (pipe with a nominal diameter of 6 in. or 152 mm) X60 grade pipe [14] specimens were successfully completed, and the results are discussed in this paper.

The internal pressure was either reduced to zero or kept unchanged during load step 3, as shown in Table 1. For specimens 2 and 4, the internal pressure was reduced to zero, and the internal pressure for other two specimens (specimens 1 and 3) were not changed during this load step. The objective of changing pressure for specimens 2 and 4 in load step 3 was to simulate the shutdown condition of the field pipeline and to study the effect of absence of internal pressure, which is presumed to be a critical one for producing a wrinkle shape and rupture similar to the field NPS10 line pipe (Fig. 3).

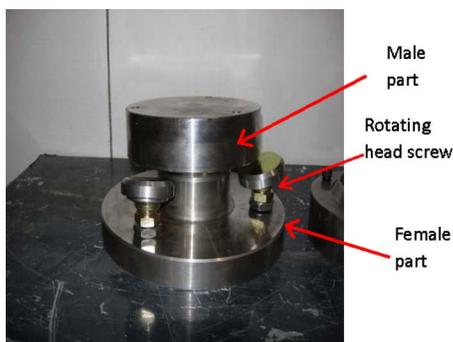
Fig. 6 Swivel head support assembly

The test setup was complex and required careful design and fabrication since the end conditions of the specimens were required to be changed between the pin and clamp when the specimen was under large loads. Special and complicated end conditions, which will be called as “swivel head support (SHS),” was designed, manufactured, and used to simulate both the pin and clamp end conditions, and to control the end rotations in the desired manner. The SHS has a male-female cup and cone type steel assembly with specially designed screws in between the two parts, as shown in Fig. 6. Each SHS is able to rotate up to 20 deg, and rotation can be frozen to any desired value by locking the rotating heads of special screws even when the pipe specimen is fully loaded and under internal pressure. One SHS at each end of the pipe specimen was mounted, as shown in Figs. 4 and 5.

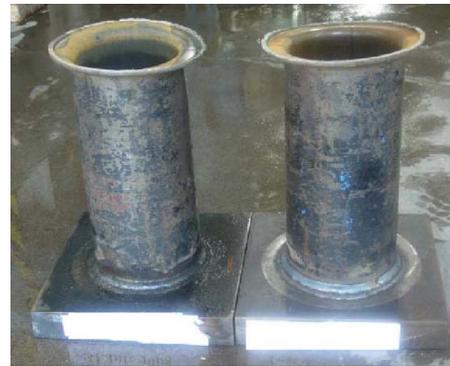
Fig. 13 Specimen 3 split into two pieces during the pressure test

since the specimen was resting on the floor. The pipe specimen ruptured either at the top foot of the wrinkle or at the crest when the pressure was in the range of $0.14p_y$ and $0.17p_y$ (Table 1). Specimen 3 split into two pieces through the crest of the wrinkle (Fig. 13) when the pressure was only 6.1 MPa, which is equivalent to $0.17p_y$ (Table 1). An increase in pressure during the pressure test created tension in the pipe wall and as a result, the cracks which developed during the main load test opened up and thus, rupture occurred.

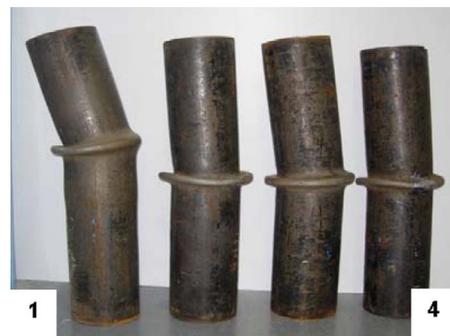
Fig. 14 Shape of all specimens before the pressure tests

5.2 Deformed Shape and Rupture. The final deformed shapes of all the specimens before pressure tests are shown in Fig. 14. The specimens are arranged in their chronological order from left to right. The deformation shape of specimen 2 after the pressure test is compared with the field specimen in Fig. 12. As mentioned before, end rotations for specimen 1 could not be controlled in the desired manner and as a result, this specimen bent

much more than the other three specimens. Nevertheless, the shape of the wrinkle in this specimen was also similar to the field NPS10 line pipe (Fig. 14).
