Seismic performance of three-storey full-scale sub-standard reinforced concrete buildings

Mustafa Comert¹ · Cem Demir¹ · Ali Osman Ates¹ ·
Kutay Orakcal² · Alper Ilki¹

Abstract Two three-story full-scale sub-standard reinforced concrete buildings were tested under self-weight and reversed cyclic lateral displacements to examine their behavior during earthquakes. While one of these buildings was a part of an actual existing building (TB1) built in the beginning of 1990's in Istanbul, the other was constructed by the authors as a representative building (TB2) that reflects the most common structural deficiencies of existing building stock in Turkey. Both buildings were constructed with plain bars, low strength concrete and inadequate lateral reinforcement. The differences between these buildings were axial load levels of first story columns, expected location of major structural damages (weak beam–strong column for TB1 and strong beam–weak column for TB2) and connection details of longitudinal bars in columns at the foundation–column interface (continuous for TB1 and lap-spliced with 180° hooks for TB2). Both buildings were pushed and pulled at increasing displacement amplitudes up

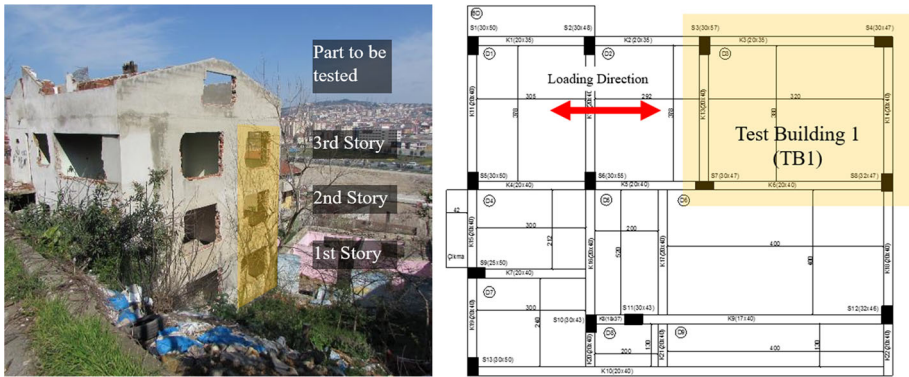
Fig. 1 General view of the test site and plan of the existing building

The experimental phase of the study, which includes reversed cyclic loading tests on two full-scale buildings, was implemented at the Fikirtepe district of Istanbul city. The area is home to hundreds of sub-standard buildings, which lack appropriate engineering design, construction practice, and supervision. Based on the Urban Transformation Law (Law No. 6306 on the Transformation of Areas Under Disaster Risk), that aims to reconstruct or retrofit seismically vulnerable buildings on a mass scale, the area has recently been designated as a high seismic risk area and was abandoned for demolition at the time of testing. Considering a number of factors including the availability of area for construction of the reaction wall and the second test building, availability of the test site during the entire period of the testing project, compatibility of the test building with characteristics of the existing building stock, accessibility to site, access to power and water, and the technical capabilities of the available test equipment; the reinforced concrete building shown in Fig. 1 was selected for execution of the test program. The existing three-story building was standing at the bottom of a steep slope, so that the entrance to the original building was from the third story. In order not to exceed the limitations of the load capacities of the reaction wall, as well as the hydraulic actuators and the load cells used, the existing building was demolished partially so that the remaining part was designated as Test Building 1 (TB1) (as shown in Fig. 1), and the site was arranged for construction of the reaction wall and Test Building 2 (TB2), as shown in Fig. 2a. After partial demolishing of

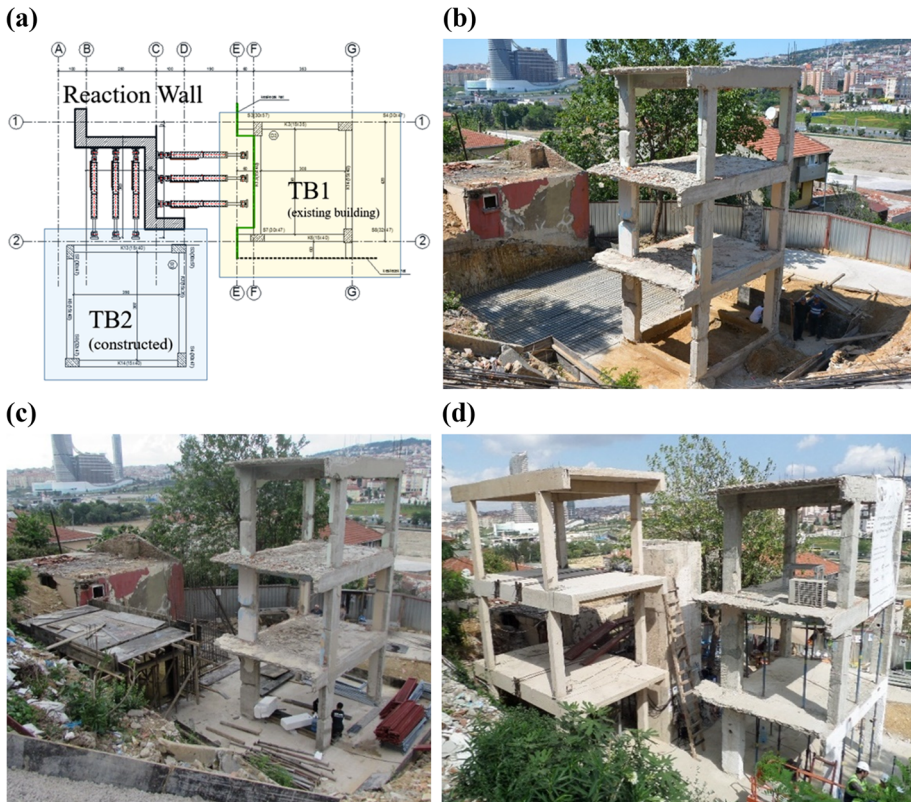
Fig. 2 a Layout of the test site and b–d stages of site preparation

the existing building, the test site was leveled and lean concrete was poured, which was followed by construction of a 0.6 m thick mat foundation (Fig. 2b). The mat foundation not only supported the reaction wall and TB2, but also TB1, which only had unreinforced footings with approximately 0.15 m thickness underneath the columns. In the next step,

construction of the 0.5 m thick reaction wall took place, which was followed by construction of the second test building (Fig. 2c, d). The 7.0 m high reaction wall had an oblique W-shaped cross-section in plan, so that it provided the sufficient stiffness and lateral load capacity for the two buildings to be tested consecutively, only by repositioning of the hydraulic actuators (Fig. 2a).

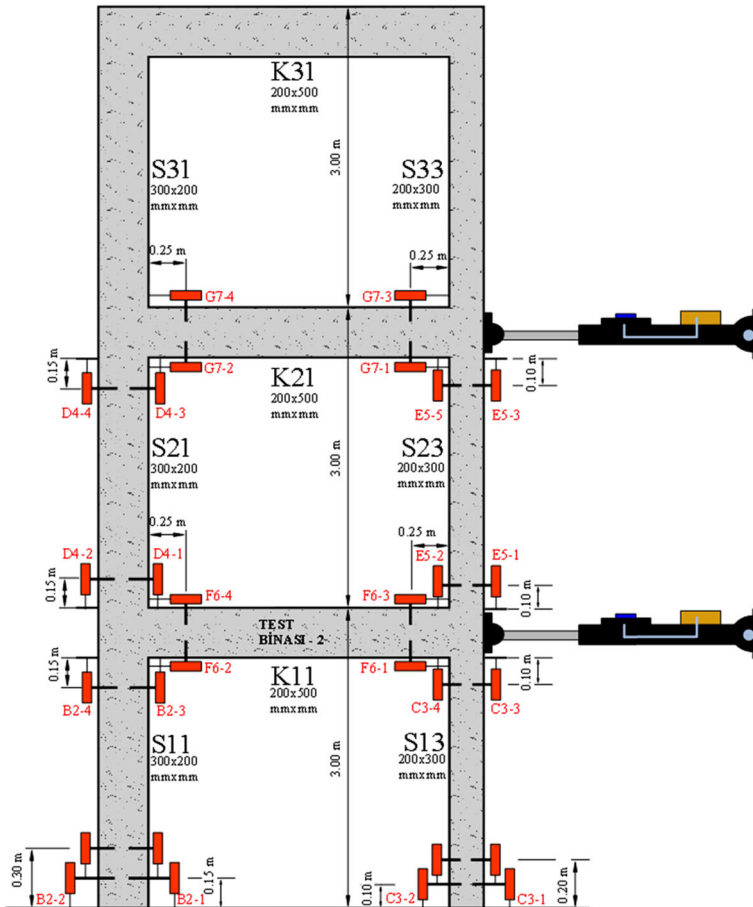
Fig. 5 Instrumentation layout

The measurement system, which collected data from approximately 80 channels, consisted of data loggers, load cells, displacement transducers and strain gauges. General layout of the measurement system can be seen in Fig. 5. The first and second story-level lateral displacements were measured by the internal displacement transducers of the actuators as well as external Linear Variable Differential Transformers (LVDTs) mounted on stiff reference piers constructed using steel profiles. The lateral loads applied on the structure were monitored using the internal load cells on the actuators. Deformations at potential plastic hinging regions of the beams and columns were measured using longitudinal displacement transducers with a measurement (gauge) length of $h/2$, where h is the depth of the beam or column cross-section. Additional displacement sensors were also used at the bottom of the first story columns, where internal forces and deformations were

expected to be higher. These additional transducers spanned a gauge length equal to the depth of the column cross-section. In case of TB2, strain gauges were also bonded on the longitudinal reinforcement of the first-story columns.

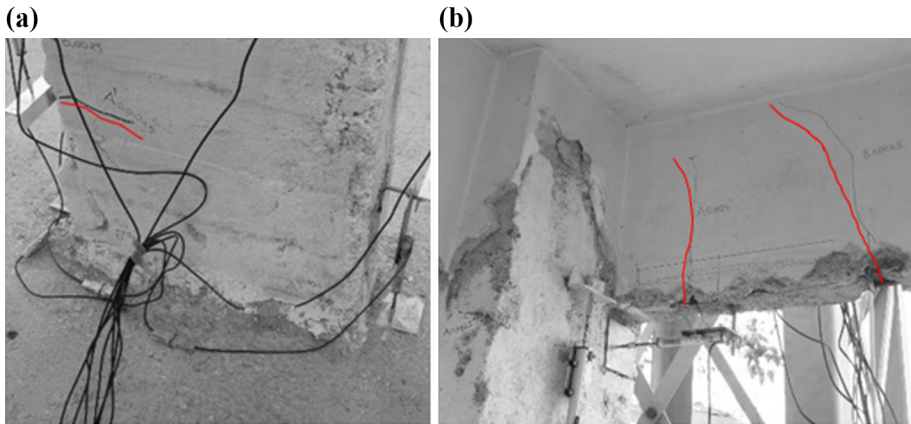
Fig. 7 First cracks observed **a** S14 column and **b** K11 beam at 0.25 % drift ratio

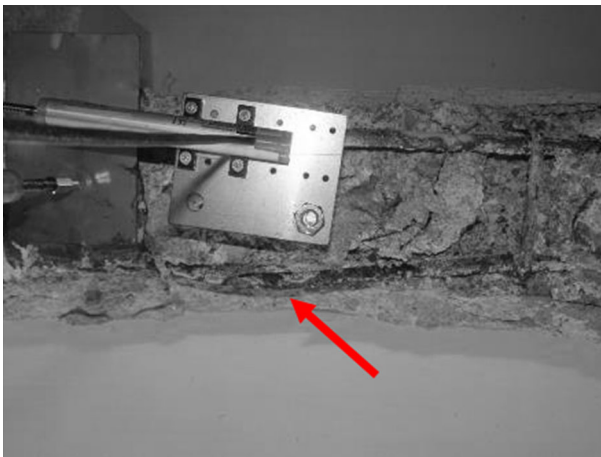
Fig. 8 Buckling of longitudinal bars of beam K12 at 0.75 % drift ratio

(Fig. 8). When a drift ratio of 1.0 % was reached, almost all bottom longitudinal bars at the end regions of the first-story beams, that were parallel to the loading direction, had buckled. Following buckling of beam longitudinal bars, the bottom end regions of the first-story columns started to experience extensive damage. Vertical cracks and cover crushing were observed on column S14 at 1.0 % drift ratio (Fig. 9), and the longitudinal bars of column S14 buckled at 1.5 % drift ratio (Fig. 10). No significant damage was observed on columns S12 and S13 of the first story, which were weaker in the loading direction. As well, no significant damage (apart from flexural cracking) was observed in any of the beams or columns located in the second or third stories of the building. Average longitudinal strains along a length of $0.5h$ at the column base (where h is the depth of the column cross-section) were measured using two transducers installed on the opposite faces of the column in the direction of bending. Similarly, average longitudinal strains along the potential plastic hinging regions of the beams were measured using displacement transducers attached to the top and bottom of the beam end regions. Measurements of these

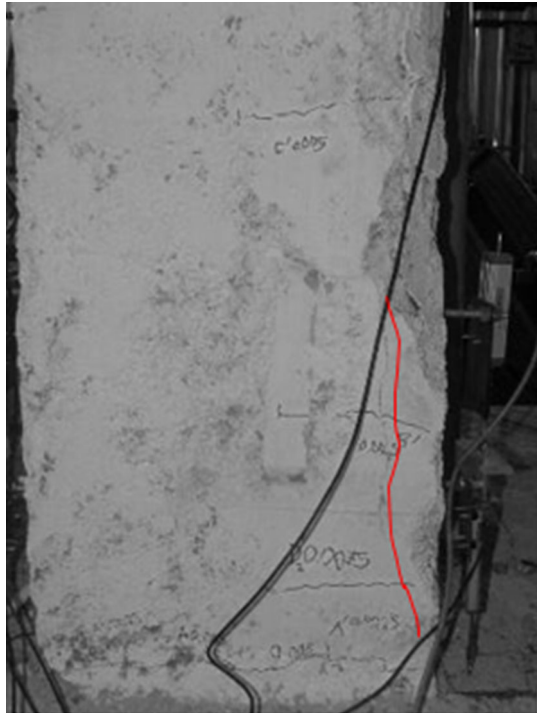
Fig. 9 Vertical crack on column S14 at 1.00 % drift ratio

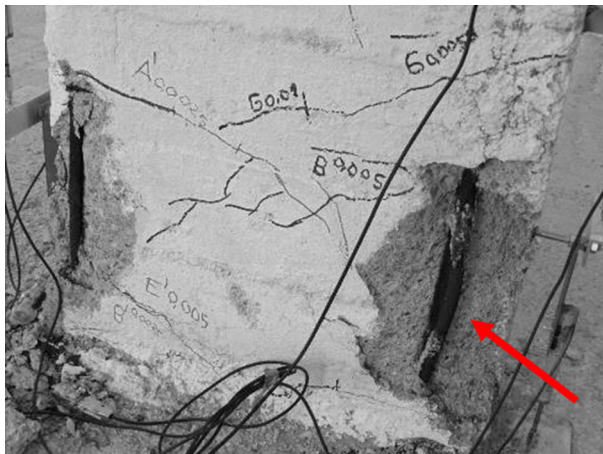
Fig. 10 Buckling of longitudinal bars of column S14 at 1.50 % drift ratio

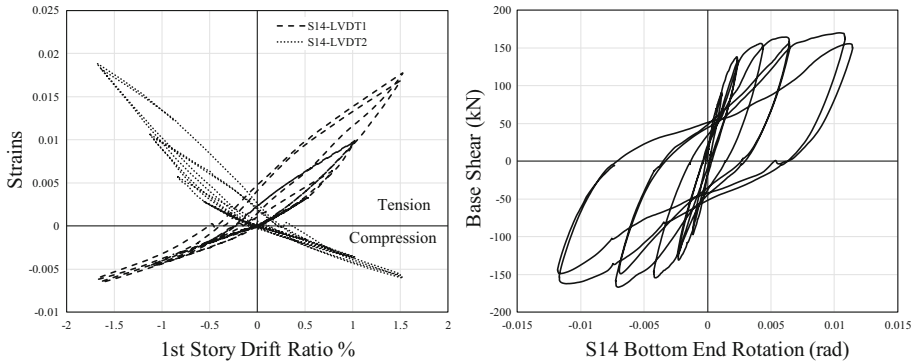
Fig. 11 Strain and end rotation measurements of column S14

transducers were used for calculation of beam and column end rotations. The measured longitudinal strain versus drift ratio and base shear versus end rotation response of severely shear damaged members (S14 and K12) are presented in Figs. 11 and 12. As can be seen in these figures, the maximum average tensile and compressive strain values measured on column S14 are recorded as 0.018 and 0.065, respectively. Additionally, the end rotations created by these longitudinal strains at the bottom of column S14 is 0.012 at a story drift ratio of

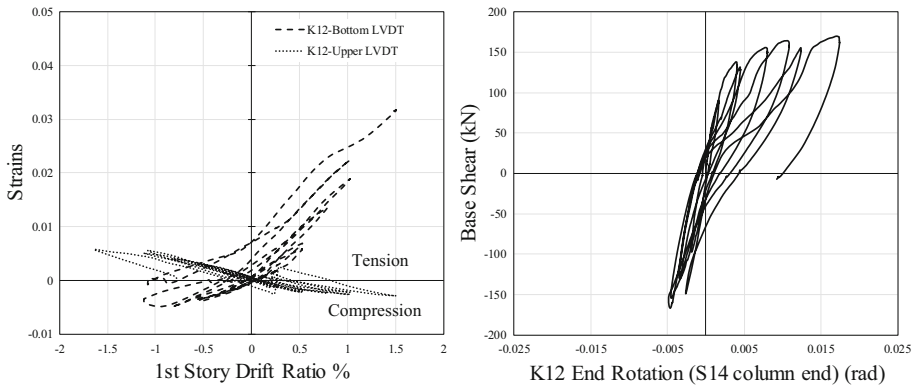
Fig. 12 Strain and end rotation measurements of K12 beam

1.5 %. The maximum tensile strains measured along the uppermost and lowermost longitudinal fibers at the support cross-section of beam K12 are 0.005 and 0.03, respectively. This difference can be attributed to the contribution of the slab to on the bending flexural behavior of the beam in under positive bending moment direction. The maximum compressive strains measured on the beam were approximately 0.004 along both the uppermost and lowermost fibers.

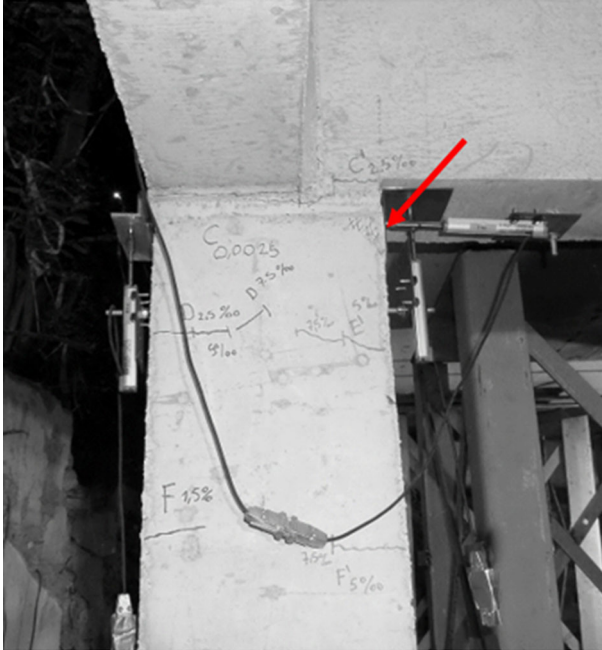
Fig. 15 Cover crushing at 1.50 % drift ratio in column S11

first-story columns at a drift ratio of 0.25 % (Fig. 14). First signs of concrete crushing were observed on column S11, at a drift ratio of about 1.5 % (Fig. 15). Cover spalling was observed on columns S11 and S13 at approximately 2.5 % drift ratio (Fig. 16). Average longitudinal strains measured using the displacement transducers installed along the potential plastic hinging regions of the columns and beams were used for calculation of the member end rotations. Additionally, strain gauges were affixed to the starter bars at the bottom of the first story columns of TB2. The distances between the foundation level and

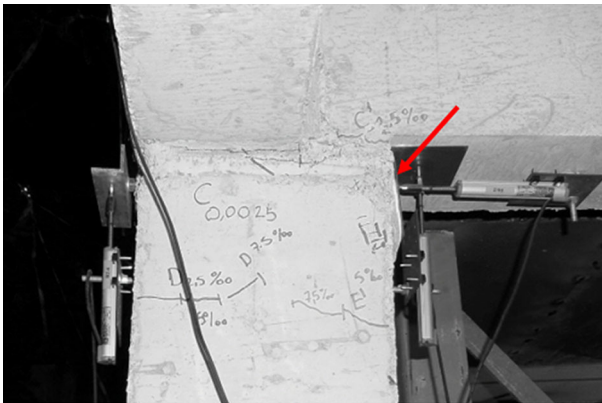
Fig. 16 Cover spalling at 2.50 % drift ratio in column S11

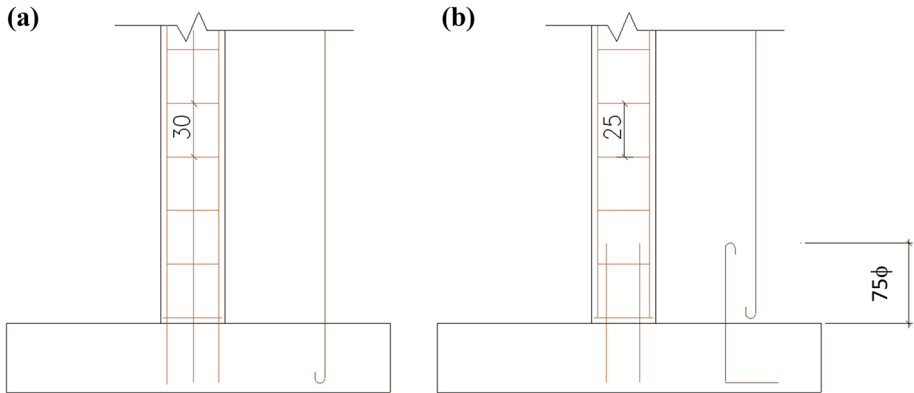
Fig. 18 Column longitudinal bar anchorage detail **a** type I (continuous) and **b** type II (lap-spliced)

glance, it may be expected that the lower axial load levels of the columns and the strong column–weak beam configuration would affect the structural behavior positively in terms of deformation capacity and evolution of the damage. Possible reasons that can help to explain the discrepancy in the observed structural responses of TB1 and TB2 in means of damage progress, are the difference in column longitudinal bar anchorage details, lower quality of workmanship observed at TB1 and relatively lower strength of concrete used for TB2. As also mentioned previously, the low workmanship quality of TB1 resulted with inadequate and irregular concrete cover thickness and random concrete quality distribution that eased the spalling of concrete and premature buckling of the longitudinal bars. Additionally, TB2 was constructed by using a lower strength concrete, which is known to be more deformable than medium strength concrete.

In the type II anchorage detail used in construction of the columns in TB2, the starter and longitudinal bars at the lap splice incorporate 180° hooks at the ends. As also indicated by Fabbrocino et al. (2004), during seismic actions, these hooks behave like semi-rigid ends with very limited slip, while the straight region of the bar loses its bond to concrete at strain and stress levels much lower than yield. Due to debonding along the straight region, the starter bars deform uniformly along the entire lap-splice length, and under same story displacement (and column end rotation) levels, this phenomenon causes smaller average tensile strains in the reinforcing bars (and therefore smaller average compressive strains in concrete) compared to the continuous type I anchorage condition. When this happens, visual inspection of the damage on the column indicates formation and progressive widening of a single flexural crack at the column–foundation interface, and the column exhibits a rocking-like behavior. This was also observed on the first story columns of building TB2 (with type II anchorage detail). While the damage observed on column S14 of TB1 was distributed along an approximate height of 300 mm from the column base (approximately $0.5h$, where h is the depth of the column cross-section) as shown in Fig. 10, the flexural deformation observed at the base of column S11 in TB2 was localized along the first few centimeters of the column (due to formation of a distinct interface crack), as can be seen in Fig. 19. The strain gauge measurements done for S11 column also gives hint about this behavior. Accordingly, the local tensile strains measured along the longitudinal bar (at 0.25, 0.50, 0.75 and 1.0 H distance from the column bottom) point to close values to each other (i.e. strains vary between 0.0013 and 0.0023 at 2 % drift ratio), as seen in

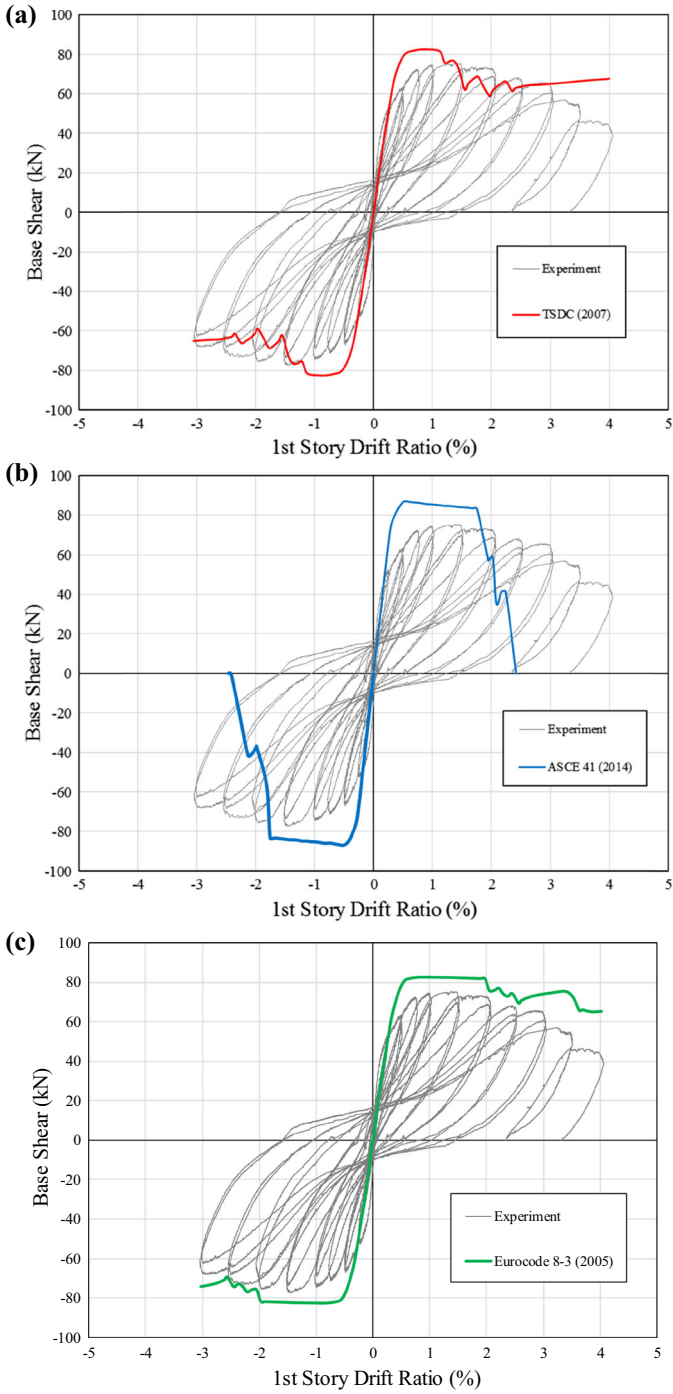
Fig. 24 Comparison of test results and analysis results for TB2 **a** TSDC (2007), **b** ASCE 41 (2014) and **c** Eurocode 8-3 (2005)

The predictions of all seismic performance assessment procedures for the base shear versus first-story lateral drift ratio response of both buildings are compared with the experimentally measured cyclic responses in Figs. 23 and 24. All modeling approaches well-predict the initial stiffness of the buildings, yet overestimate their lateral load capacity by approximately 10–20 %. Except over prediction of lateral strength, the pushover curves predicted for TB1 by the TSDC (2007), ASCE 41-13 (2014) and Eurocode 8-3 (2005) procedures show similar trend up to a drift ratio 1 %. After this point, while the ASCE 41-13 (2014) procedure predicts a sudden decrease in lateral load capacity, the TSDC (2007) and Eurocode 8-3 (2005) pushover curves do not estimate loss in lateral load up to the maximum drift ratio of 1.5 % applied during the test. This difference between the pushover curves is related to the different approaches used for modeling of columns in the performance assessment procedures. While the ASCE 41-13 (2014) backbone curves defined for plastic hinge rotations in columns incorporate a sudden decrease in the moment vs. plastic rotation behavior, the TSDC (2007) and Eurocode 8-3 (2005) did not estimate the strength loss up to larger deformations. In the case of TB2, the consideration of the plastic hinges, which was followed for the TSDC (2007) and Eurocode 8-3 (2005) approach, indicated a better agreement with the test results. Similar to TB1, the ASCE 41-13 (2014) pushover curve for TB2 exhibited a sudden drop in lateral load at a drift ratio of approximately 2 %. The experimentally observed flexural yielding hierarchy at the beam-column connections of both buildings was captured by all assessment procedures (beams of TB1 reached flexural capacity before columns and columns of TB2 reached flexural capacity before beams). However, it should be recalled that none of the performance assessment procedures accurately predicted the experimentally observed damage states of the structural members.
