Fiber Reinforced Polymer as External Reinforcement for Single Cast-in Anchors in Plastic Hinge Zones

Jian Zhao, Derek Petersen, Zhibin Lin, Baolin Wan

ABSTRACT: This paper presents a test of cast-in anchors in the plastic hinge zone of a reinforced concrete column. Design codes, such as ACI 318-11, do not allow concrete anchors in concrete that could be substantially damaged during an earthquake unless special reinforcement is provided. Steel reinforcement has been proven effective in protecting core concrete; however, it does not protect cover concrete, which is critical to the shear behavior of anchors. Fiber reinforced polymer (FRP) composite material was used in this study to protect cover concrete around the test anchors. The column specimens were subjected to quasi-static cyclic loading while the single anchors were loaded in cyclic shear. Compared with the anchors in unprotected concrete, the FRP reinforced anchors developed a higher shear capacity at a much smaller displacement. This indicates that FRP fabrics can be effective as external reinforcement for concrete anchors. Meanwhile, a systematic study is needed before practical applications.

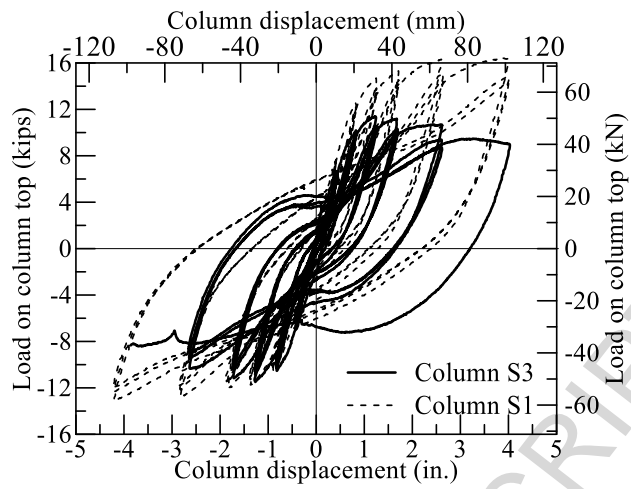
Figure 6 - Behavior of column specimens under cyclic loading

The column in Specimen S1, loaded before testing the anchors, had a typical hysteretic behavior found in flexural members, as shown by the dashed lines in Figure 6. The unsymmetrical behavior in two loading directions was attributed to a 19-mm [$\frac{3}{4}$ -in.] offset of the column at the top. An examination of the strains in the middle longitudinal bar indicated that the first yield occurred during the loading cycle at about 13 mm [0.5 in.]. The largest column displacement was about 102 mm [4 in.], corresponding to $8\Delta_y$ at a peak load about 67 kN [15

The local FRP wrapping was designed only to protect cover concrete near the test anchors, and thus was not applied to the entire plastic hinge zone of the column specimen as shown in Figs. 4 and 5. Therefore, the behavior of Column S3 was not expected to improve compared with Column S1, as the damage occurred to the concrete in the plastic hinge zone just below the FRP fabric, as shown later in Fig. 8. Meanwhile, the solid lines in Figure 6 indicates that the load-displacement behavior of Column S3 was affected by the simultaneous loading to the anchors. The required loads on the column top at designated displacements were in general smaller because of the large forces on the anchors in the same direction. A data analysis indicates that the lateral loads on the column top, combined with the loads on the test anchors, generated similar sectional behavior to Column S1.

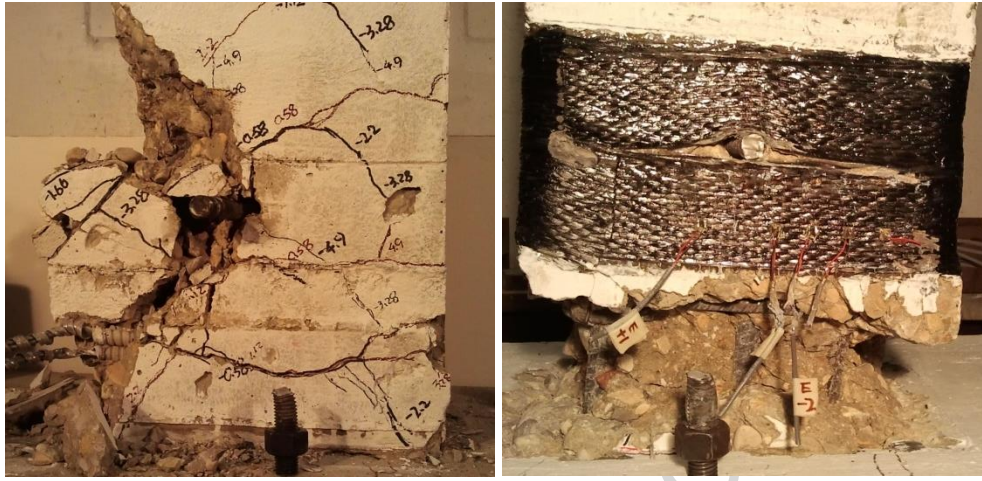
a) without cover protection (S1) ;

b) with FRP protection (S3)

Figure 8 - Concrete damage in the plastic hinge zone during the tests of anchors in shear

The behavior of the two single anchors subjected to monotonic shear is shown in dashed lines in Figure 7. The east anchor had a slightly larger shear displacement partly because of a smaller edge distance. The X-axis in Figure 7 thus shows the average shear displacement measured relative to the concrete front face in the load-displacement curve. The Y-axis shows the total shear resistance from the two single anchors. The anchors behaved elastically till about 33.4 kN [7.5 kips], beyond which the slope reduced significantly, indicating the crush of concrete in front of the anchor shafts. Cracks on the east side face first showed up at a load of 89 kN [20 kips] followed by spalling of concrete cover as shown later in Figure 8a.

Within each loading group, the anchors had an increased displacement during the second and third cycles compared with the first loading cycle. This indicated that the concrete in front of the anchors crushed as shown in Figure 8b, and the crushed concrete did not recover upon unloading. The anchors were able to carry a combined shear of 214 kN [48 kips] in the positive direction, which is very close to the predicted anchor shear capacity shown above. The anchor shaft on the east side fractured at a combined load of -191 kN [-43 kips] when the loading was

reversed (Figure 8b). The fracture was mainly attributed to low cycle fatigue.

Unlike Specimen S1, the concrete cover spalling did not occur to Specimen S3. The FRP fabrics protected the cover concrete near the test anchors as expected. The FRP wrapping also protected column segment from severe damage under lateral loads. Note that the behavior of the RC column did not see any improvement because the damage below the FRP wrapping controlled the behavior of the column, as shown in Figure 8b.

When the applied load on the east anchor was positive, the anchor had a front edge distance of 150 mm [5.4 in.], and the potential cover spalling is illustrated by the curved lines in the inserted picture in Figure 10a. The fiber strain in front of this anchor is the highest, and the fiber strains in general decrease as the gaged location moves away from the anchor. This indicates that the tensile force in this fiber gradually transferred to concrete through FRP-concrete bond when the loads on the test anchors were below their shear capacities. Meanwhile, the fiber strains were largely uniform at about 3000 microstrains from all six gages behind the anchor when the anchor load was at 214 kN [48 kips], indicating that the debonding occurred and the FRP fabrics were developed through the overlap on the north face. A close examination confirmed the debonding near the east anchor, as shown in Figure 8b.

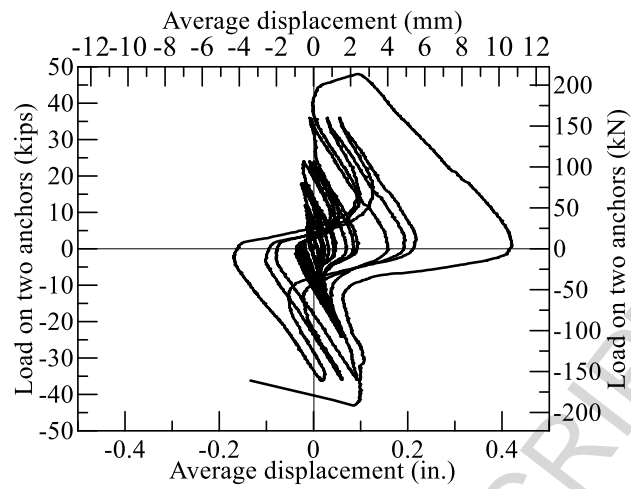
Figure 9 - Behavior of single anchors in plastic hinge zone under cyclic shear loading

The cover concrete around the anchors in Specimen S3 was protected by FRP fabrics, as shown in Figure 4. Therefore, the behavior of the anchors in Specimen S3 was greatly improved. The load vs displacement behavior of the anchors in Specimen S3 is plotted in Figure 9. Again, the displacement in the plot is the average displacement measured from LVDTs, and the load is the combined shear resistance from two test anchors. The overall load-displacement behavior seems abnormal compared to that of a typical structural element: 1) the loading and reloading branches do not always have a positive slope; 2) the peak displacements do not increase with an

increase in the apply peak load; and 3) the unloading braches have positive slopes. The interaction between the two actuators in Specimen S3 is deemed the reason for the observed anchor behavior and the column behavior in Figure 6: the loading rates for both actuators were selected such that the peak loads on the test anchors would be achieved when the peak displacements were applied to the column top; however, this synchronized loading was not always maintained during the loading. Specifically, the column unloading may have been at a faster pace than the anchor unloading; therefore, the anchors experienced decreased deformation at loading stages and increasing deformation during unloading stages.

The cyclic anchor behavior is simplified, as shown by the solid lines in Figure 7, which were created by connecting the first peak point of all five loading groups shown in Figure 9. One point (shown by a cycle) is added corresponding to the apparent yield load ($0.6f_{yta}A_{s,v}$) of 187 kN [42 kips]. In addition, the last point (shown by a square in Figure 7) is a random point on the unloading path indicated that the fracture occurred during this loading cycle. The anchors in Specimen S3 had a rigid behavior all the way up to the maximum loads. The displacements corresponding to the two peak loads in both directions are about 2.5 mm [0.1 in.] though the displacement measurements may be affected by the column deformation. This rigid behavior is beneficial to the anchor connection and the brace in Figure 1.
