## Pedicle screw rupture: A case study

In this work we present a technical description related to the rupture of a titanium alloy pedicle screw and connecting bar implanted in dorsal vertebrae of a patient. Only metallurgical facts are described, with no attempt to identify any imperfections in the clinical aspects related to the rupture. The results described here are based on extensive analysis of the broken materials in a material sciences specialized laboratory. Excluding an incorrect prosthesis implantation in the surgical procedure and a possible low bone density, an information not available to the research team, with high probability the rupture of metallic pieces used in the prosthetic implant, was produced by the low fatigue resistance resulting by an improper machining process and excessive bending of the connecting bar prior to implant.

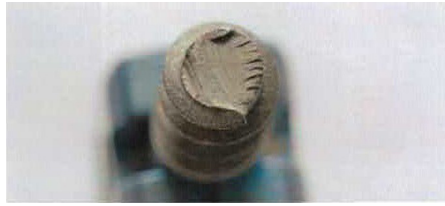
Fig. 2. View of the fracture surface of broken screw [26].

Fig. 2 shows, clearly and without any doubt, that the pedicle screw utilized in the surgical procedure, ruptured by fatigue under alternate flexure, with several points of origin of the fatigue process, under low level of nominal stress. That is, the broken screw showed low resistance to fatigue. Electronic microscopy of this same area validates this hypothesis. About this we shall comment later in this work.

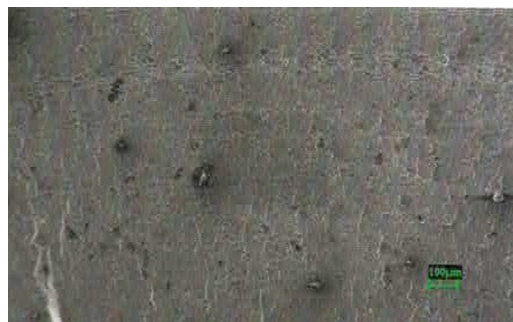
Fig. 4. Fractography – “beach marks” are observed in the region of cracks propagation [26].

The fractographic analysis shown by Figs. 3 and 4 simply confirm the results of the electronic microscopy.

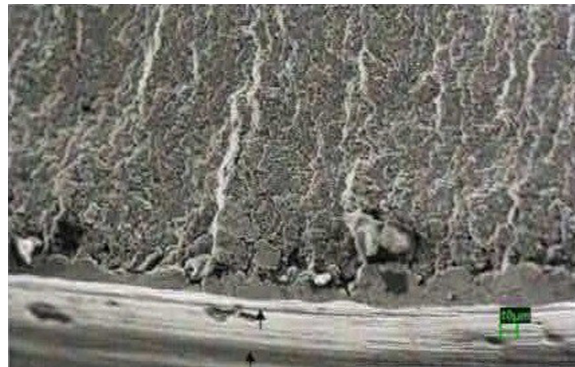
Fig. 8. Fractography. Detail of a point of fracture origin [26].

In Fig. 8 are shown ratched marks and machining scratches. These were relevant facts for the conclusion of the present case. In fact, SEM analyses of the screw lateral surface close to the fracture region, reveal the presence of rough machining scratches. It was obvious that the screw presented stress concentration regions, where fatigue rupture initiated. These regions were produced in the screw machining process, with no relation with the following prosthetics utilization by the patient.

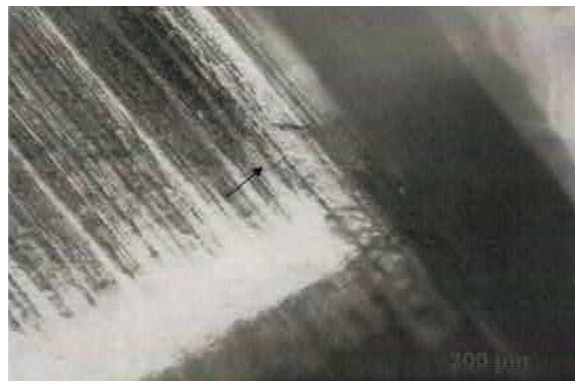
Figs. 9, 10 and 13 serve as a clear confirmation of the above reasoning, stressing the hypothesis of a poor machining process. In Fig. 10 it is relevant the fatigue crack close to a coarse machining scratch (black arrows). Figs. 11 and 12 show secondary cracks in the broken screw, showing its fragility in several regions.

Fig. 9. SEM analysis. Coarse machining scratches parallel to threads and presence of a secondary crack (arrow) [26].

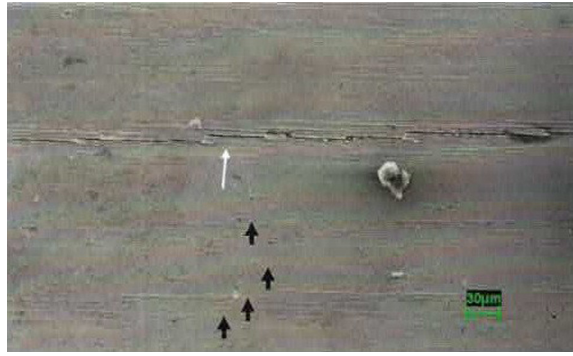
Fig. 10. Secondary crack shown in Fig. 9, identified by a white arrow [26].

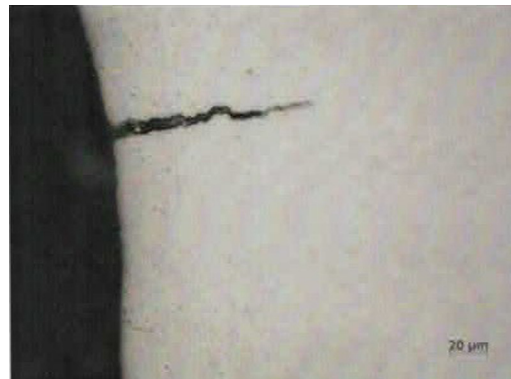
Fig. 12. Metallography. Detail of crack observed in Fig. 11 [26].

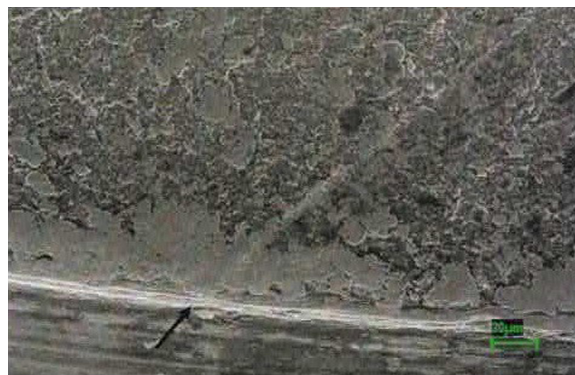
A second stage of the analyses and tests dealt with the rupture of a connecting bar serving as a stabilization bridge between the pedicle screws on each side of the vertebra. Chemical and metallographic analyses of the broken bar and the integral bar show no sensible difference and their conformity for the proposed utilization. The integral bar shows a large curvature, eventually necessary for the correct positioning of the bar and screws kit. No information was available about how many flexures were necessary for the prosthetics correct positioning. The rupture of the connecting bar shows a unidirectional flexure or stress. This seems to indicate that the bar fracture could initiate before the implant procedure since, on the contrary, we suppose, a bidirectional flexure should be observed. Such fact could be related with the technique used to adjust the bar curvature until the correct value was achieved, a difficult point to be analyzed. On the other and Fig. 14 shows that the fatigue fracture initiated in a ratched marks region at the bar surface. The question raised at this point was the cause

Fig. 14. Ratched marks in the region of fracture origin [26].

of this ratched mark, since with high probability the fatigue crack started at this point and propagated along the entire broken section.

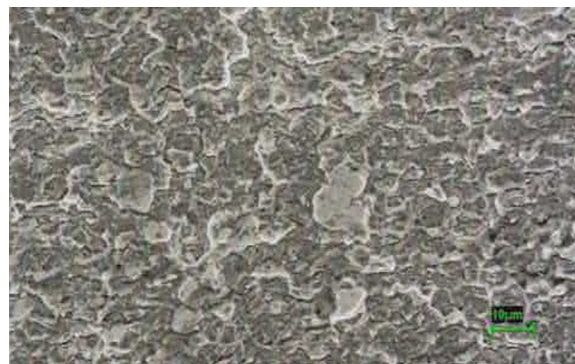
Another important information was given by Fig. 16, where it is seen that ratched marks and stain cover the fatigue fracture cracks.

Fig. 16. Scratches in a region far from fracture origin, ratched marks and oxidation disguise secondary scratches [26].

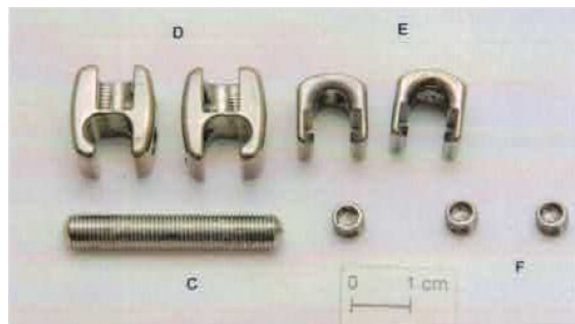
With respect to the remaining components (Fig. 19), nothing was to be reported, although the fact that they play an important role in the prosthetic structure.

Fig. 19. Visual examination of other parts of prosthetics show no failure [26].
