Case Studies in Structural Engineering

Earth retaining structure in Tirana

A large cinematographic and shopping centre is designed to be built in Tirana. It will be a special structure, partially underground, situated in an excavation of depth 22 m, with a minimum distance of 10 m to a large existing shopping centre. For the first phase of the project, the main engineering challenge was to design a safe and economic structure to ensure the stability of the neighbouring existing shopping centre and the ground itself. This paper is focused on the engineering challenges of the design and construction of the earth retaining structure, which was decided to be a combination of a piled wall and reinforced concrete frames forming a rather complicated structure but a very economical solution. The solution described in this paper made the construction costs drop to 35% of the cost of the initial design. The construction of the earth retaining structure began in 2011 and was successfully completed in 2012. The rest of the project, the commercial centre itself, is still under construction.

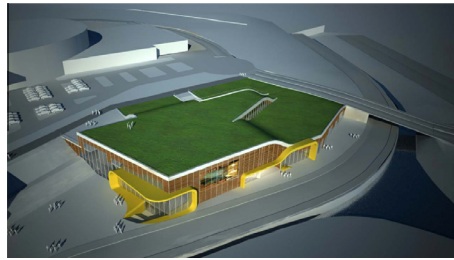
Fig. 1. Architectural three dimensional view of the proposed shopping centre.

The main project consists of the design of the new commercial centre in eastern suburbs of the capital of Albania, Tirana. The architectural three dimensional view of the commercial centre is shown in Fig. 1, where it can be observed that it lies in a slope, with the back part underground.

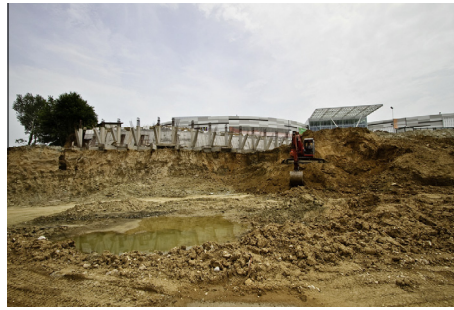
Fig. 4. Photo during the construction of the frames.

After the completion of the cap, the next stage consisted in construction of frame elements such as horizontal elements, columns above the already built bored piles and inclined elements. Next, the excavation of the slope began down to further 9 m in depth, reaching the level of front piled wall cap. A photograph taken at this stage is shown in Fig. 4, where the back piles and nearly half of the frame have been built.

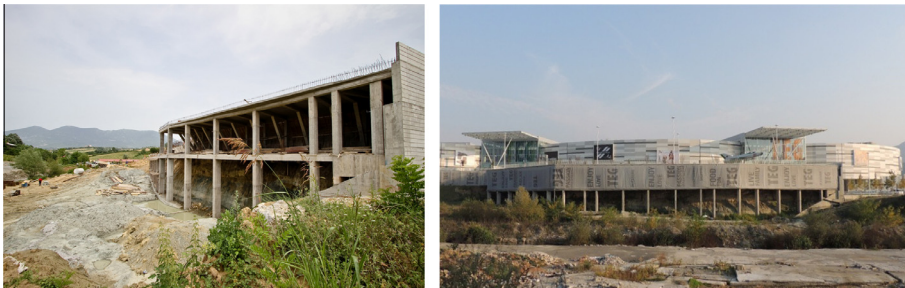
Fig. 5. Photo of completed frames (left) and present state of the structure (right).

Probably the most difficult stage was the next one, consisting of the construction of the final details of the earth retaining structure. The partially built structure had a few missing elements, such as the front columns and nearly half of the length of horizontal and bracing elements. Their reinforcement had to be carefully positioned in the intersection joints with the already built elements. Another challenge was the construction of columns with height 9 m while ensuring good vibration of concrete. To achieve this, the concreting was done in three levels of the column (at 3 m, 6 m and on top). The successfully completed frames and development of excavation down to the level of the front piled wall are shown in Fig. 5.

After the completion of all the structural elements, including the top slab and interconnecting horizontal elements, the structure could be considered complete in 2012 (Fig. 5, right). The only missing structural elements are the anchors at the front piled wall. They are intended to be built after the excavation of the top three metres below the level of the cap. The ducts for the anchors are already prepared, however few concrete drilling works might be necessary during construction. The construction of the new shopping centre has not yet begun, but the earth retaining structure is ready for the continuation of excavations.
