# Full-scale Tests of Stabilized and Unstabilized Extended Single-plate Connections

## ABSTRACT

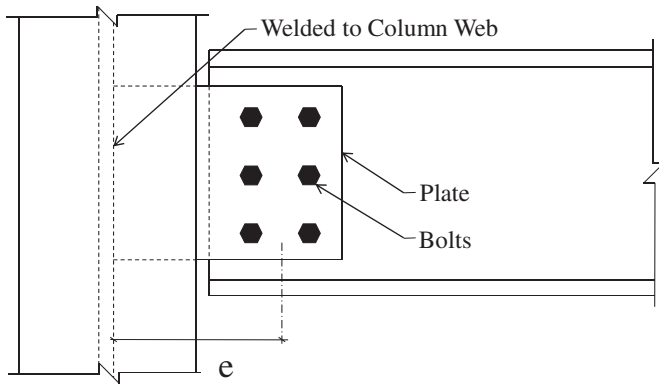
Fig. 1. Extended Single-plate Connection to Column Web.

Extended single-plate connections have the same configuration as conventional single-plate connections, but normally frame into the supporting member's web and extend beyond its flanges, as shown in Fig. 1. This creates a larger geometric eccentricity,  $e$ , the distance between the face of the support and the bolt group centroid, that must be accounted for explicitly in design. The recommended limit on eccentricity for conventional single-plate connections is 89 mm (3.5 in.) according to the *Steel Construction Manual* [1], whereas the extended type can have eccentricities up to 360 mm (14 in.) in many practical applications. The effect of this large load eccentricity on the stability and performance of the plate is investigated herein. Since axial loads are common in steel shear connections, and an understanding of their influence on connection behaviour is important to design, this parameter was included in the research program. Finally, extended single-plate connections can be stabilized by welding the plate either directly to the flanges of a girder or to perpendicular stabilizer plates located between the flanges of a column; thus, both stabilized and unstabilized plate behaviour was studied.

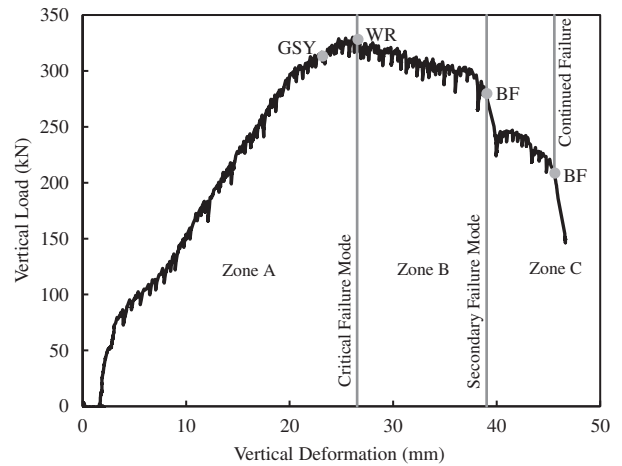
Fig. 4. Load–Deformation Response of Specimen 3B-10-U-0.

In zone A, the 0.03 rad beam rotation is imposed, horizontal load is then applied (if required), and the vertical load is applied subsequently. During the beam rotation and application of horizontal load, a small amount of vertical connection deformation was recorded (approximately 2 mm (1/16 in) during beam rotation in Fig. 4). During the

After initial failure occurred, load redistribution began in zone B. When weld rupture was the critical failure mode, the load decreased gradually as the rupture propagated, as is the case in Fig. 4. The vertical load tended to drop more suddenly when bolts fractured. In other cases, the load remained relatively constant until secondary failure occurred. The extent of deformation between the critical and secondary failure modes varied considerably among tests.

number and extent of the load drops in this zone varied. During the 3B-10-U-0 test, two bolts failed, shown in Fig. 4 as the secondary failure mode and “continued failure” points.

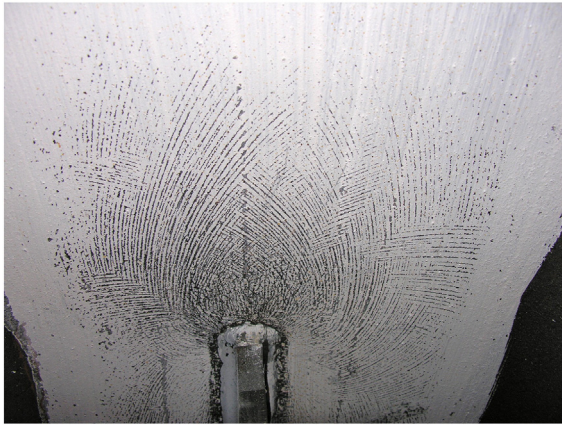
Fig. 6. Column Web Lüders' Lines at the Compression Edge of the Plate.

to determine the column web yield pattern. The whitewash revealed Lüders' lines extending radially on the column web from the top and bottom of the plate, as shown in Fig. 6. Specimen 3B-10-U-200T, which did not exhibit signs of column web yielding prior to the weld rupturing, was the only exception.

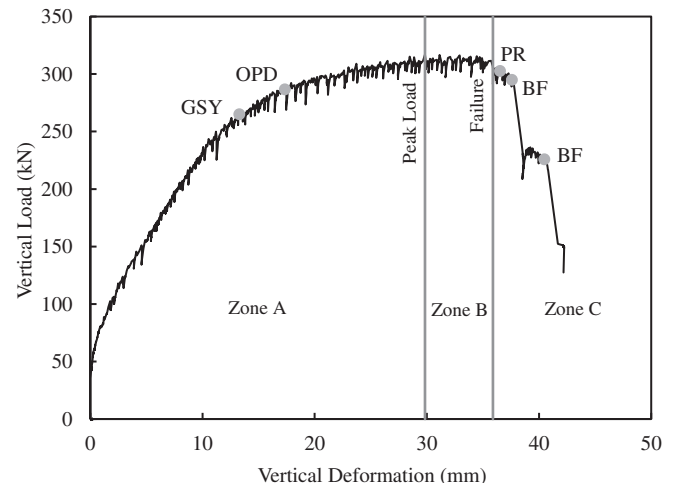
Fig. 7. Load–Deformation Response of Specimen 2B-10-S-0.

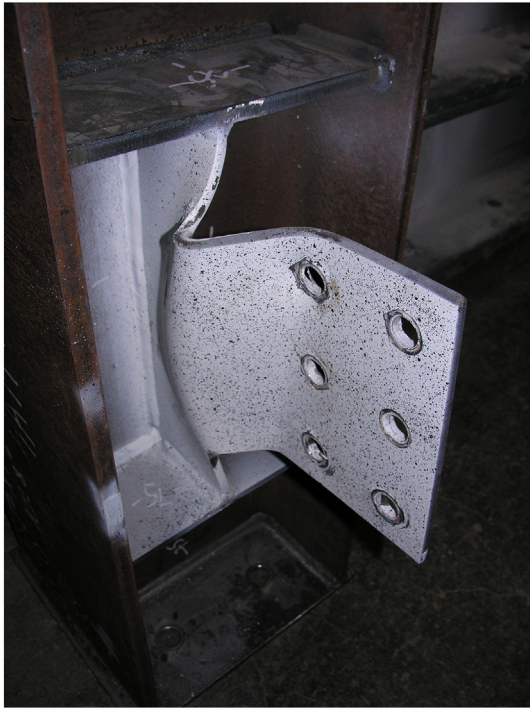
Fig. 8. Out-of-plane Deformation of Stabilized Specimen.

design of the column. Further research is needed to help quantify the appropriate eccentricity to be used to evaluate the design moment, but the inflection point for the stabilized connection plate at the connection's capacity was typically half way between the tip of the stabilizer and the centerline of the bolt group. The extra moment being attracted to the column enabled the stabilized connections to reach a large enough load that plate out-of-plane deformation became the failure mechanism. The stabilizer plates in essence shorten the “span” of the plate, requiring a much more severe curvature than is required for the unstabilized case with a longer plate, for the same rotation and displacement. This sharp curvature cannot be accommodated through in-plane bending, so out-of-plane deformation is induced. Fig. 8 shows the typical mechanism that formed in the stabilized single-plate connections.
