Journal of Structural Fire Engineering

Post-fire assessment and reinstatement of steel structures

C. Maraveas^{1,2,*}, Z. Fasoulakis², K.D. Tsavdaridis³

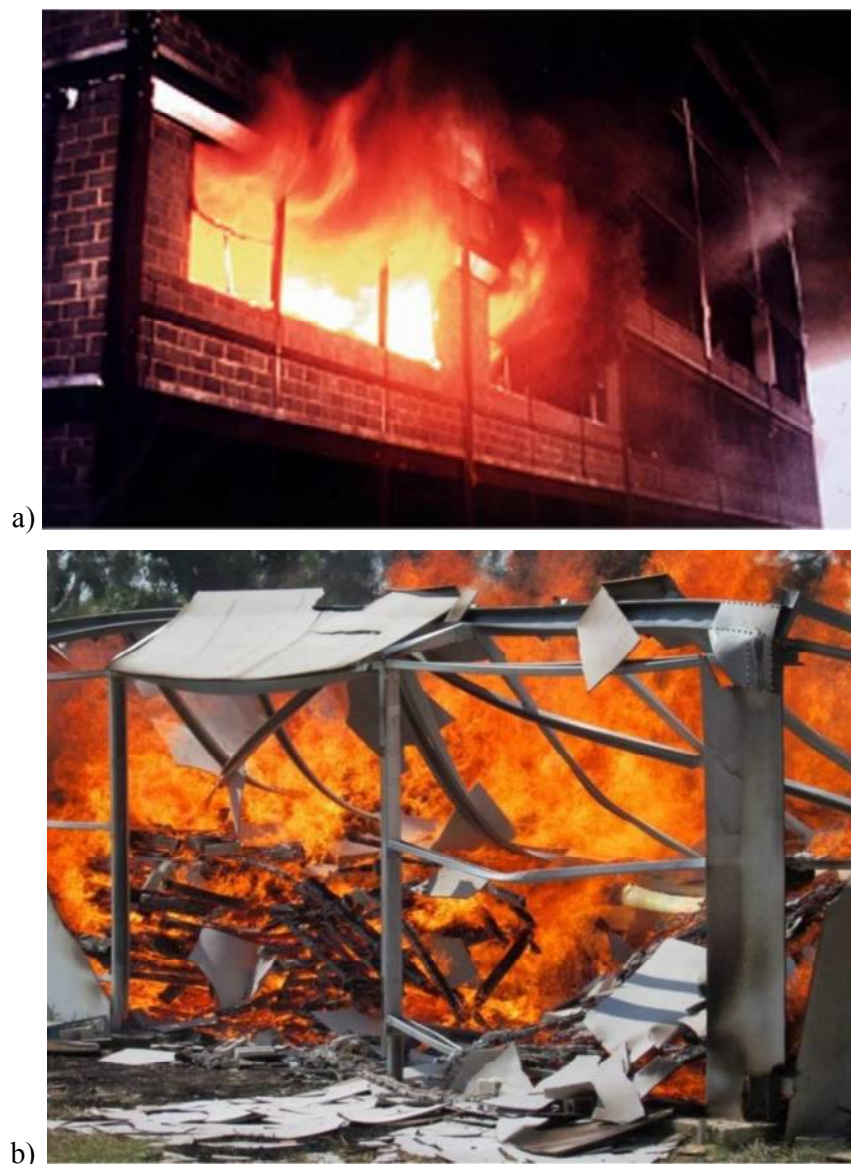
Figure 1. Fire tests in progress, conducted by a) Kirby et al. [21] and b) Johnston et al. [22].

storey steel framed building, while a cold-formed steel portal frame was tested by Johnston et al. [22]. Both of the studies above, which can be observed in **Fig. 1**, adequately represent the true behavior under fire conditions, aiming to the rational guidance establishment.

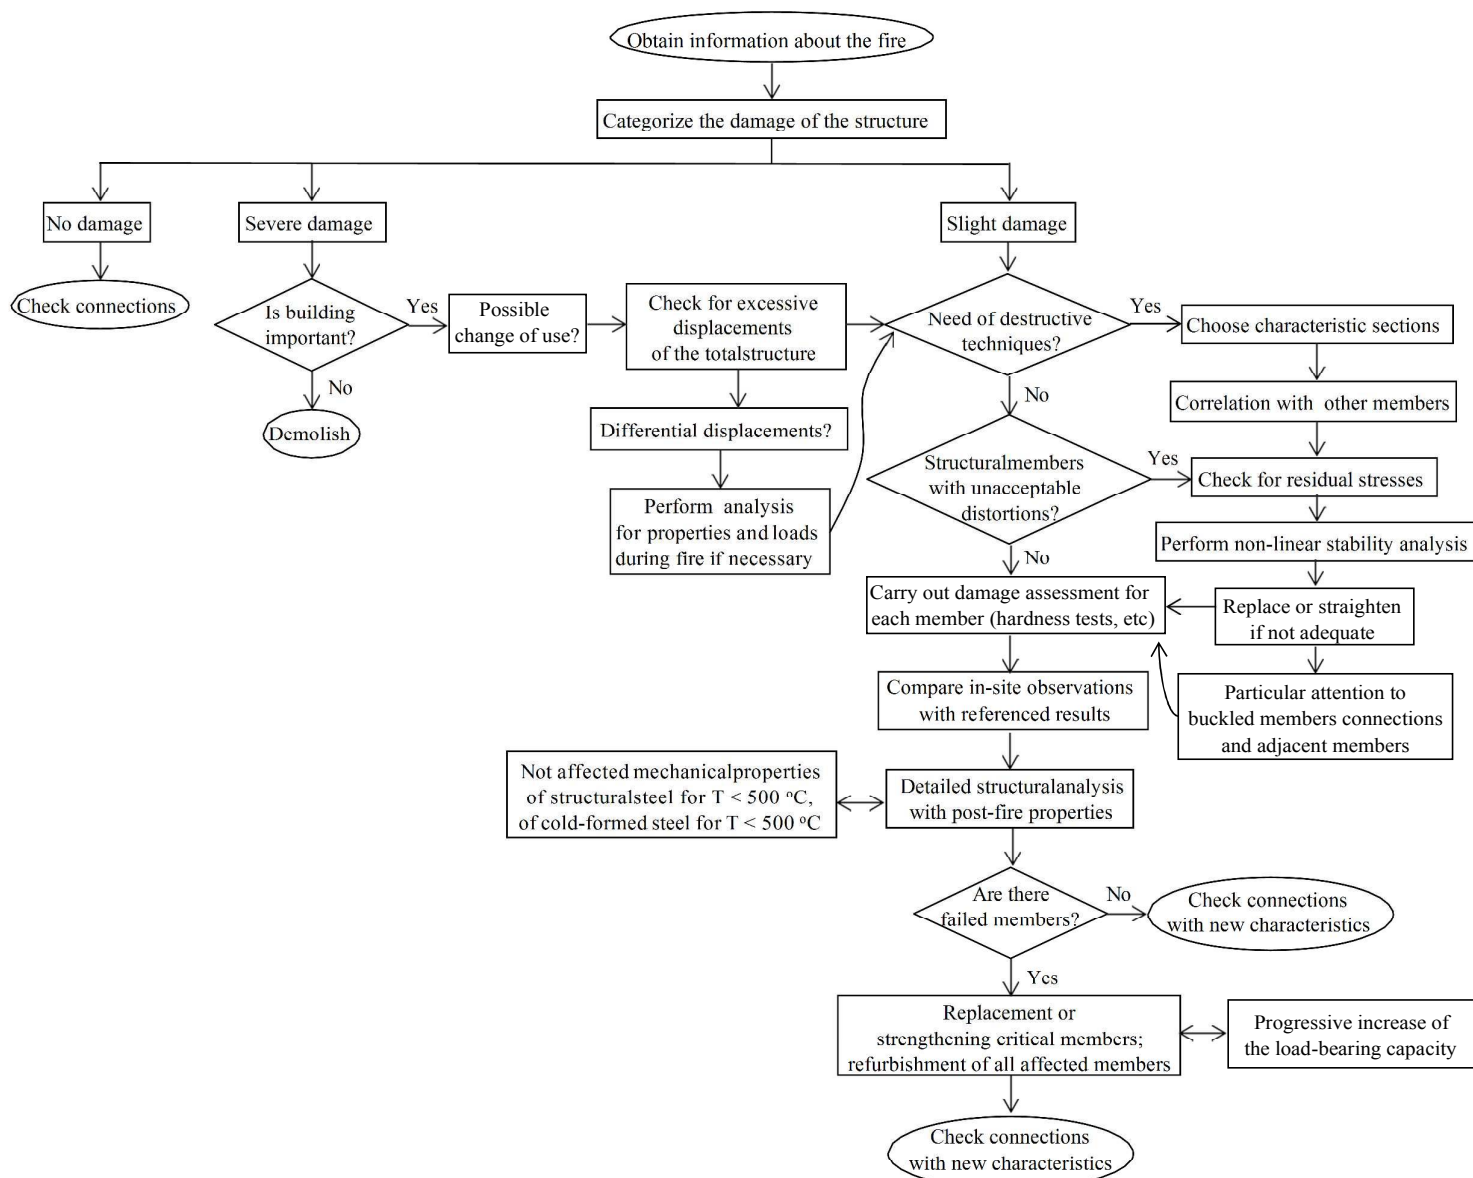
Figure 2. Reinstatement survey flow chart for fire damaged steel structures.

The step-by-step process of the fire damage appraisal is dissimilar to the fire resistant design of structures, which can be followed by prescriptive approaches. **Fig. 2** depicts the reinstatement survey flow chart of steel structures which illustrates the basic steps.

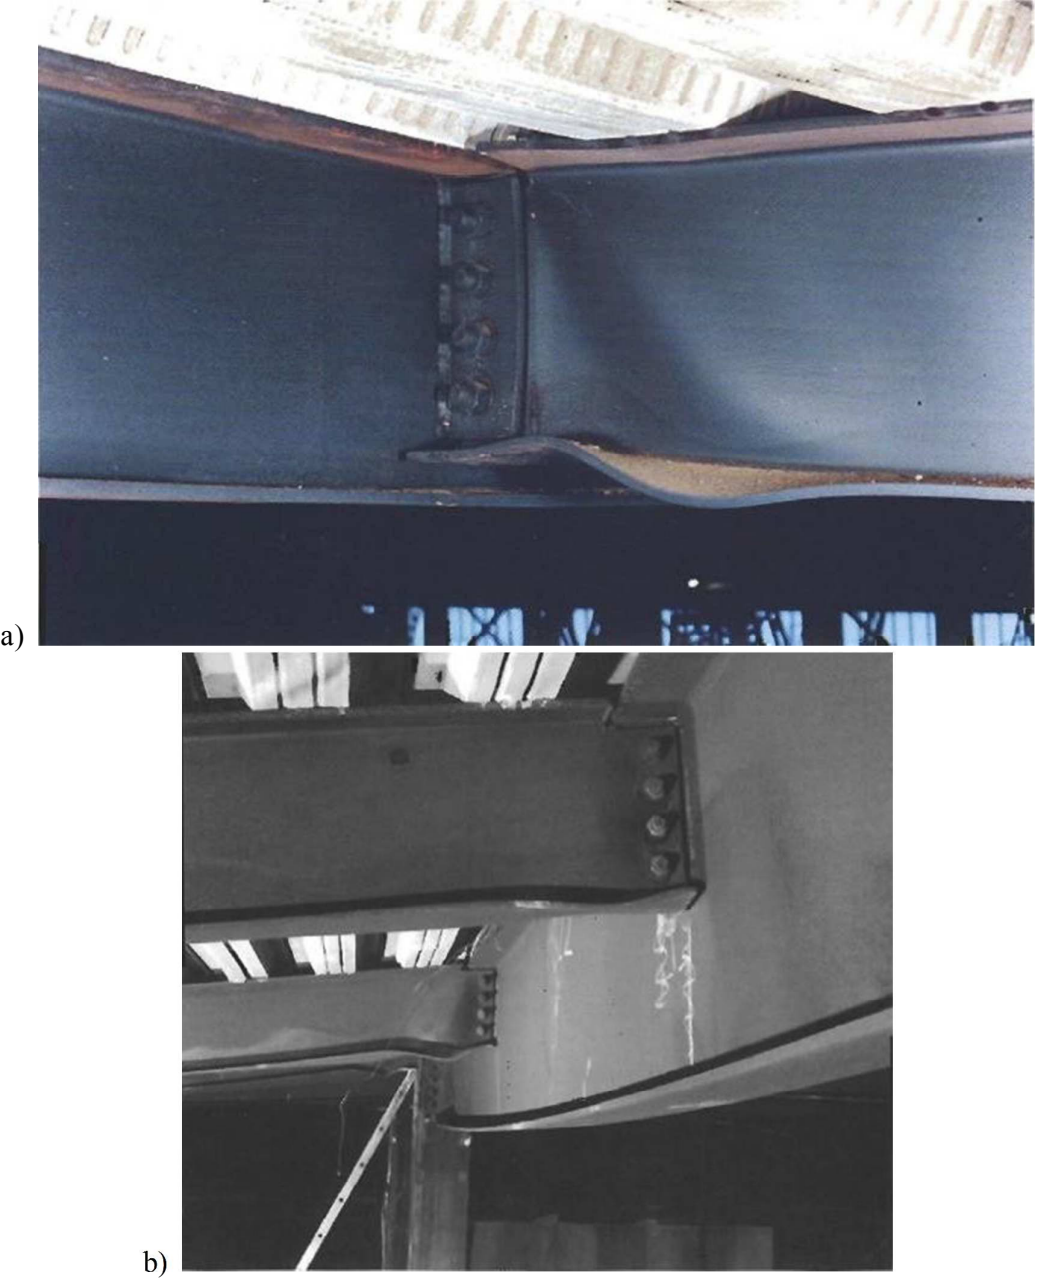
Figure 3. Fin-plate connections of secondary beams showing local buckling [21].

The observation of fire damaged elements provides to the engineers great insight into the ability of structures to withstand in the fire. For this reason, structural deformations of special interest, created during or after fire events are attached in **Figs. 3-4**. In particular, local buckling of the bottom flange and web folding occurred at a secondary beam (**Fig. 3a**) during the heating and cooling phases of the Cardington multi-storey steel frame test, respectively [21]. Such failure is attributed to the axial rigidity of the adjacent connection, the bolts of which do not seem to be affected. In this case, it is highly recommended for the inspector to check for any possible twisting of the primary beam, as it is observed for the corresponding one in **Fig. 3b**. Another failure that highlights the stress development during the cooling phase is attributed to the shear fracture of the bolts at the fin-plate joints. These facts reinforce the statement that localized damages of key elements may be more critical for the overall stability. Another type of distortion, regarding cold-formed steel frames, is observed in **Fig. 4** [12]. The column under investigation is regarded

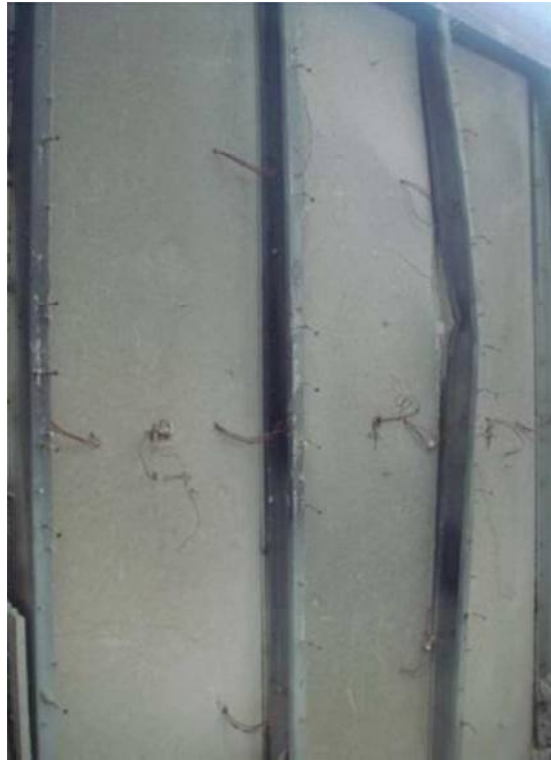
Figure 4. Cold-formed steel frame after fire [12].

noticeably deformed (category b); the restoration through heat-straightening works is preferable as opposed to its replacement.

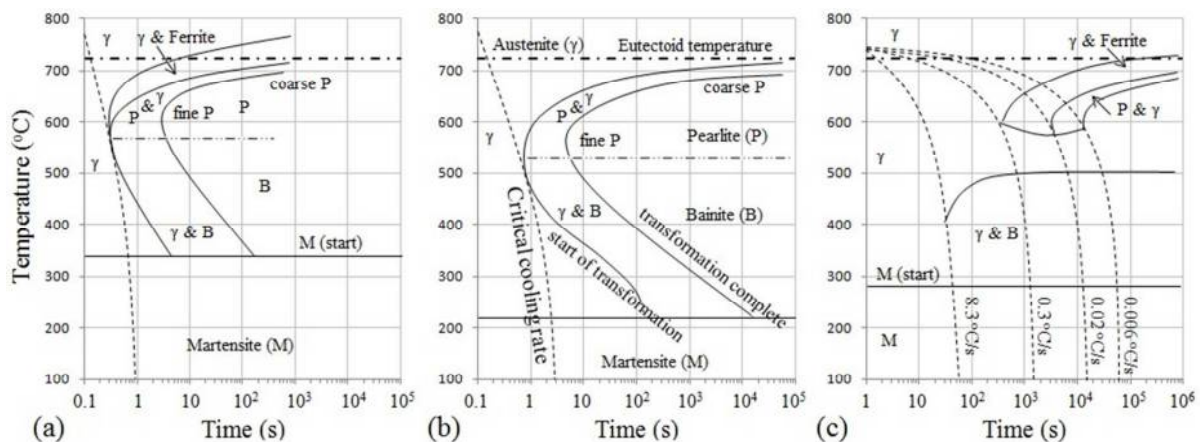
Figure 5. Schematic diagrams illustrating isothermal curves (IT), critical cooling curves and resulting microstructures for a) hypoeutectoid, b) eutectoid and c) alloy steel [26].

Fig. 5 demonstrates the isothermal time-temperature-transformation (TTT) diagrams for three different types of steel: a) hypoeutectoid steel (less than 0.8% of carbon), b) eutectoid steel (0.8% of carbon) and c) alloy steel. Firstly, the steel is held at elevated temperatures, greater than the eutectoid temperature ($A_1=727^\circ\text{C}$), where the transformation to austenite begins. The temperature A_3 is associated with the completion of the transformation of ferrite to austenite. It must be noted that for hypoeutectoid steel, A_3 varies linearly, inversely related to the carbon composition ($A_{3,\text{max}}=910^\circ\text{C}$).

The course of transformation can be completed in either an isothermal or a continuously cooling way. If the austenite is cooled unchanged to a relatively low temperature (M_s), partial transformation takes place instantaneously, producing martensite. This formation attributes to the maximum hardness that can be obtained while the transformation can take place by cooling in water (CIW) or in ice. The critical cooling rate for each steel type is illustrated in **Fig. 5**.

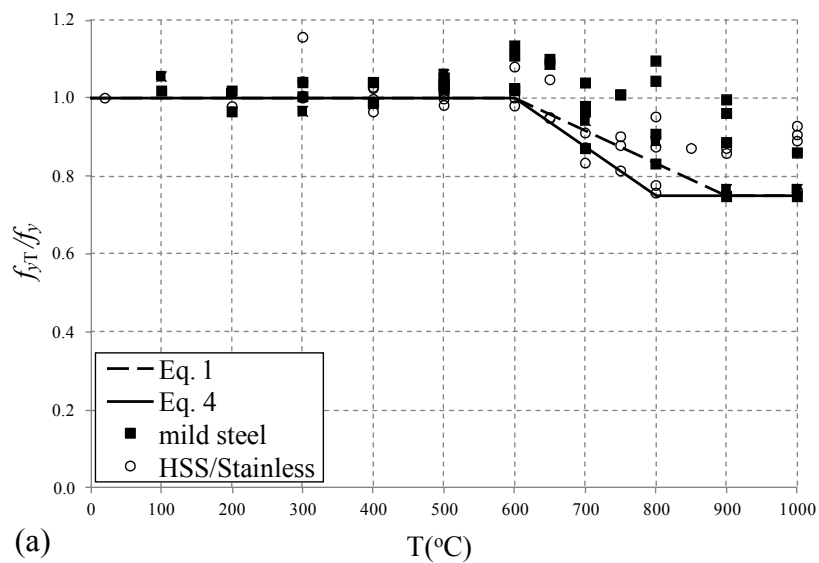
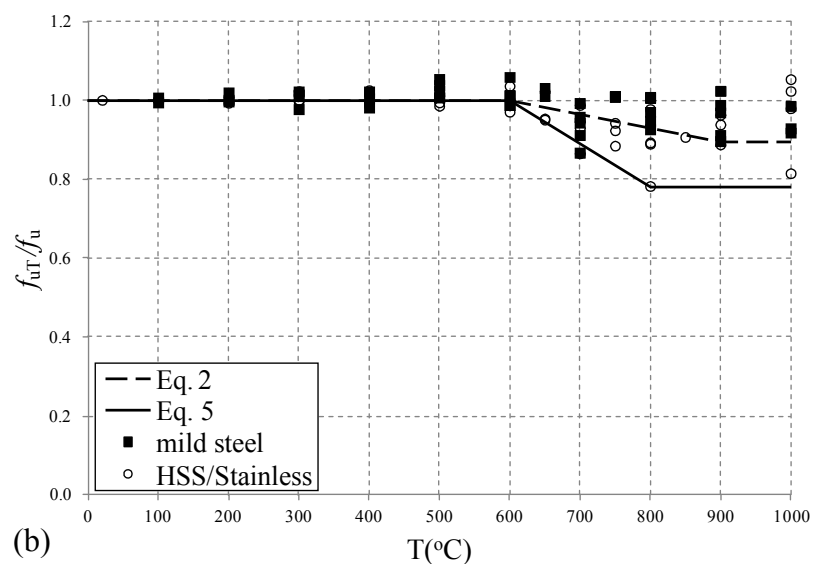
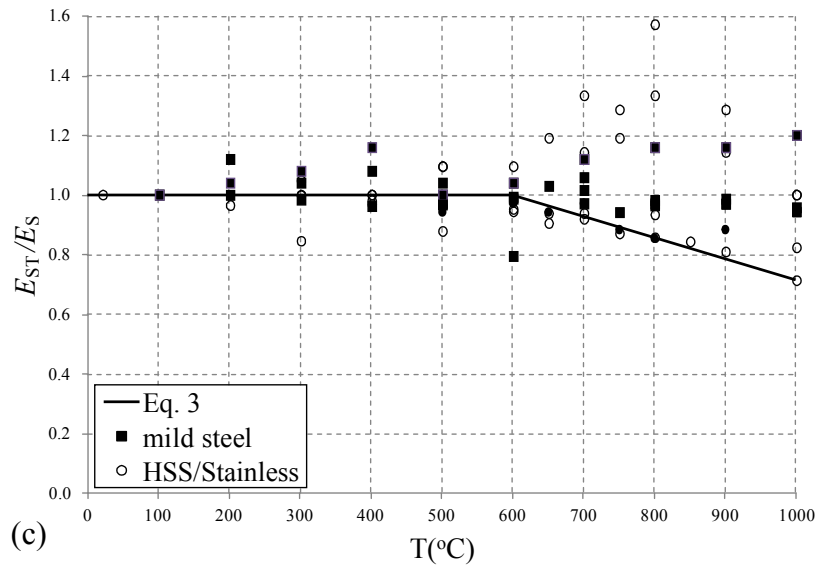
Figure 6. The ratio of a) f_{yT}/f_y , b) f_{uT}/f_u and c) E_{sT}/E_s as a function of temperature for hot-rolled steel.

The experimental ratios of f_{yT}/f_y , f_{uT}/f_u and E_{sT}/E_s for hot-rolled steel are plotted in **Fig. 6**, where f_y , f_u and E_s are the reference yield strength, ultimate strength and elastic modulus (i.e. before the fire exposure), while those with the subscript T are the corresponding temperature dependent values.

Eqs. (1)-(5) define the potential predictions and are compared with the test data. Eqs. (1)-(2) are the most accurate ones according to all test data with mild steel, but sometimes overestimate the strength of high strength steel. Eqs. (4)-(5) are recommended for practical use to determine the residual yield and ultimate strength of high strength, alloy and stainless steel after cooling down from fire temperatures up to 1000°C.

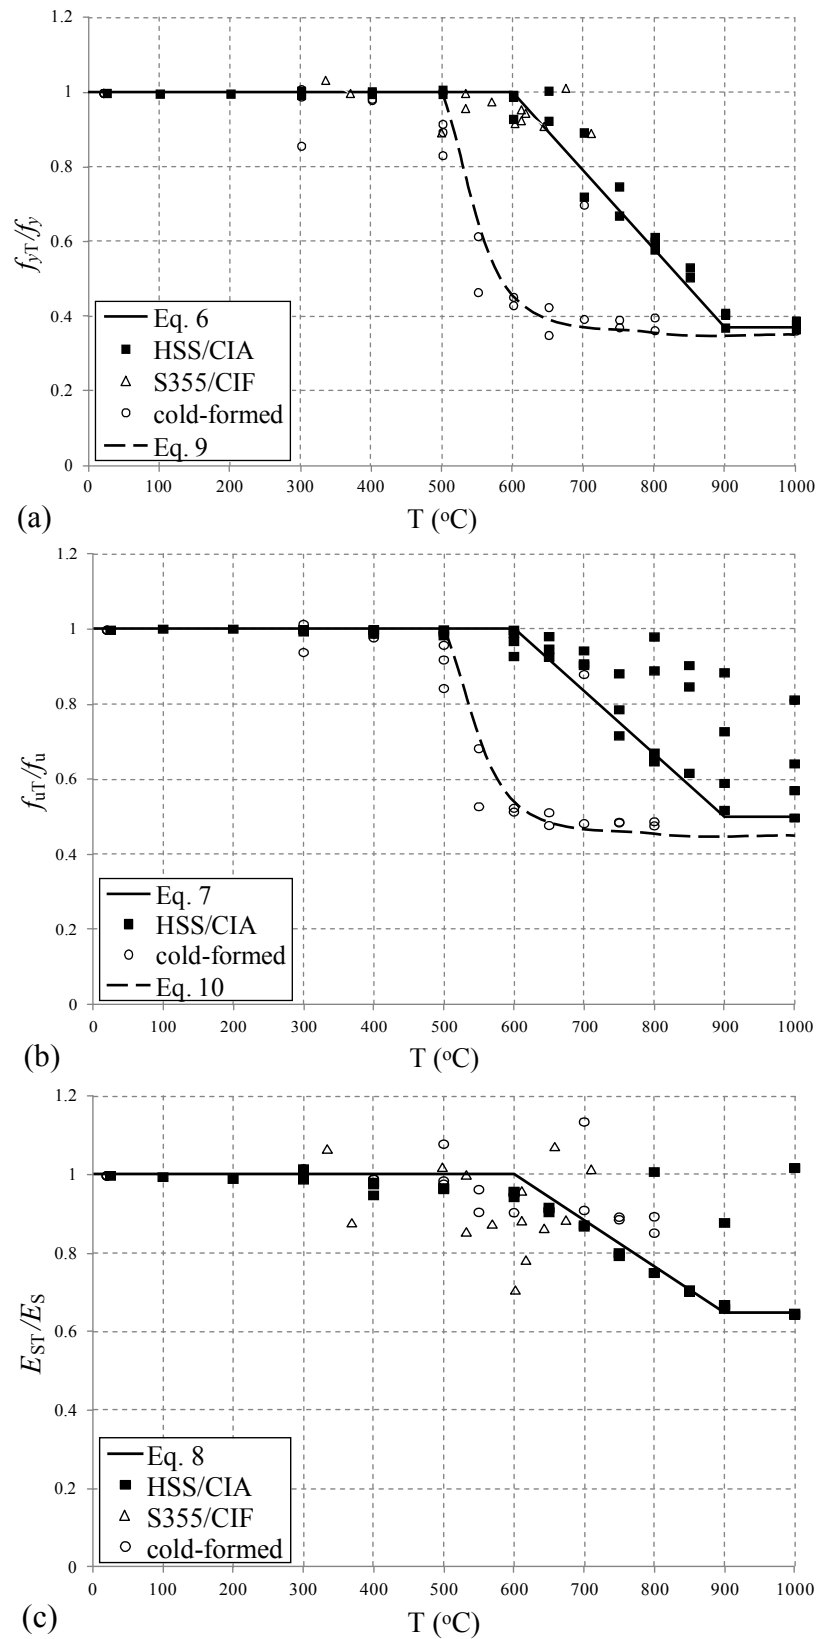
Figure 7. Comparison of predicted residual factors a) f_{yT}/f_y , b) f_{uT}/f_u and c) E_{sT}/E_s for heat-treated and cold-formed steel.

Post-fire mechanical properties for heat-treated steel are defined by Eqs. (6)-(8). An obvious difference between cold-formed and heat-treated steel is apparent in terms of yield and ultimate strength [6,12,13]. Therefore, the residual capacities for cold-worked steel and the sudden decrease of which is clearly illustrated in **Fig. 7**, are established by Eqs. (9)-(10), respectively. The comparison of the corresponding equations with the test data is also presented.

It is concluded that the post-fire behavior of structural steel is hardly influenced after exposure to temperatures up to 500°C. In addition, the residual ultimate strength of mild steel is found greater than 90% of the initial one, whereas none of the properties of hot-rolled steel is reduced more than 25%. The distinction between mild steel and HSS is also stated in Appendix B of British Standards 5950-8 [23], which recommends the reuse of steel grade S235 and S275, following a 10% reduction in the initial strength. On the other hand, for steel grade S355, at least 75% of the strength is regained on cooling from temperatures above 600°C, which is in agreement with the experimental results [5,7,8] (**Fig. 6**). On the other hand it is worth to note that these suggestions are considered as non-conservative for heat-treated [8,9] and cold-worked steel, as the deterioration of the capacity is more significant (**Fig. 7**; residual factors over 35%).

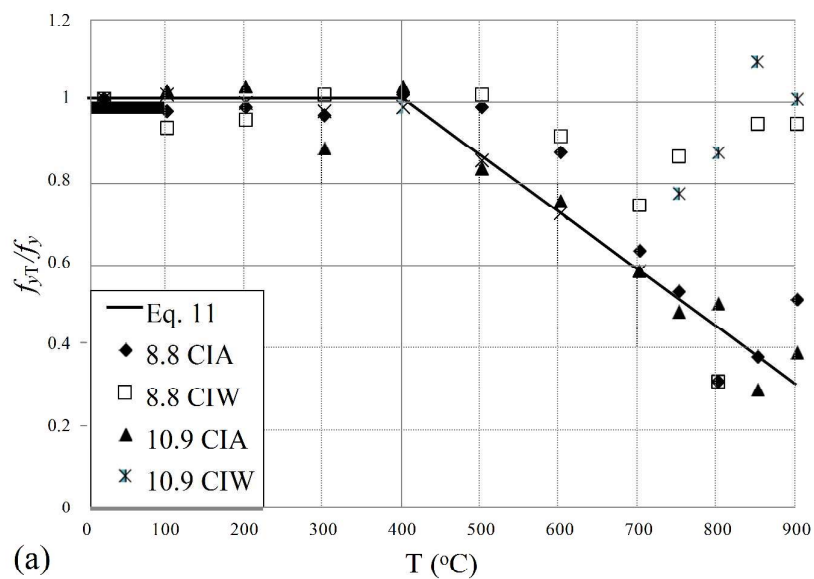
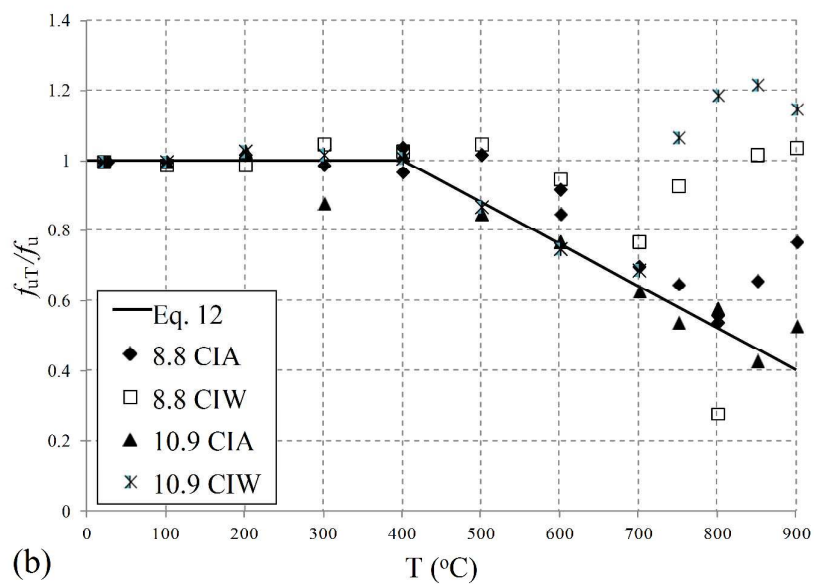
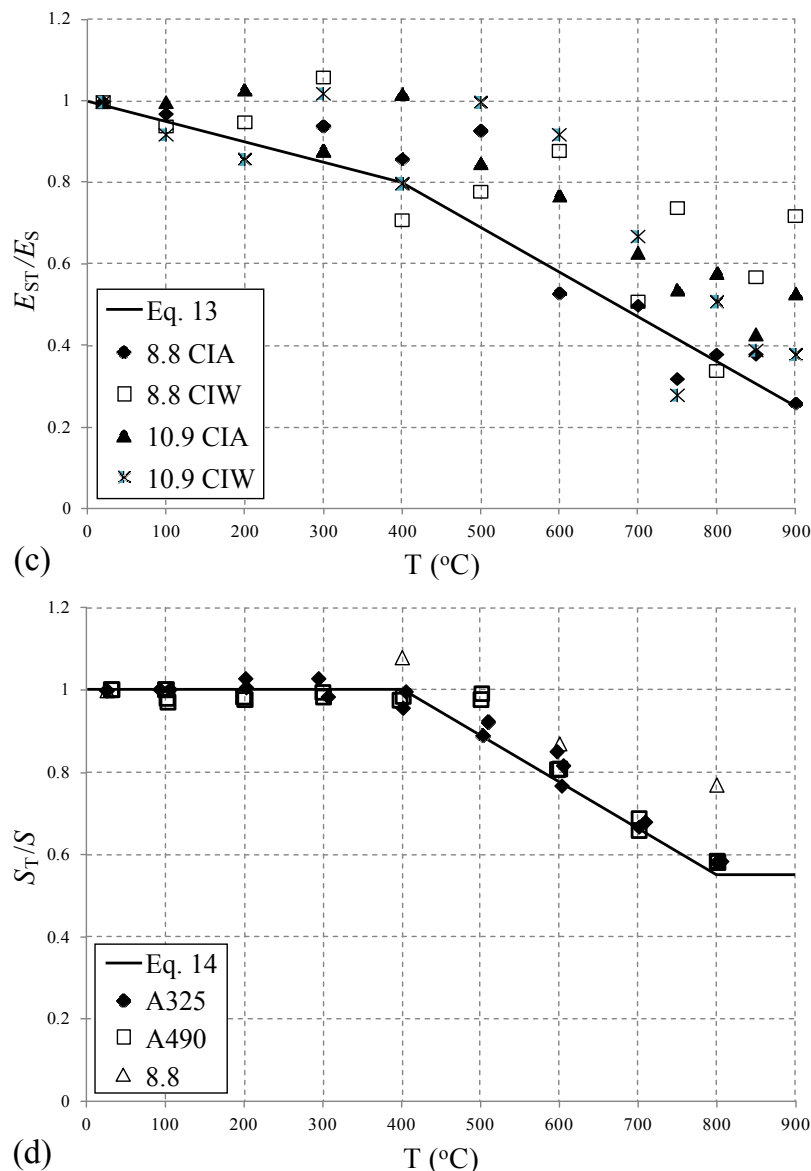
Figure 8. Comparison of predicted residual factors a) f_{yT}/f_y , b) f_{uT}/f_u , c) E_{sT}/E_s and d) S_T/S for high-strength bolts.

The residual factors of a) the yield strength, f_{yT}/f_y , b) the ultimate strength, f_{uT}/f_u , c) the elastic modulus, E_{sT}/E_s , and d) the shear strength, S_T/S , can be obtained from **Fig. 8**. Different bolt qualities (eg. class 8.8 and 10.9) demonstrate similar behavior after the fire event while the mechanical properties' enhancement for the water cooled specimens is easily noticed. The adopted formulas account for the air cooling experimental results, thus the worst case scenario. The proposed Eqs. (11)-(14), which are graphically compared with the test data in **Fig. 8**, indicate that the post-fire

properties remain unaffected for temperatures up to 400°C, whereas the mechanical properties deteriorate from 25-55% of the initial ones for temperatures up to 900°C.

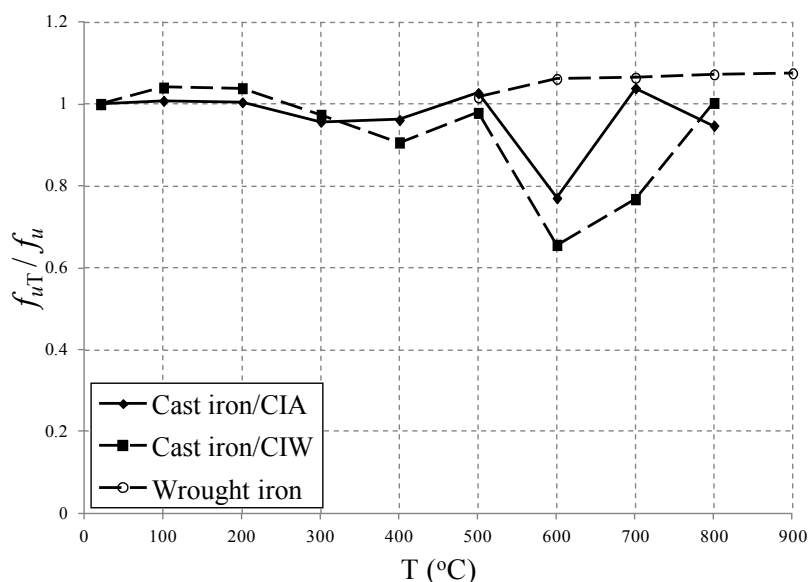
Figure 9. Residual factors f_{uT}/f_u for a) cast iron [14] and b) wrought iron [4].

Wrought and cast iron materials have been widely used in historical structures [14], the preservation of which should be taken into account after fire events. Their post-fire behavior was observed by Kirby et al. [4]. Nevertheless no experimental data is available nowadays, except the recent results conducted by Maraveas et al. [14]. The work conducted in this paper demonstrates the mechanical behavior of cast iron under high temperatures as well as after cooling to ambient temperature. The results indicate deterioration in capacity only for temperatures between 600°C and 700°C. Oppositely, wrought iron demonstrates the same mechanical behavior after cooling from elevated temperatures [4]. The observations above are graphically displayed in **Fig. 9**.
