International Conference on Analytical Models and New Concepts in Concrete and Masonry Structures AMCM'2017

## Seismic behavior of strengthened URM masonry – an overview of research at ZAG

Petra Triller<sup>a</sup>, Miha Tomaževič<sup>a</sup>, Marjana Lutman<sup>a</sup>, Matija Gams<sup>a,\*</sup>

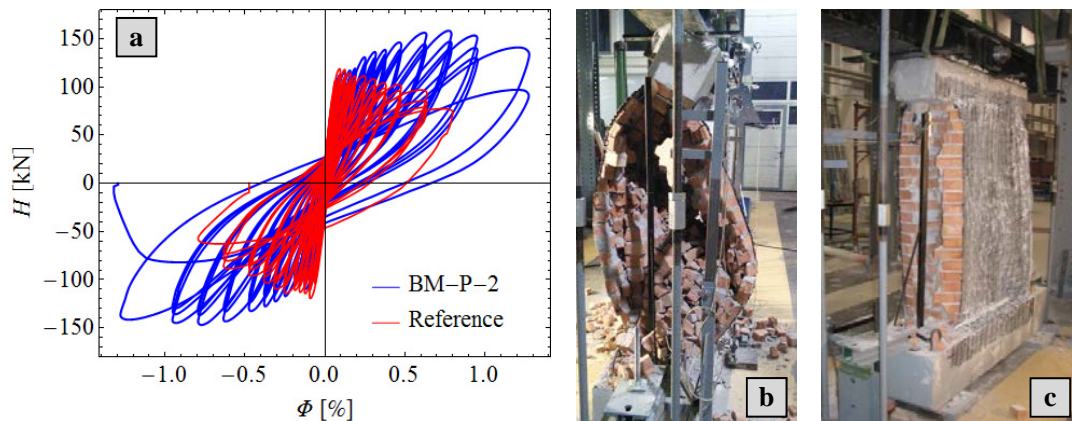
Fig. 8. Hysteretic response of wall strengthened by polymer PM (a), the contact between coating and masonry was not lost even at collapse (b), wide opened crack at the side of the wall during test (c).

The key observations during testing were two: (i) the coating did not lose the contact with the masonry at any time and even at extreme deformations (Figs. 8b and 8c), and (ii) the behavior of the strengthened walls was much better than that of reference walls (Fig 8a). The strengthened walls exhibited higher strength (up to 40 %), almost double energy dissipation and maximum resistance at many times higher displacement (rotation).

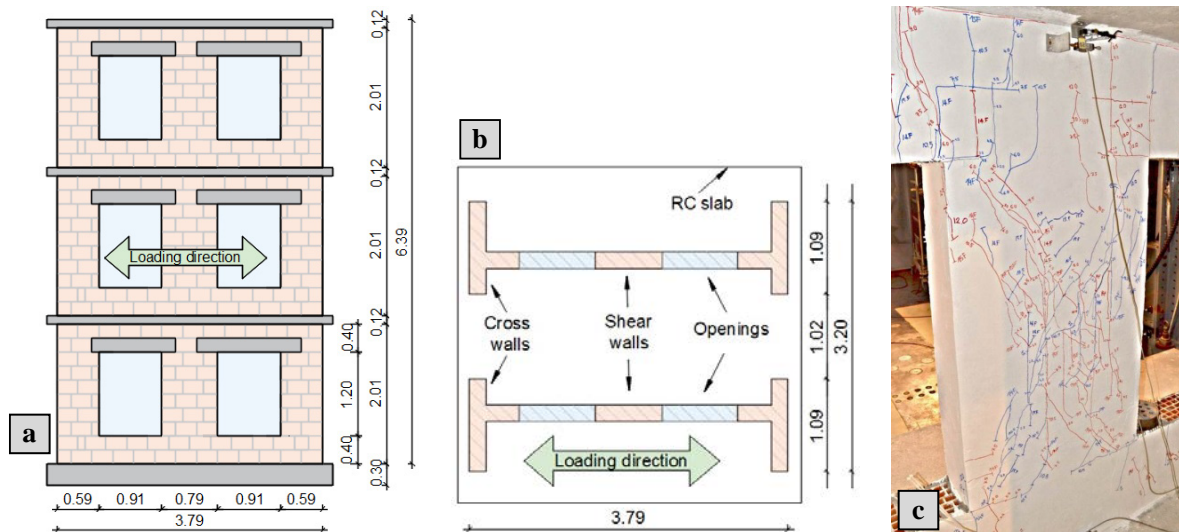
Fig. 9. View of the model (a), floor plan (b) and damage pattern on a pier (c).

The multistorey model was built from hollow clay units (compressive strength 15 MPa) and general purpose mortar (compressive strength 1.8 MPa). The compressive strength of masonry according to EN 1052-1:1998 was 3.8 MPa. The building model was made of two 0.19 m thick three storey shear walls with openings, which were connected to cross walls in order to provide out of plane stability. Floor structures were 12 cm thick reinforced concrete slabs. The model can be seen in Figs. 9a and 9b.

The strengthened model responded in shear and a clear storey mechanism was observed. In the first floor, there was typical diagonal shear crack pattern in the piers (Fig 9c). Some of the cracks appeared also above and below the openings. In the phase when maximum resistance was attained, the delamination of the coating of the middle pier was observed. This test was terminated at the first storey drift of 1.4 %, when large damage appeared and there was fear of actual collapse.
