# Large-scale test as the basis of investigating the fire-resistance of underground RC substructures

Fire disasters occurring in underground structures generally result in severe damage. In order to investigate the fire performance of typical underground structures, a large-scale fire test on a three-span frame structure was carried out. The tested model was loaded both by vertical and horizontal earth pressures. The applied temperature history, representing the time-dependent fire load, was determined by simulations of fire scenarios in the underground structure with the help of the software FDS. The paper contains test results of the temperature of the air in the furnace, the concrete and the steel bars in the structural model, and the state of deformation of the model. Apparent phenomena, such as cracking and spalling, were observed throughout the whole testing process. The results show that a very dangerous situation of the underground structure exposed to fire may occur during the cooling process. Curling of the top slab was observed during the heating process. More attention in fire-resistance design must be paid to the columns. The fire test results are useful for validatio

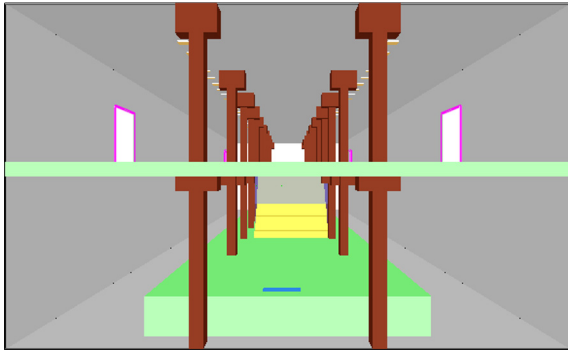
**Fig. 2.** Model of the investigated subway station (perspective drawing obtained from FDS).

Firstly, fire scenarios in underground structures are studied in order to be able to investigate the structural performance in case of fire disasters. The typical “two layers, two columns” subway station, as shown in Fig. 2, is modeled on the basis of the actual topography, as illustrated in Fig. 1, by FDS [11], which is widely used in fire simulations.

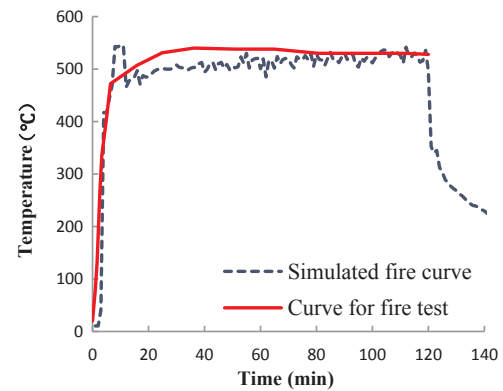
**Fig. 3.** Simulated temperature curve for the investigated subway station.

According to the simulation results from different fire scenarios, the highest temperature of the air was obtained by assuming the fire source in the middle of the platform layer. This was regarded as the most unfavorable fire scenario. The corresponding time-dependent temperature curve, see Fig. 3, was taken as the fire curve for the fire test.

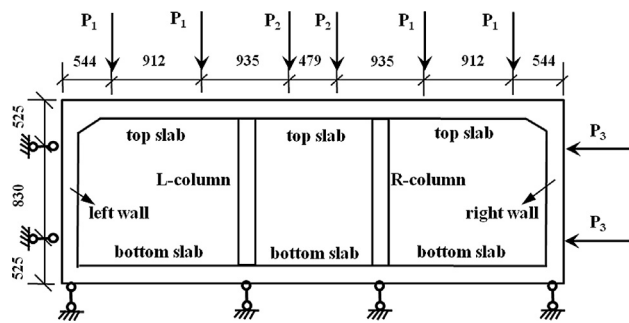
Fig. 6. Loading system.

The aim of the first step is to simulate the mechanical state of the subway station at service conditions. The actual distribution of the pressure loads is rather complicated. Therefore, the external pressures are replaced by three sets of point loads,  $P_1$ ,  $P_2$ , and  $P_3$ , see Fig. 6. The resulting internal stresses are mechanically similar to the ones resulting from the real pressure distribution in the model. The values of the three sets of point loads are listed in Table 4.

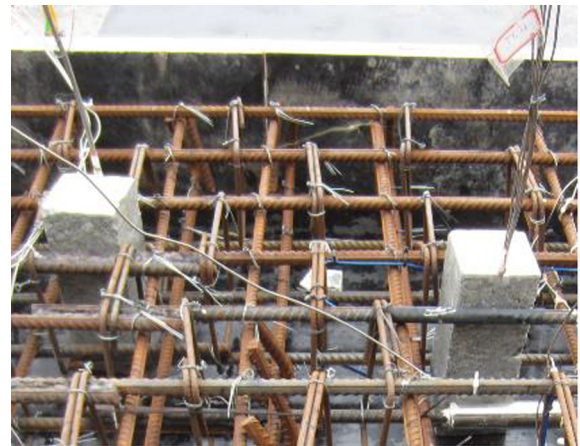
Fig. 10. Precast concrete blocks with thermal couples.

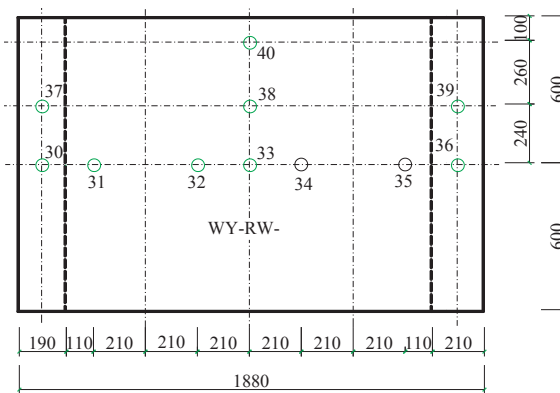
(a) displacement sensors at the top slab

(b) displacement sensors at the right wall

(c) displacement sensors in the vicinity of the corners

Fig. 11. Displacement sensors.

testing process. The test results were automatically collected by an HP data acquisition system and recorded via a R-232 connection line. Considering the symmetry and the deformation characteristics of the model, the displacement sensors were mainly arranged at the top slab and the right wall. There were twenty-nine locations at the top slab (Fig. 11(a)), with nineteen points on the central line to measure the vertical displacement of the top slab in the width direction. Four sensors, designated as WY-F-41, WY-F-42, WY-F-43, and WY-F-44, were placed on the bottom slab, at the same positions as WY-C-1, WY-C-19, WY-C-20, and WY-C-26 on the top slab. Eleven sensors were placed on the right wall, see Fig. 11(b), and five sensors were placed on the left wall, designated as WY-LW-45, WY-LW-46, WY-LW-47, WY-LW-48, and WY-LW-49, at the same positions as WY-RW-30, WY-RW-33, WY-RW-36, WY-RW-37, and WY-RW-39 on the right wall.

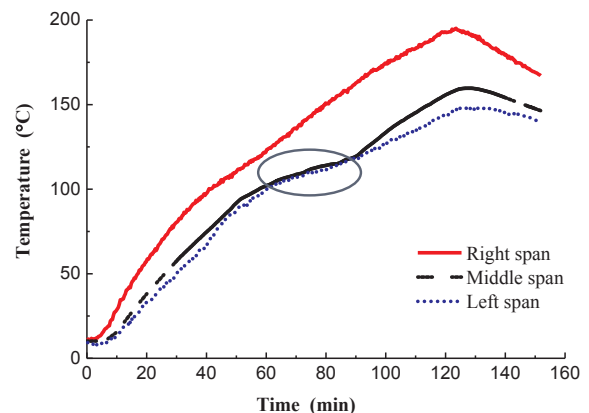
Fig. 15. Temperature evolution at the same depth (30 mm) of the three spans.

The evolution of the temperature at the left span, the middle span, and the right span of the top slab, at the same depth, i.e. 30 mm away from the fire-exposed surface, are compared in Fig. 15.

At the same depth, the temperature in the column increases faster than that in the walls, see Figs. 15–17, since the columns are heated from four sides. The increase of the temperature in the right column after termination of heating, i.e., after 120 mins, see Fig. 17, may be caused by spalling of the column right after the beginning of the cooling process.

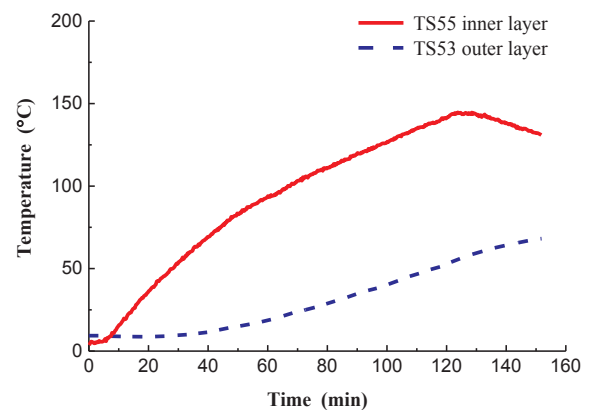
Fig. 19. Temperature evolution in the steel bars of the wall.

Fig. 18 shows the measured temperature evolution in the steel bars of the top slab, including the steel bars of the inner and the outer layers. The steel bars of the inner layer are close to the surface that is exposed to the fire. Fig. 19 refers to the measured temperature evolution in the steel bars in the right wall. Fig. 20 shows the monitored temperature

decrease, see Figs. 18 and 19.

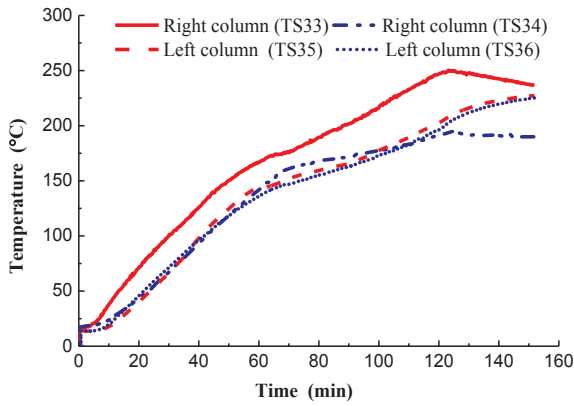
Fig. 20. Temperature evolution in the steel bars of the columns.

During the first 90 mins of heating, the temperature of the steel bars in the right column was nearly the same as the one of the steel bars in the left column. After 90 mins, the temperature recorded by TS33 of the right column increased much faster than the temperature recorded by the other three sensors. After 120 mins of heating, it was nearly 50 °C higher than that of the left column. This can be explained by cracking of concrete before spalling.

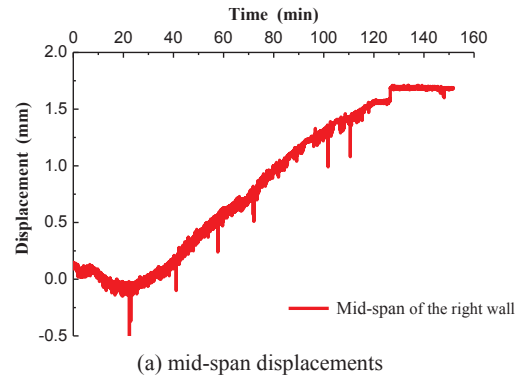
(a) mid-span displacements

(b) displacements along the height

Fig. 22. Displacements of the right wall.

During the loading and heating process, the whole structure experienced a rigid body motion. To account for it, the overall horizontal movement was firstly determined by means of the displacement sensors. It was subtracted from the measured results. Fig. 21 shows the displacements of the three spans of the top slab, and Fig. 22 illustrates the displacements of the right wall.

- (1) In the early period of heating (0–30 mins), when the thermal expansion of the concrete is insignificant and the material properties only begin to degenerate moderately in the heating process, the mid-span displacement of all slabs tends to increase in the loading direction.
- (2) In the later period of the heating (30–120 mins), the mid-span displacements of the three spans of the top slab are only slightly increasing, while that of the right wall is increasing moderately with increasing heating time.
- (3) Spalling occurred 10 mins after the start of cooling. It led to a slight jump in the mid-span displacement curves for both the top slab and the right wall.

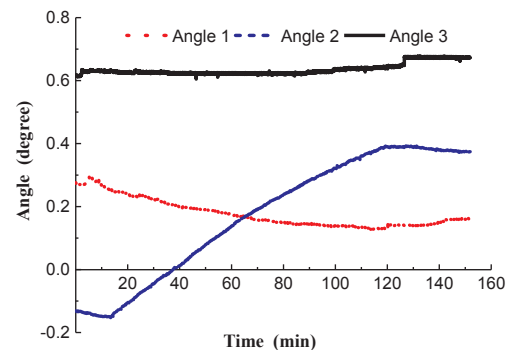
Fig. 23. Rotations of the three monitored corners.

The diagrams in Fig. 23 can be interpreted as follows:

- (1) Angle 1 shows a slight increase at the very beginning of the heating

process and then decreases with heating time due to the thermal expansion. There is a small jump when spalling of concrete occurs and a slight recovery during the cooling process.

- (2) Angle 2 illustrates an increase from a negative to a positive angle after a small decrease at the beginning of the heating time. It is affected by the bending of the top slab and the thermal expansion of the right wall.
- (3) Angle 3 is the rotation of the right-hand corner of the bottom slab. It does not experience a significant change during the heating process. The jump after spalling of the concrete is small.

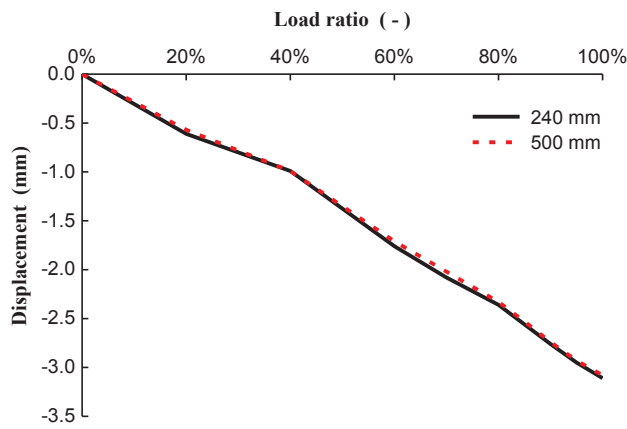
(a) displacements during mechanical loading process

(b) displacements during heating process

Fig. 24. Curling of the top slab.

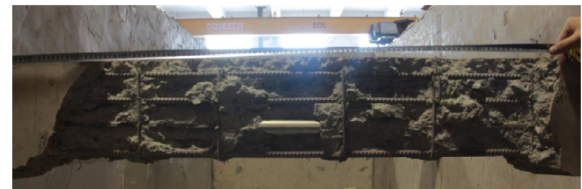
(a) bottom surface of the right column

(b) right surface of the right column

Fig. 25. Spalling of the right column after the fire.

the right column. Spalling occurred at the bottom and the right surface of the right column, see Fig. 25. The concrete cover of these two parts was spalling and the inner reinforcement layers were exposed. The spalling depth was up to 60 mm. Fig. 26 shows the two largest concrete blocks found under the structure in the furnace.

Spalling did not occur at the end of the left column and in the slabs of the structure. This corroborates the conclusion that the weakest location of frame underground structures is the middle part of the columns rather than the vicinity close to its two ends.
