Soil liquefaction in seasonally frozen ground during the 2016 Mw6.6 Akto earthquake

Yuan Yao^{a,b,*}, Jie Chen^b, Tao Li^c, Bo Fu^b, Haoran Wang^b, Yuehua Li^b, Hailiang Jia^d

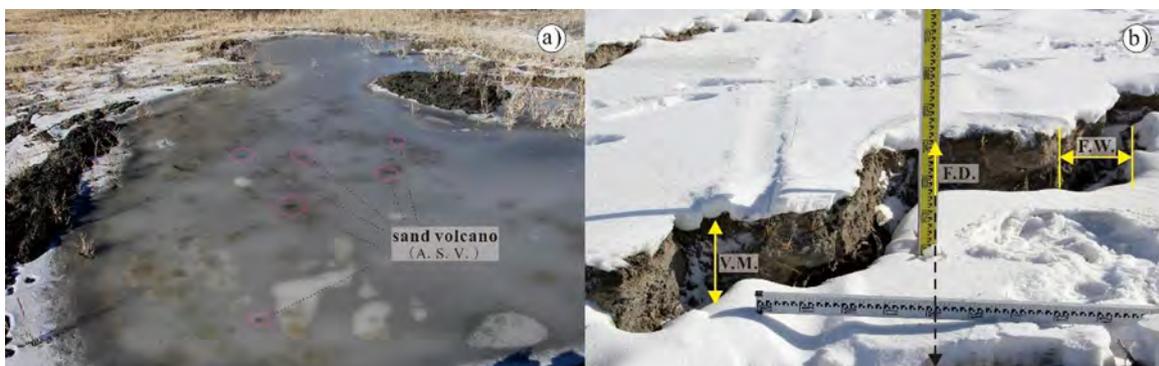
Fig. 7. Schematic diagram of the related measurement parameters. (a) ASV (Table 1). (b) VM, FD, and FW (Table 2).

Site No.: number assigned during field investigation (see Fig. 3a); DSV.: diameter of sand volcano; DS: diameter of spring; FL: fissure length; ASV: amount of sand volcano (There are some small sand volcano, and we have counted it. The characteristic of sand volcano are show in Fig. 7.).

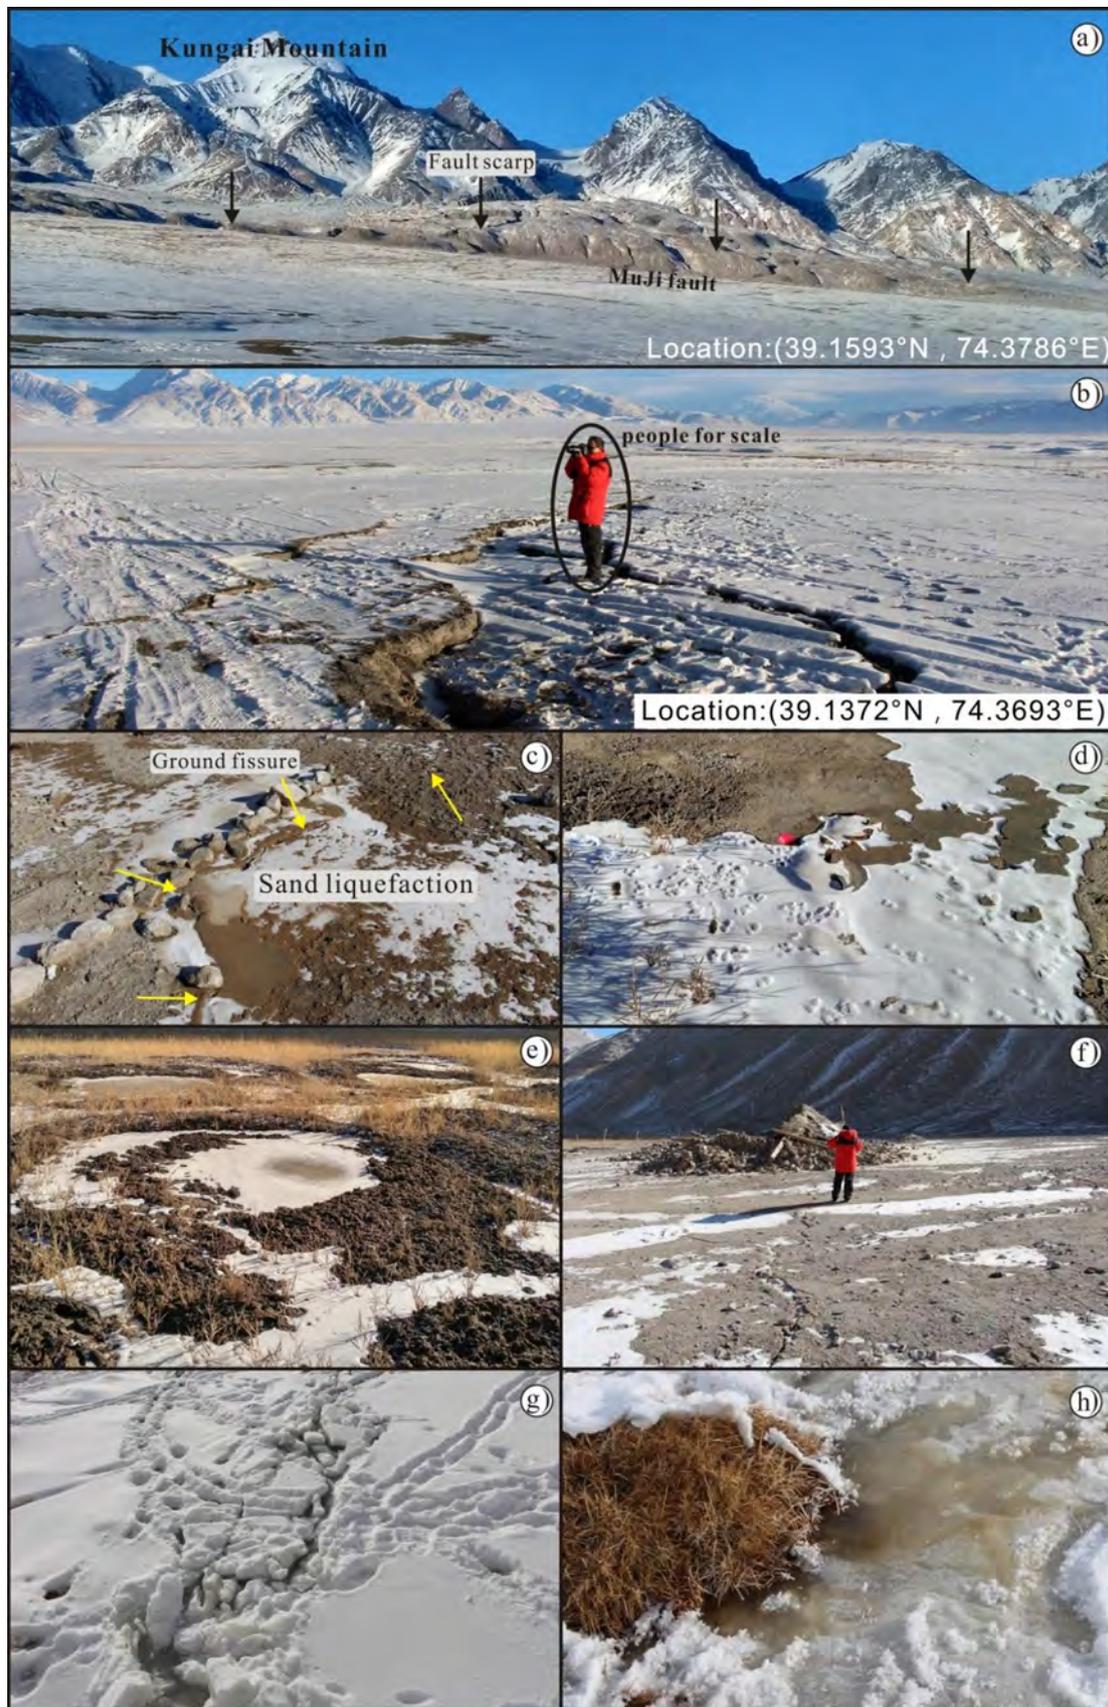
Fig. 10. Field photographs of this earthquake. (a) The fault scarp of the Muji fault. (b) Coseismic ground fissures in the Bulake study area. (c) and (d) Liquefaction originating from ground fissures in the epicenter. (e) The primary spring at the epicenter. (f) Property damage caused by coseismic ground fissures. (g) and (h) Sand liquefaction in the Bulake study area.

Two types of liquefaction occurred in the frozen soil layer during this earthquake (Fig. 8): that which occurred along the original fault (Fig. 10d) and that which formed along the ground fissures (Fig. 10c). The results of our field investigation allowed us to conduct a preliminary analysis of the formation mechanism of these two types of
