# CHAPTER 18

## The Tohickon Aqueduct

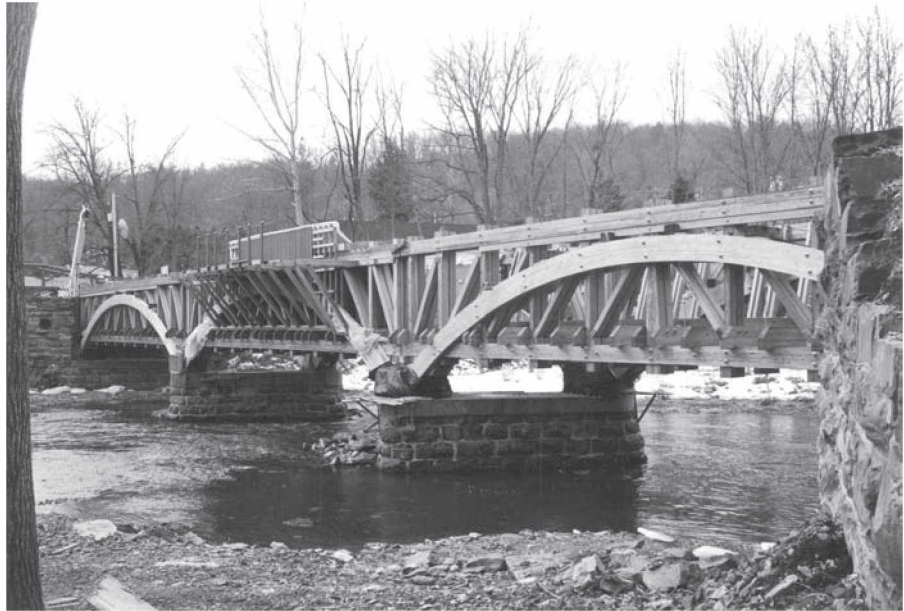
**FIGURE 18-1**  
The aqueduct consists of three equal spans of 66 feet. (See color insert.)

The Burr arch system was designed as a redundant system with either the arch or the truss able to support all loads, independent of the other. The nineteenth-century builders would proportion each and then simply "yoke the two together." In this way, they could circumvent the question of whether the truss stiffens the arch, or the arch stiffens the truss.

In this case, the truss and arch were analyzed separately and then also together. Instead of superimposing the arch on the truss, in the computer we actually suspended the less stiff continuous truss from three two-hinged arch spans. The Burr arch structural system was designed to support a total weight of 8000 plf.

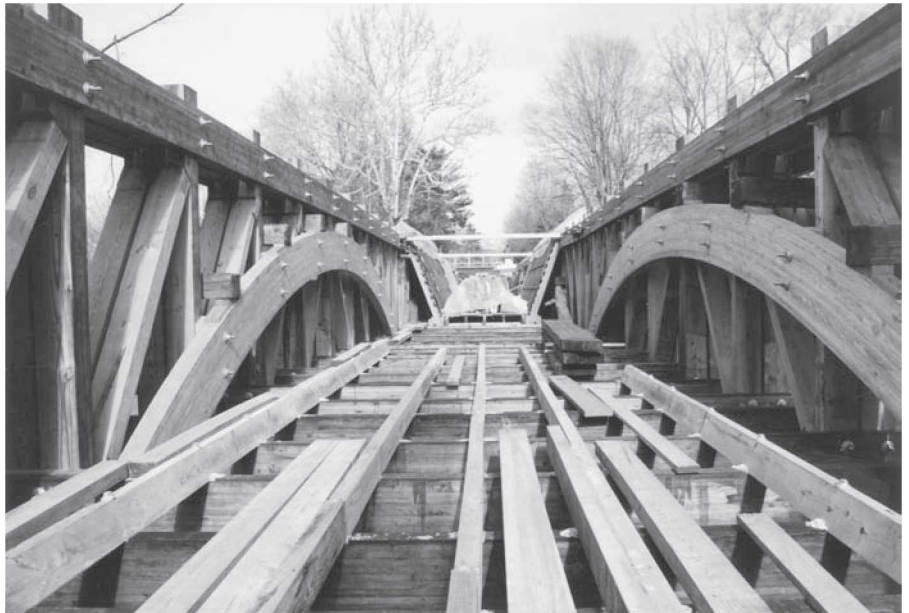
**FIGURE 18-2**  
The arches were replaced through "value engineering" by glued laminated timber.

The structural system was value engineered to reduce costs by simplifying details, remove requirements for traditional timber framer qualifications, and introduce more glued laminated timber into the project, in particular, for the two-hinged arches.

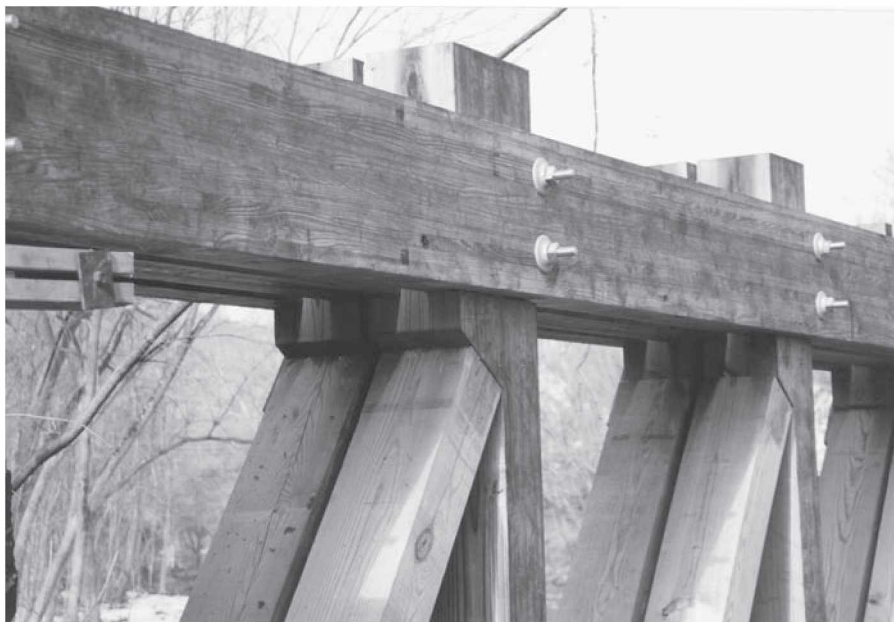
**FIGURE 18-4**  
The chords are  
pressure-treated glued  
laminated timber.

It includes three 66-foot spans with double  $6\frac{3}{4}$  inch by  $23\frac{3}{8}$  inch glued laminated two-hinged arches yoked to a multiple kingpost truss with double  $6\frac{3}{4}$  inch by  $16\frac{1}{2}$  inch and single  $8\frac{3}{4}$  inch by  $16\frac{1}{2}$  inch glued laminated timber chords, top and bottom.

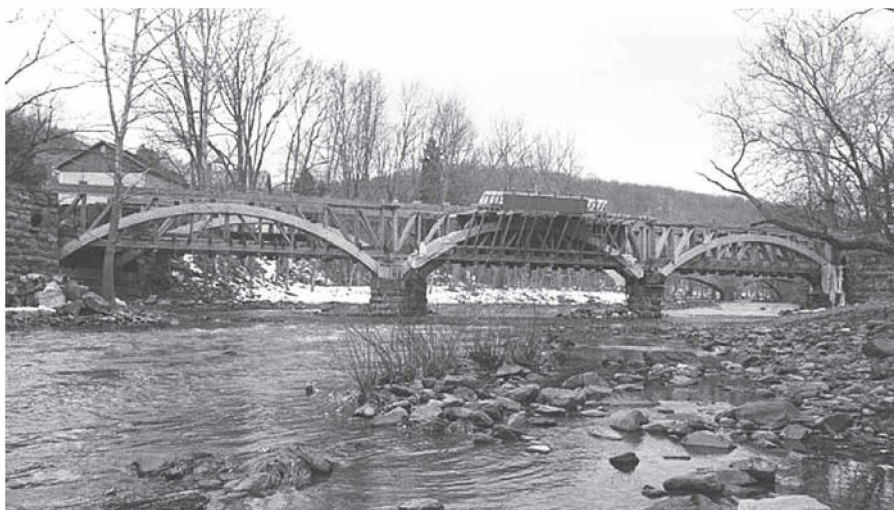
**FIGURE 18-5**  
The superstructure  
was constructed of  
pressure-treated  
southern pine.

Traditional hand-crafted joinery was deleted, including the complicated bolt-o'-lightning splices. The three spans were designed to be individual trussed systems identical in geometry. The use of Pennsylvania red oak was deleted as an alternative and the more easily obtained southern pine was specified.
