# Experimental Study on Steel–Concrete Composite Twin I-Girder Bridges

**Author keywords:** Twin girder bridges; Steel–concrete composite; Experimental study; Theoretical analysis; Intact case.

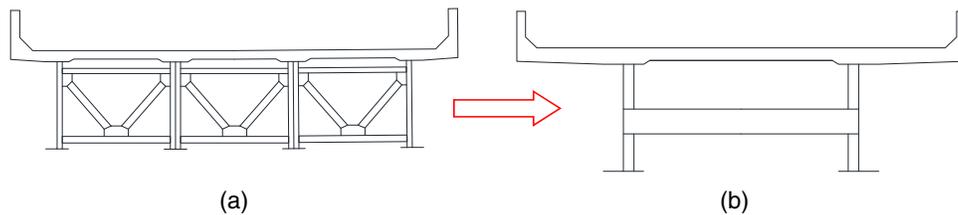
**Fig. 1.** Traditional multi-girder composite section and new structural form of twin girder composite section: (a) multi-girder composite section; and (b) twin girder composite section.

Fig. 1(a), Multigirder bridges, as shown in are one of the most common types of medium-span composite bridge, which can be used for a single span or for continuous multiple spans, and it is particularly effective where construction depth is limited. In multigirder bridges, a number of similarly sized longitudinal plate girders are arranged at uniform spacing across the width of the bridge. The deck slab spans transversely between the longitudinal girders and cantilevers transversely outside the outer girders (Sarraf et al. 2013). The girders are braced together at supports and at some intermediate positions. Composite action between the reinforced concrete deck slab and the longitudinal girders is achieved by means of shear connectors welded on the top flanges of the steel girders. Because twin girder bridges are classified as nonredundant structures according AASHTO (2012) specifications, their construction was rather limited in the US and many other countries. Recently, however, the two-girder steel–concrete composite bridges have been widely used in practice in several other countries, like Japan. In comparison with traditional multigirder bridges, twin girder composite bridges have the following characteristics: the use of prestressed deck and composite deck makes the larger space between the main girders possible; the resistance of the deck for

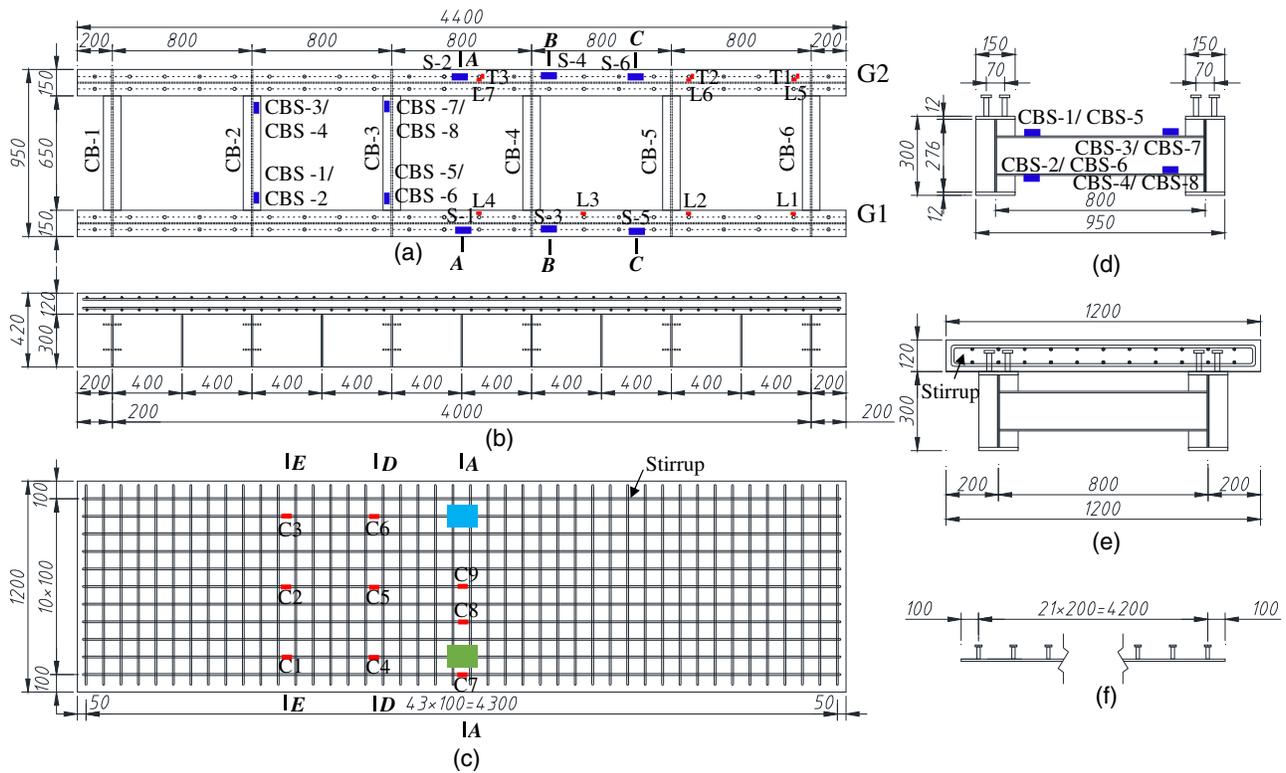
**Fig. 2.** Size dimensions of the connection joint after strengthening (unit: millimeters): (a) plane view of steel girder and shear strain gauge on studs; (b) side elevation; (c) plane view of concrete deck and reinforcement; (d) cross-section of steel girder; (e) composite section; and (f) stud distribution.

specifications (JRA 2012; JSCE 2007). The specimen was designed as 4.4 m in length and was simply supported at a span length of 4 m by considering the available space in the structural laboratory. The width-to-span ratio and depth-to-width ratio were taken to be similar to that of typical composite twin I-girder bridges used in Japan. Two I-girders with a height of 300 mm were used as main girders, and the width of the concrete slab was determined as 1,200 mm. According to bridge design specification in Japan (JRA 2012), the minimum thickness of a concrete slab is 110 mm. To also study the real behavior of studs and avoid possible damage to the slab during transportation, the slab thickness was determined as 120 mm. The influence of the deck thickness on general behavior of such structures was investigated based on numerical analysis (Lam 2017; Lam et al. 2017), and the results clearly indicate that the thickness of the concrete slab as well as the concrete strength have no effect on the global behavior of such structures. Vertical stiffeners were welded at support points and other key sections at an interval of 400 mm to prevent buckling failure and crippling of the web before flexural failure. Six cross beams (CB-1 to CB-6) were also used between the twin main girders for load redistribution. Vertical stiffeners on the web were also appropriately designed and arranged between cross beams. Four rows of shear stud connectors with the diameter of 16 mm were placed with a uniform spacing of 200 mm in the longitudinal direction to ensure the full (or complete) connection between the steel girder and the concrete slab. The theoretical values of yield and ultimate bending moment capacity of the specimen considering the actual yield stress from the material tests were determined as 676 and 886 kN · m, respectively. Size dimensions and design details of the test specimen are shown in Fig. 2.

Six strain gauges were attached on the bottom flange of the steel girder on three key sections (Section A, Section B, and Section C), denoted by S-1 to S-6, as shown in Fig. 2(a). The strain results of the steel bottom flange under both symmetric and asymmetric loadings were measured in the tests and illustrated.

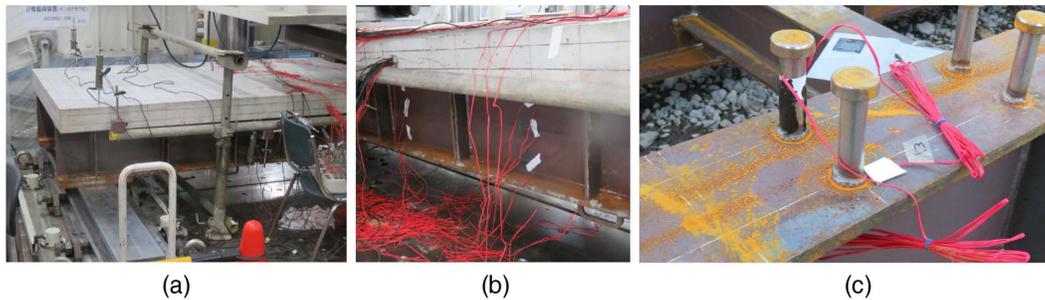
**Fig. 3.** Instrumentation in the loading test: (a) LVDT for displacement; (b) strain gauges on main girder; and (c) strain gauges on stud.

The instrumentation of the loading test is shown in Fig. 3. LVDTs were used to measure the vertical deformation at the span center section and support location at both ends. With the purpose of determining the neutral axis, strain gauges were used to measure the strain in the web, steel flanges, and the reinforcement as well as the concrete slab surface in key sections. In addition, shear strain on stud connectors in both longitudinal and lateral directions were also measured.

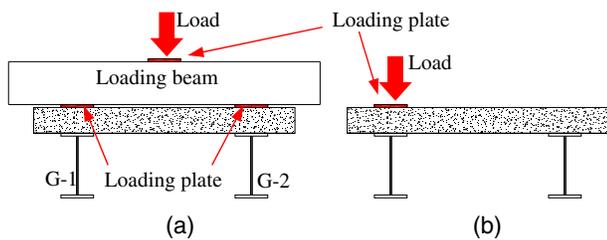
**Fig. 4.** Loading conditions: (a) symmetric load; and (b) asymmetric load.

Fig. 4(b). The load was applied by static loading with unloading process. The loading was terminated when either the maximum stroke of the jack was reached or the load level of the test specimen dropped significantly. In both symmetrical and asymmetrical loading conditions, preloading until 50 kN was applied to check the reliability of the measuring equipment and the stability of the test specimens. The displacement control method was used in the loading process with loading rates of 0.004 mm/s for the preloading and 0.008 mm/s for following loading test. The test specimen was supported by a roller system at two ends. The setup of the specimen in the experiment is shown in Fig. 5.

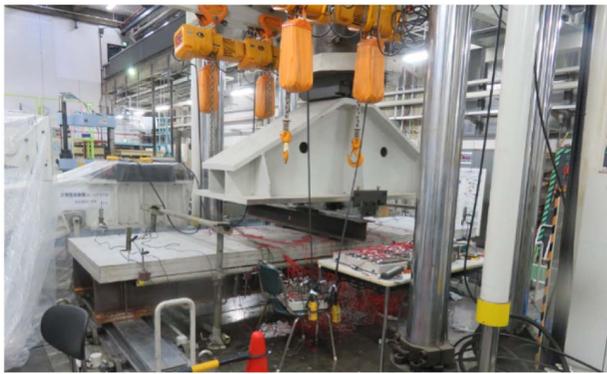
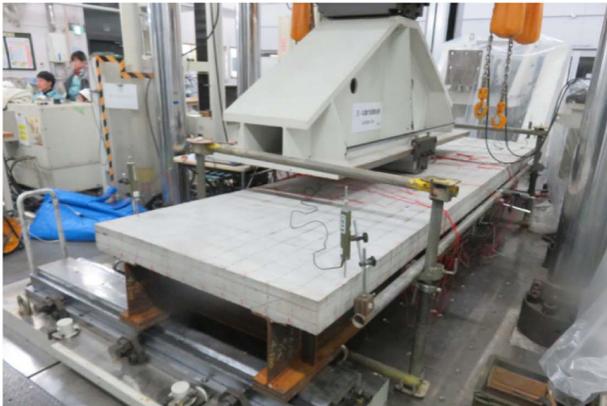
**Fig. 5.** Loading test setup: (a) symmetric load ( $P < 150$  kN); and (b) asymmetric load.

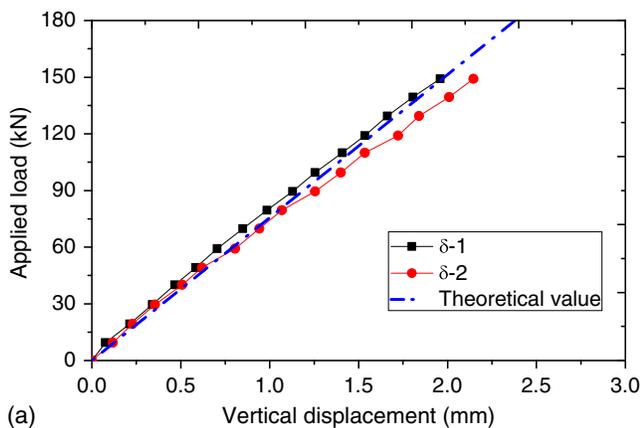
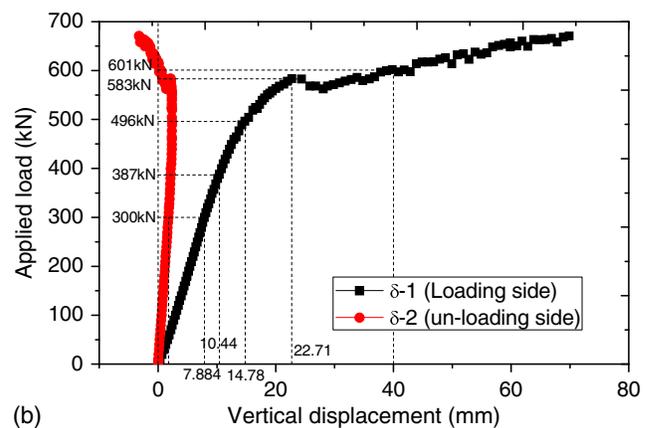
**Fig. 6.** Load–displacement relationships: (a) symmetric load ( $P < 150$  kN); and (b) asymmetric load.

The load–vertical displacement curves of the test specimen under both symmetrical and asymmetrical loading are illustrated in Fig. 6. The displacement was taken at the midspan section of the test specimen. Due to space limitations under the deck, the LVDTs were used on the bottom of the concrete slab but not the bottom of the main girders. The displacements on Girder 1 (G1) and Girder 2 (G2) are referred to as  $\delta-1$  and  $\delta-2$ , respectively. For asymmetrical loading, the load was only applied on G1, as shown in Fig. 4.

When subjected to a symmetrical load, the load–vertical displacement curves are shown in Fig. 6(a). It can be found that both  $\delta-1$  and  $\delta-2$  increase linearly with the increase of the applied load. Though there is a small difference, the displacement of  $\delta-1$  was similar to that of  $\delta-2$ , indicating that identical loads were applied on the two main girders. In addition, the theoretical value of the load–displacement curve of the specimen was also provided. In computing the theoretical value, all the materials were assumed to be elastic and the effective width of the concrete slab was considered to account for the shear lag effects. The effective width of the concrete slab in twin I-girder bridges was determined according to Eq. (1) according to the “Specifications for Highway Bridges” (JRA 2012) in Japan. Full connection was assumed for the steel–concrete interface, and the transformed section method was used to determine the moment of inertia of the composite section. The theoretical values were then determined according to the classic theory for simply supported girders. The comparison indicates that the theoretical results determined according to current elastic design theory agree well with the test results, demonstrating the twin I-girder bridges can be designed appropriately on the basis of the current bridge design method

When subjected to an asymmetric load, the load–vertical displacement relationships are shown in Fig. 6(b). In the initial loading stage, both  $\delta$ -1 and  $\delta$ -2 increase linearly with the load increases. However,  $\delta$ -1 was much larger than  $\delta$ -2, caused by the asymmetrical load applied on the side of G1. Taking the applied load of 300 kN as an example, the corresponding displacement at G1 (7.884 mm) was nearly 4.5 times the displacement at G2 (1.764 mm), thus G2 carries around 18.3% [= 1.764/(1.764 + 7.884)] of the load carried by the main girders. The results indicate that before crush or cracking, the concrete slab is capable of transferring a certain level of applied load from G1 to G2, but not zero as can be predicted according to the lever principle.

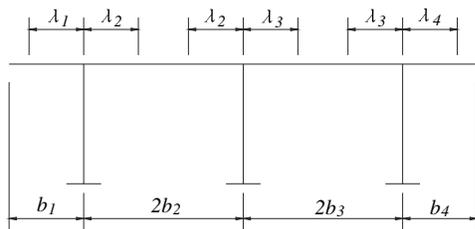
Fig. 7. Effective width of flange.

where  $\lambda$  = half effective width of flange (mm);  $b$  = half spacing between webs or projection width of cantilever portion (mm) (Fig. 7); and  $l$  = equivalent span length (mm).

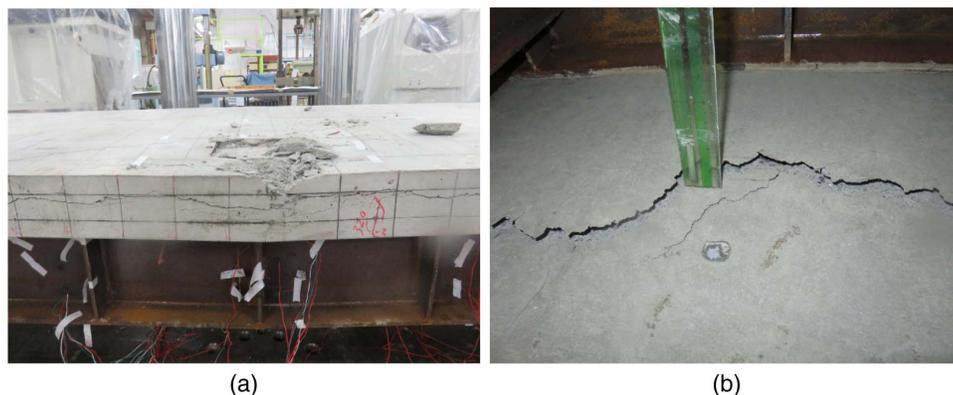
Fig. 8. Failure mode of the test specimen: (a) top view; and (b) bottom view of the concrete slab.

In general, the functional limit state of a structure can be determined as the maximum vertical deflection of the superstructure reaching a value equal to the span length divided by 100 (40 mm for the specimen used in this study) (Lin et al. 2013). In this study, however, vertical displacement of G1 had been loaded to nearly 70 mm and no sudden failure was observed. In this study, the failure mode of the specimen can be concluded as the local failure of the concrete slab at the loading point due to concrete crushing, the cracking (top surface) and the stripping of the concrete slab (bottom surface) due to the torsion, and lateral bending (bending moment perpendicular to the bridge axis) caused by the eccentric loading, as shown in Fig. 8.

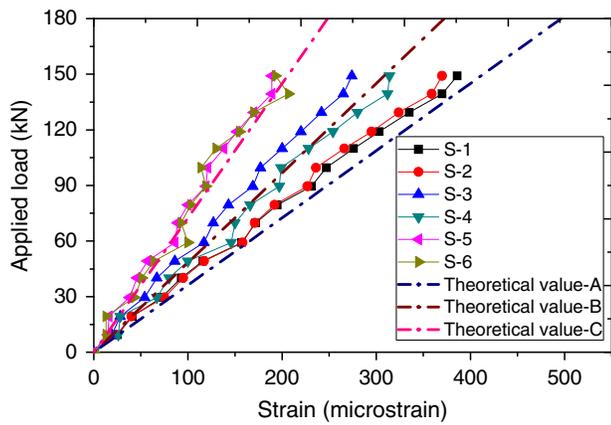
Fig. 9. Strain on bottom flange (symmetric load).

When the specimen was subjected to symmetric loading, the strain on the steel girder was as shown in Fig. 9. The corresponding theoretical relationships between the applied load and the strain on the basis of the elastic theory at Section A, Section B, and Section C (denoted as Theoretical value-A, Theoretical value-B, and Theoretical value-C, respectively) are also provided. Both strains on G1 and G2 increase linearly with the increase of the load, and the strains on G1 were similar to those on G2. Also, the comparison shows that the theoretical results agree well with the measured results in all three sections, indicating the applicability of elastic design theory in designing such bridges.

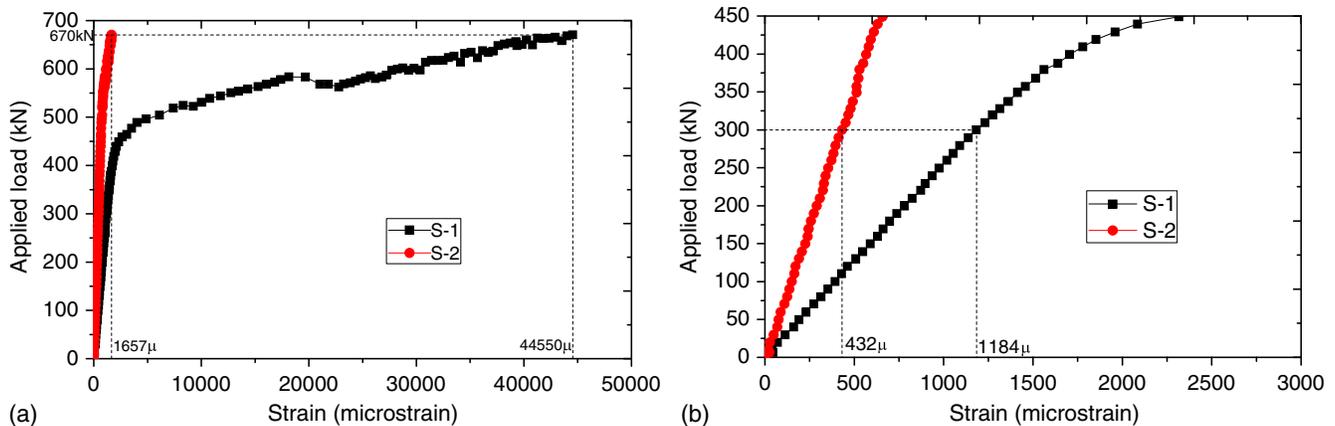
Fig. 10. Strain on bottom flange (asymmetric load): (a) whole loading stage; and (b) initial loading stage.

When the specimen was subjected to asymmetric loading, the strain on the bottom flange of the steel girder in the midspan section was as shown in Fig. 10. In the initial loading stage, both strains on G1 and G2 increased linearly as the load increased, as shown in Fig. 10(b). However, the strain on G1 was much larger than that on G2, which was due to the different vertical displacement as discussed in the previous section. Taking the applied load of 300 kN as an example, the corresponding strain on G1 (1,184 microstrains) was nearly 2.75 times of that on G2, indicating that G1 carries

nearly 73% of the load on the main girders. In the plastic stage ( $P \geq 387$  kN), however, this ratio becomes smaller and smaller with the load increase. Due to the local crush and cracking of the concrete slab, the load transmission capacity between two main girders becomes less and less. Different from the displacement reduction confirmed in Fig. 6(b), strain reduction on G2 was not confirmed. This is presumably because of the torsional deformation of the girder caused by the eccentric loading.

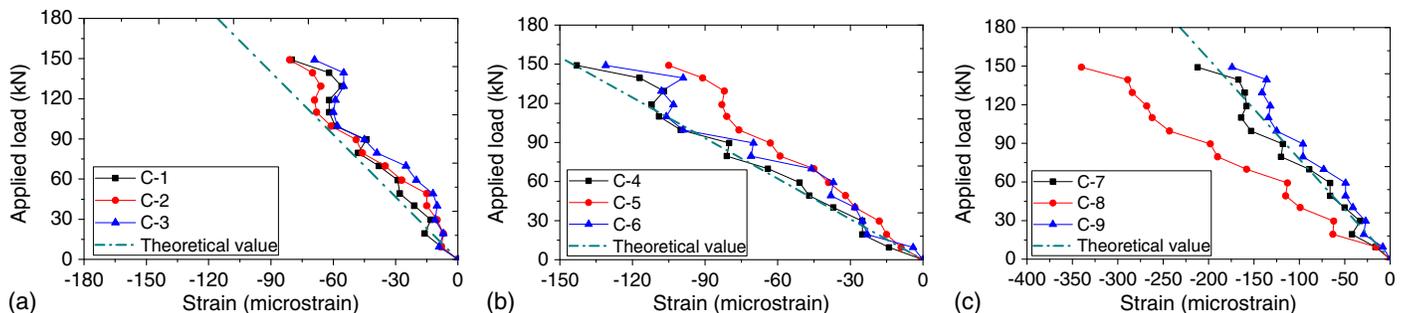
Fig. 11. Normal strain on top surface of the concrete slab (symmetric load): (a) Section A; (b) Section D; and (c) Section E.

When two symmetric loads were applied, the normal strain on the top surface of the concrete slab was as shown in Fig. 11. The corresponding theoretical values of the normal strain according to elastic theory were also determined and are provided. The results indicate that the normal strain on the concrete increased linearly with the increase of the applied load. For Sections A and B, the normal strains on the right top of the main girders (C1, C3, C4, and C6) are close to the strain on the middle top of the cross section (C2 and C5), indicating the negligible shear lag effect of the concrete slab under symmetric loads. This is also confirmed the effective width calculation for the concrete slab. According to Eq. (1), the effective width of the concrete slab is determined to be 1.12 m, which is very close to the actual width of the slab

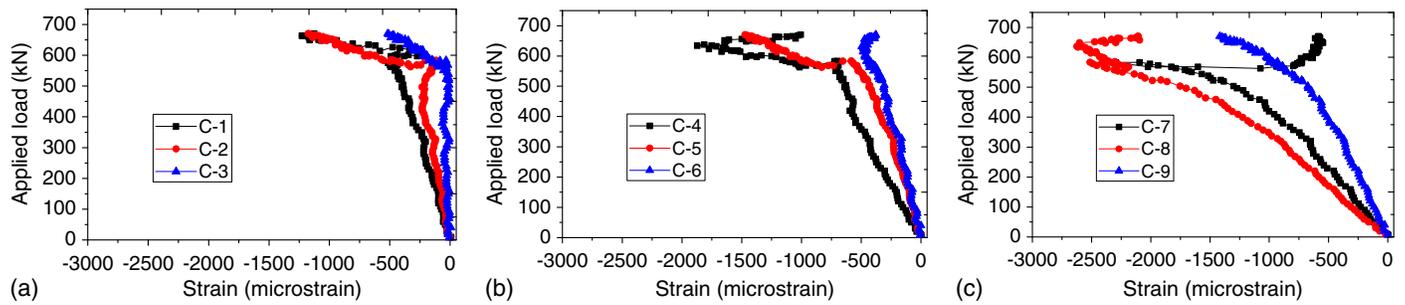
**Fig. 12.** Normal strain on top surface of the concrete slab (asymmetric load): (a) Section A; (b) Section D; and (c) Section E.

When the applied load changes to asymmetric loading, the strain on the top surface of the concrete slab at all measured sections (Section A, Section D, and Section E) was as shown in Fig. 12. In the initial loading stage ( $P \leq 300$  kN), normal strains on all three sections increased linearly as the load increases, as shown in Fig. 12(b). After that, the strain kept increasing until the load increased to 583 kN, when the local failure of the concrete slab and sudden drop of the applied load was observed. As a result, decreasing of the normal strain was observed at C1, C4, C7, and C8. The strain at C1 and C4 kept decreasing even after the rebound of the applied load, indicating the local failure of at the loading point. Also, as the normal strains of C7 and C8 were still smaller than the ultimate strain of concrete [ $-3,500 \mu$  according to JSCE (2012)], the failure of the concrete was due to the combined effects of the vertical compression and longitudinal compression caused by the applied load and bending moment. For strain gauges at other locations of the concrete slab, the strain of the concrete kept increasing with the increase of the applied load, indicating that the concrete slab remains effective in carrying and distributing the applied load to a certain extent until the ultimate load.

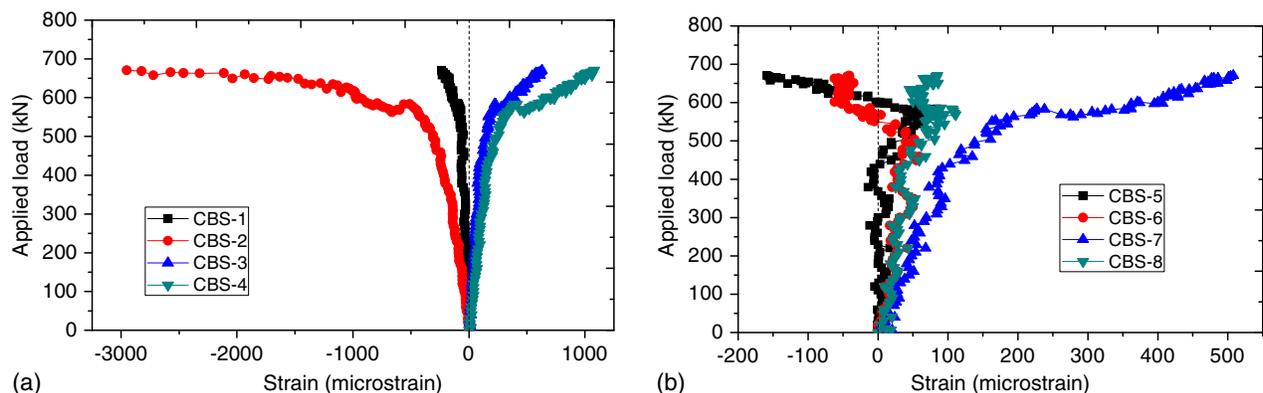
**Fig. 13.** Normal strain on cross beams: (a) CB-2; and (b) CB-3.

The load–flexural strain results of two cross beams are shown in Fig. 13. As the flexural strain keeps increasing with the increase of the load, the cross beams in twin girder bridges are functional. Also, it was found that the further the cross beam was located from the loading point, the larger the strain that can be confirmed. The deformation of cross beams may consist of vertical deformation, longitudinal deformation, and twist deformation. Because the vertical deformation decreases with the distance from the cross beams to loading point, the strain was mainly caused by the lateral deformation of the beam. Another interesting phenomenon is that the flexural strain on both top and bottom flanges in cross beams have the same sign conversion, indicating that they are in either tension or compression simultaneously. If the cross beams are mainly subjected to vertical forces (shear or bending), the flexural strain on top and bottom flanges should have equal (or similar) strain values with different sign conversion. When subjected to asymmetrical loading, however, lateral bending (bending moment perpendicular to the cross-beam axis) and the torsional moment will occur in cross beams due to the relative deformation between the two main girders, which might be the major cause for this phenomenon. This is not going to happen if the cross beams are mainly subjected to vertical bending. Therefore, in comparison with the load-carrying capacity for vertical bending, the cross beams are more functional for sustaining the lateral bending (bending moment perpendicular to the cross-beam axis) and the torsional moment.

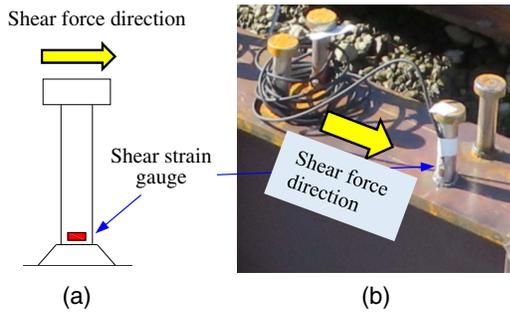
**Fig. 14.** Shear strain gauge on shear stud: (a) shear strain gauge location; and (b) stud in the test specimen.

studies were generated and analyzed from push-out tests. The specimens were short and had a limited number of shear connectors, and the tests were essentially pure shear tests (Yen et al. 1997). Also, flexural strain was mostly measured instead of shear strain, in view of studies performed by Lin et al. (2014). In actual twin I-girder structures, the composite girder is subjected to bending moment and transverse shear forces, and the specimens contain many more shear connectors. Based on this background, the shear strain at the foot of the studs was measured in the loading tests, as shown in Fig. 14. There were 10 shear strain gauges in the test specimen, as shown in Fig. 2(a). Shear strain gauges L1–L4 were used to measure the shear strain of studs in longitudinal direction on G1, while L5–L7 were used to measure that of studs on G2. Also, in order to confirm the shear strain of a stud in the transverse direction, another three strain gauges (T1–T3) were attached on studs in G2.

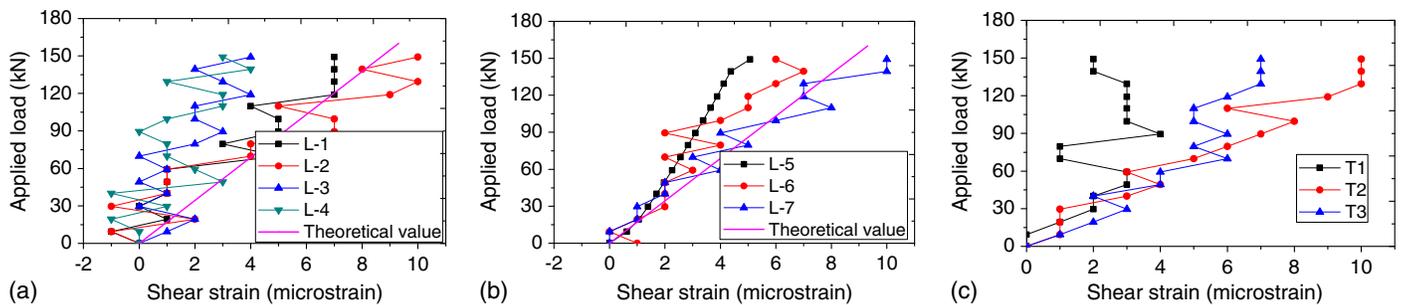
**Fig. 15.** Longitudinal and transverse shear strain on shear studs (symmetric load): (a) longitudinal shear strain, G1; (b) longitudinal shear strain, G2; and (c) transverse shear strain, G2.

Shear strain results of studs in the loading tests subjected to symmetric load are shown in Fig. 15. Also, the theoretical prediction of the longitudinal shear strain at the measured location based on elastic theory is provided. Complete connection was assumed on the steel–concrete interface, which means the slip on the interface was not considered. The theoretical value of longitudinal shear strain was determined by using the following equation:

The longitudinal shear strain of studs on G1 and G2 are shown in Fig. 15. A zigzag increase of shear strain on studs was observed, which might be caused by shear force transmission at the initial loading stage. Theoretically speaking, the shear strain at different sections should be the same due to the same shear forces under symmetric loading applied at the midspan. However, the strain results in Figs. 15(a and b) indicate that the shear strain on studs near the quarter-span was larger than those on studs near the girder end section or midspan section, which was similar to the results observed in previous tests (Lin et al. 2014), and the fraction forces on the interface caused by reaction forces at the supports and the applied loads are considered as the main reasons. In addition, the comparison indicates that the theoretical results agree well with the results of the measured shear strain at L1 and L2, but slightly larger than the results at L3 and L4. Therefore, it can be confirmed that the slip on the steel–concrete interface can be ignored at the elastic stage, and full shear connection can be used for designing the twin I-girder bridges with full connection. On the other hand, the results in Fig. 15(c) indicate that the shear strain of studs in the lateral direction has a similar increasing trend as that in the longitudinal direction as shown in Figs. 15(a and b).

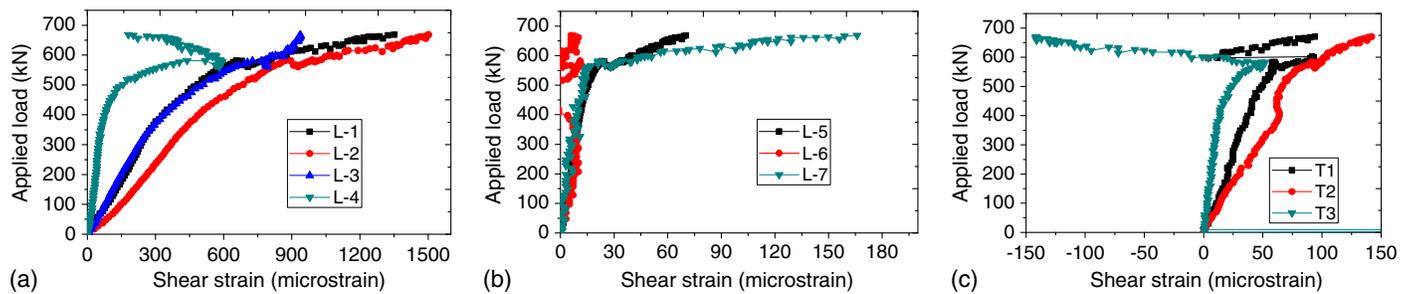
**Fig. 16.** Longitudinal and transverse shear strain on shear studs (asymmetric load): (a) longitudinal shear strain, G1; (b) longitudinal shear strain, G2; and (c) transverse shear strain, G2.

When subjected to an asymmetric load, the shear strain increase on studs versus applied load relationship was as shown in Fig. 16. The results in Fig. 16(a) show that shear strains on all measured studs increased linearly with increase of the applied load at the linear stage. After that, shear strains increased significantly as the applied load increased, which might be caused by two reasons: upward movement of the neutral axis and breaking of the bonding on the interface. After the yielding of the bottom flange, the neutral axis on G1 moved from the elastic neutral axis (in the web of the steel girder) to the steel–concrete interface, which caused the higher shear force transmission on the interface. On the other hand, the failure of the chemical bond or friction on the steel–concrete interface caused the shear force transmission from the chemical bond to the stud shear connectors. In addition, the comparison of the shear strain on different studs on G1 indicates a similar conclusion as that observed in Fig. 15, that the maximum shear strain is more likely to occur on studs near the quarter-span. Approximately equal shear strain according to the constant shear force distribution was not confirmed at the measured studs on G1. The shear strains on studs near the girder end and near the midspan are likely to be smaller, which might be caused by the friction forces on the interface due to the reaction force and the applied load at the girder end and midspan, respectively. The shear strain shown in Fig. 16(a) indicates that the shear studs on G2 undertake very small shear force under the concrete crush, indicating that little shear force

was transmitted from G1 to G2. When the applied load increased to 583 kN (local crush of concrete), significant shear strain increase was observed on L5 and L7, but little increase was observed in L6. However, all the shear strains are relatively smaller than those observed in studs on G1. It can be concluded that for an asymmetric load applied right top of the one main girder, the shear force transmission on the other main girder (unloaded girder) can be ignored. Fig. 16(c) shows the transverse shear strain at the foot of studs on G2. It can be seen that the transverse shear strain of shear studs on G2 was much larger than their longitudinal shear strains in both the elastic and plastic stages. Therefore, the results clearly indicate that the combination of shear strains at both longitudinal and transverse directions should be considered in the design of studs in twin I-girder steel–concrete composite bridges.
