# Experimental study on the cyclic behavior of reinforced concrete bridge piers with non-uniform corrosion

Coastal bridge  
Non-uniform corrosion  
Cyclic load test  
Seismic performance  
Plastic hinge

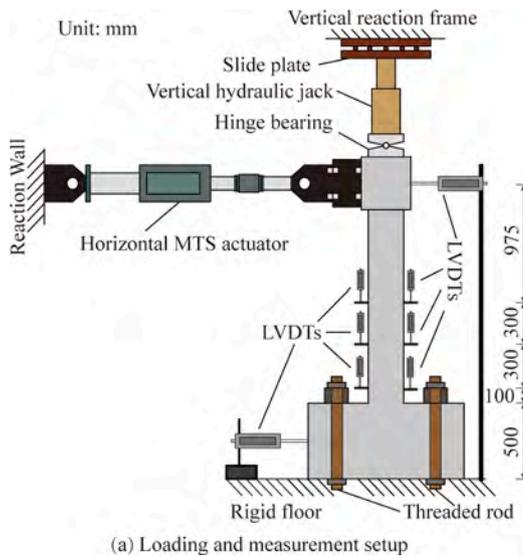
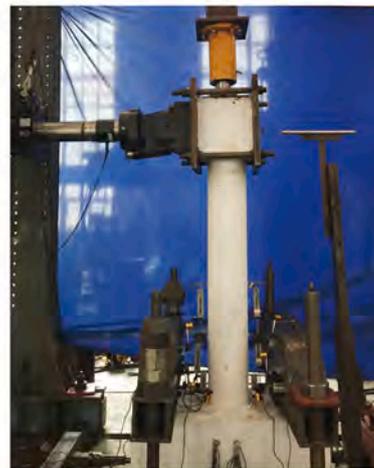
Fig. 4. Experimental setup.

(a) Loading and measurement setup

(b) Actual test model

Fig. 4 shows the experimental setup of loading test. As shown in Fig. 4, the foundation of the test model was anchored to the rigid floor by four threaded rods. During the experiment, all the test models were loaded under a constant axial compression and a cyclic lateral displacement with increasing amplitude. The constant vertical axial load applied by the hydraulic jack was 310 kN and the corresponding axial compression ratio was 0.2. The unilateral cyclic displacement loads were applied by a horizontal MTS actuator and increased by 4 mm at each loading level as shown in Fig. 5. The experiment was stopped when the lateral resistance force dropped to less than 85% of the peak load.

As shown in Fig. 4(a), two LVDTs were used to directly capture the lateral displacement at the top and bottom of the pier models. Meanwhile, the two LVDTs can be also used to check the actual displacement output by the actuator and the slip between the pier foundation and the rigid floor. Moreover, to observe the transfer of plastic hinge, the curvature of the section of the pier bottom and the end sections of the corrosion zone were measured by installing three pairs of LVDTs at the heights of 100 mm, 400 mm and 700 mm above the pier bottom.
