This study aims to gain insight into the behavior of the Fujinuma dam during the time of the earthquake by using the FE method. Both the observed motion and the simulated motion are used to determine the response of the dam during the excitation. The soil behavior of the dam materials is described by using the Mohr–Coulomb soil model available in the Plaxis FE code [25]. Dynamic analyses of the model are conducted, and the overall dam behaviors presented. Discussions and comparisons between the simulation results and existing facts are expressed.

2.1. Fujinuma dam

The Fujinuma dam was an earth-fill embankment dam near Sukagawa, Fukushima prefecture, Japan. It was established on the Ebana River, a tributary of the Abukuma River, 16 km west of the city office of Sukagawa (37°18'07"N, 140°11'41"E). The dam construction began in 1937 and it was completed in 1949 after construction was halted during World War II. The primary purpose of the dam was water supply for irrigation. The cross section of the main dam and its layout is shown in Figs. 2 and 3. The dam was an embankment type, 18.5 m high and 133 m long with a structural volume of 99,000 m³ and a crest width of 6 m. On the upstre

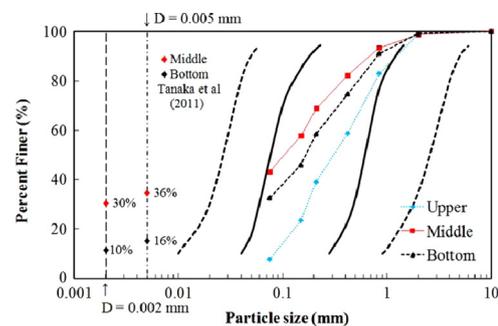
Fig. 6. Particle size distribution.

2.3.2.1. Sieve analysis. Sieve analysis is a practice or procedure used to assess the particle size distribution of a granular material. In this study, due to the unavailability of the laboratory instrument at the time of study, the small particles analyses using a hydrometer were not conducted and the sieve number was in the range of 4–200. However, the information on the distribution of small particles was obtained from the study of Tanaka et al. [24]. The results show that both the middle and bottom layers consist of a high percentage of fine particle sizes (Fig. 6). It can be seen that for particles smaller than $5\ \mu\text{m}$, the middle and bottom soil samples are found to be about 36% and 16% respectively. Also, the clay content (particles smaller than $2\ \mu\text{m}$) of the middle and bottom portions is about 30% and 10%, respectively. Whilst, the upper part is consist mainly of sandy materials. The boundaries for potentially liquefiable soil (b–b) and boundaries for most liquefiable soil (a–a) are shown in Fig. 6 [30,31]. Generally, to judge the liquefiability of soil, more than one criterion is needed.

For clayey soils, Seed and Idriss [32] stated that these soils could be susceptible to liquefaction only when all of these three conditions are met: 1) the soil that contained less than 15% of $5\ \mu\text{m}$ and finer particles, 2) liquid limit is less than 35 and 3) water content/liquid limit is greater than 0.9. Similarly, Andrews and Martin [33] summarized that soils are susceptible to liquefaction if they contain less than 10% finer than $2\ \mu\text{m}$ and liquid limit less than 32, soils are not susceptible to liquefaction if they contain greater or equal to 10% finer than $2\ \mu\text{m}$ and liquid limit greater or equal to 32, and further study is required for soils that meet one, but not both, of these criteria. According to the Seed and Idriss [32] criteria's first condition, both the middle and bottom parts are not met so the soils are not being vulnerable to liquefaction. Also, by considering Andrews and Martin [33], both the middle and bottom are not susceptible to liquefaction. However, further study should be conducted in order to obtain more accurate results including liquid limit.

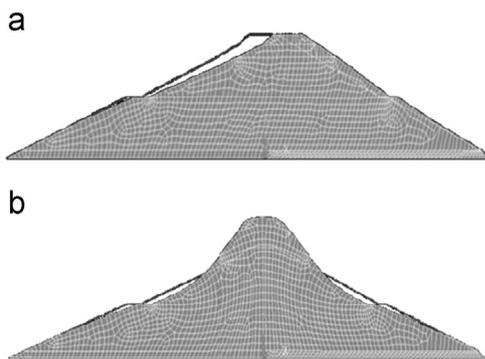
Fig. 10. Natural frequency. (a) 1st mode: 1.64 Hz (horizontal direction). (b) 2nd mode: 2.45 Hz (vertical direction).

Modal analysis is conducted to extract the natural frequency and its corresponding mode shape. In this study, two dam models were analyzed. Both cases were analyzed under the empty reservoir condition. In Fig. 10, the results of the modal analysis are shown. The natural frequency is 1.64 and 2.45 Hz for the first two modes, respectively. For the remaining dam model, the natural frequency is 2.35 Hz for the translational mode in the horizontal direction.

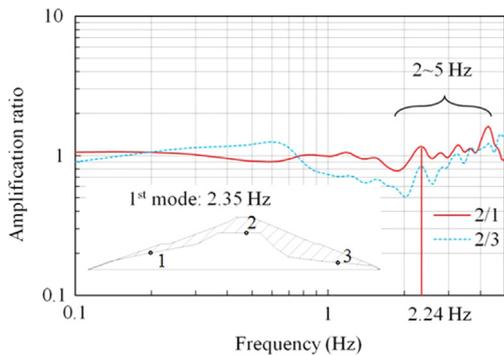
Fig. 11. Amplification ratio.

Fig. 11 shows the amplification ratio that was taken from the top of the remaining dam to two locations near the dam base of the upstream and downstream slopes, defined as 2/1 and 2/3, respectively. By comparing the numerical results with microtremor test results, it can be seen that in the latitudinal direction, the amplification ratio is within the range of 2–5 Hz. The results obtained from the modal analysis of the remaining dam agree well with field observations in relation to the vibration in the latitudinal direction. Therefore, the estimated predominant frequencies of the original dam are 1.64 and 2.45 Hz. The comparison

between the natural frequency of the remains dam obtained from the microtremor observation and the modal analysis of the original dam model shows that the natural frequency of the actual dam model is less than the microtremor test. This is due to the geometry of the original dam in which the dam's height is higher while the remains dam is plump in shape. It should be noted also that as the soils possibly subject to the large strain at the time of the dam failure that may cause degraded values of the shear modulus. As a result, the natural frequency of both microtremor test of the remains dam and the modal analysis result of the actual dam model may be different from the current results if the actual material properties can be acquired.

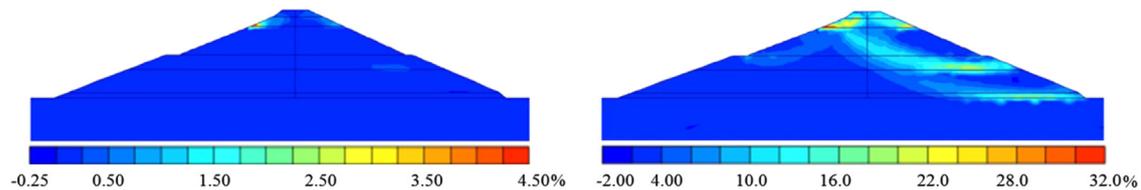
Fig. 19. Shear strain contours at 40 s and at the end of motion using simulated motion.

Shear strain contours for various times obtained using the observed motion are shown in Fig. 17. Most of the dam body experienced an insignificant rate of shear strain. It can be seen that initially, large shear strains occurred in the upper portion, especially on the upstream side. Thereafter, the occurrences of large shear strain can be observed clearly on both sides of the dam in the middle and bottom portions of the downstream slope. This excessive level of shear strain may indicate a possible cause for the dam failure. Similarly, shear strain contours obtained from the remaining motions yield almost the same pattern as the previous motion (Figs. 18 and 19). However, the exception is when using an inverse phase of the observed motion, for which large shear strains can be seen on the upstream slope instead of on the downstream slope.
