Alleviation of rolling contact fatigue on Sweden's heavy haul railway

Abstract

A test has been undertaken on Sweden's Malmbanan, or iron ore railway, to reduce rolling contact fatigue (RCF) damage by developing a preventative maintenance regime involving routine grinding of the rails. In just the first 2 years of the test, the total cost of grinding plus rail replacements was reduced by almost 40%, while both the rail and track quality generally improved immensely. Although it may not be possible to reproduce such savings everywhere that RCF damage occurs, some lessons from the test are of general relevance. In particular, the development of even existing surface-initiated defects can effectively be halted by grinding and thereafter regularly reinstating, a profile which substantially removes loading from those cracks. In this test, the rate of metal removal by grinding was about 0.2 mm per 25 MGT. Methods were also developed for objectively monitoring the transverse and longitudinal profiles of the ground rail, and the depth of metal removed from the rail, i.e. the overall grinding "quality". It would appear that the desired benefits of grinding can be obtained even if deviation

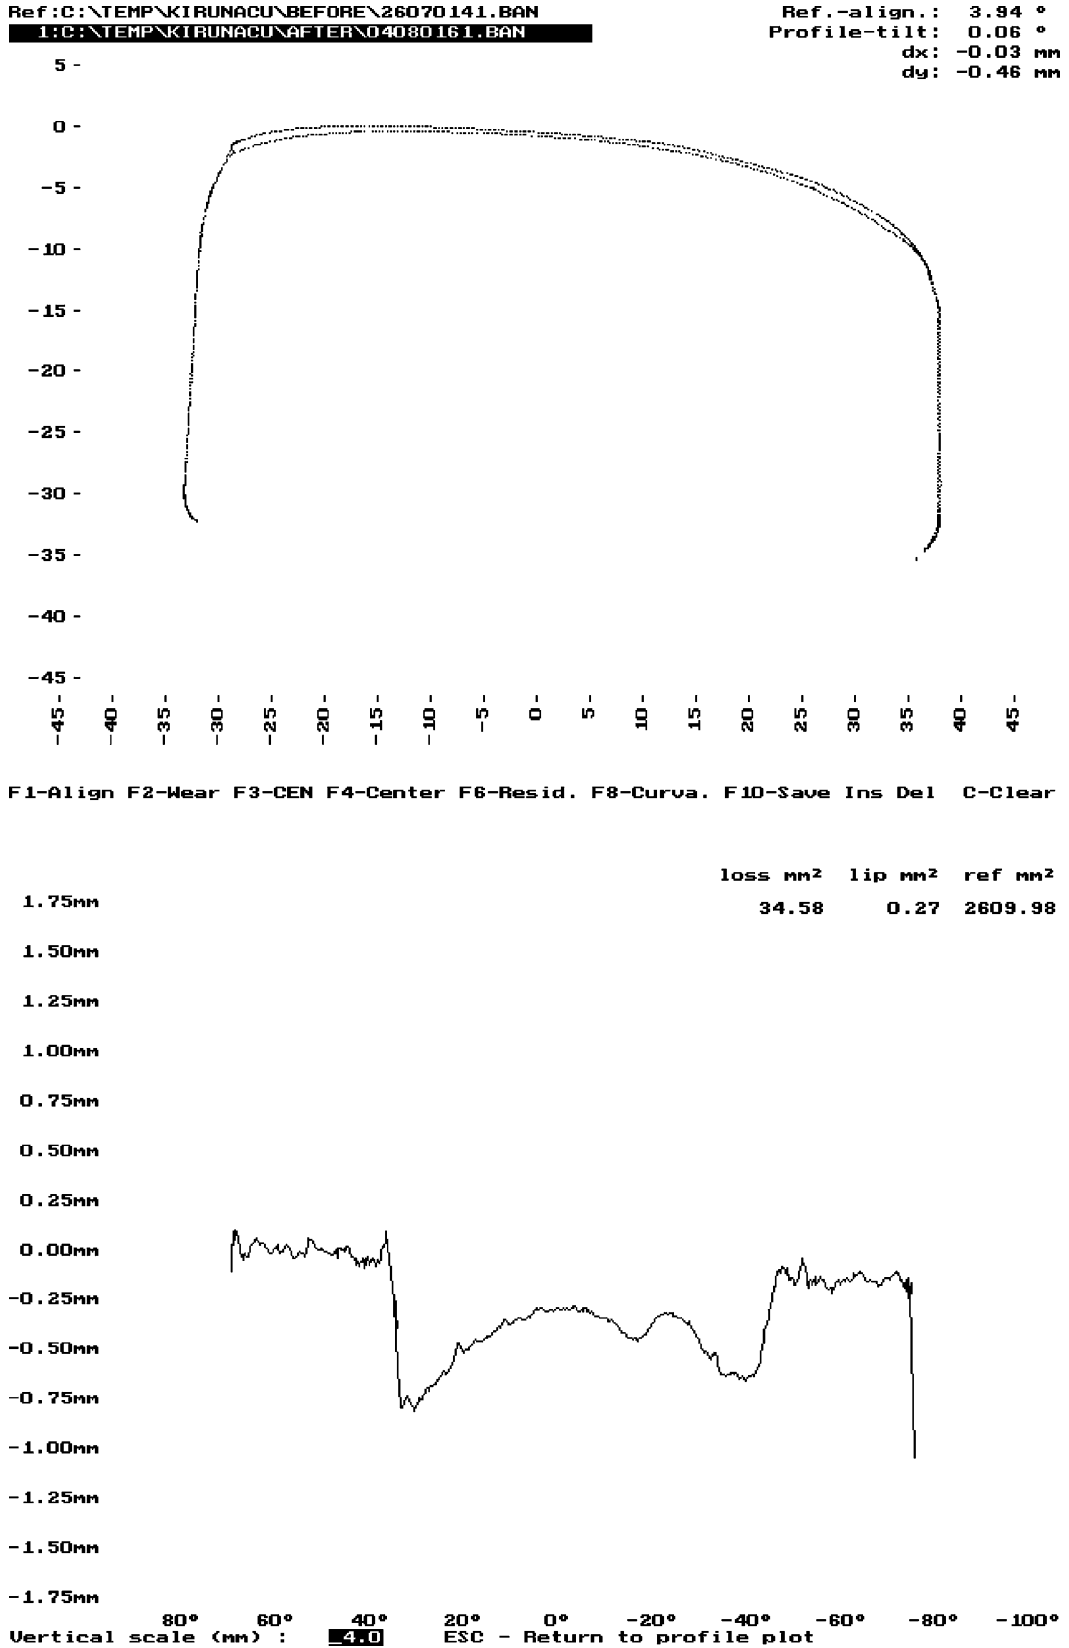
Fig. 3. Superposition of measured profiles before and after grinding, showing metal removed by grinding.

The fact that there is now relatively little change in the profiles of the rails indicates that one condition for “preventative grinding” of the rails is now established. Grinding can now be undertaken primarily to restore the profile, which now changes only slightly from the desired profile, and to remove a fairly shallow depth of embryonic cracks. Miniprof measurements of a point along a high rail, before and after grinding, are superposed in Fig. 3, showing where metal has been removed across the rail. This is evidently fairly uniform across the railhead, with slightly more removed on the field side of the rail to maintain field relief and around the gauge corner to maintain the profile within the tolerance range (in this case) of $+0.3/-0.7$ mm. Metal has been ground off across to about 50° in Miniprof angles, which is beyond the area in which head checking and spalling used to occur (Figs. 1 and 2). In service, metal tends to be worn off sufficiently quickly at deeper angles around the gauge-face by the wheels themselves. If the tolerance range were returned in future years to $+0/-1.0$ mm, slightly more metal would typically be removed around the gauge corner than is shown here.

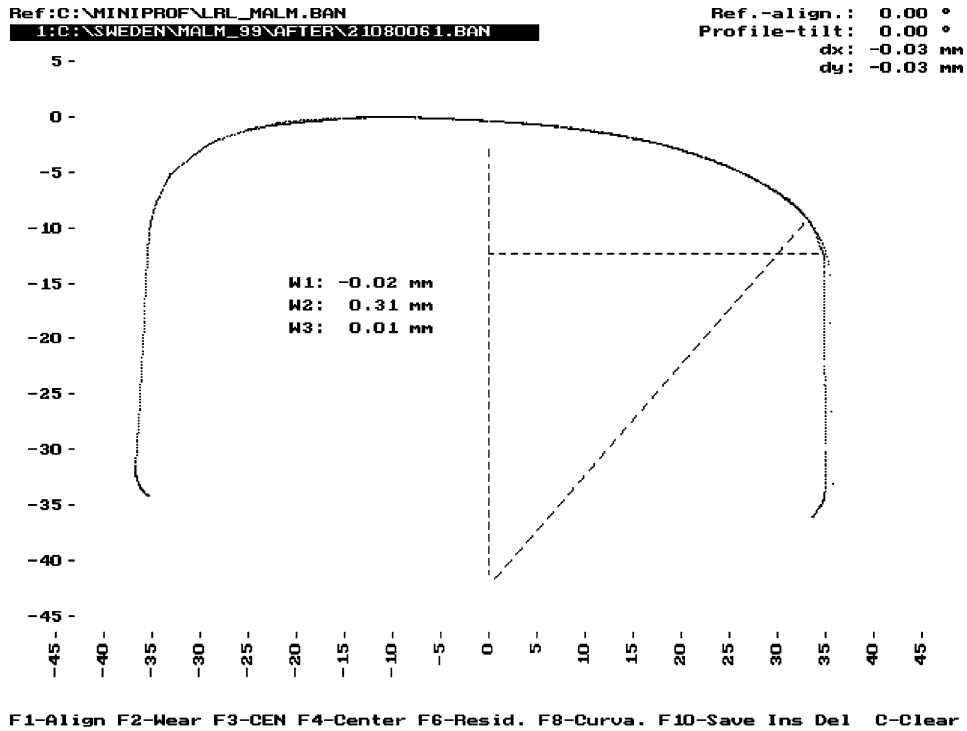
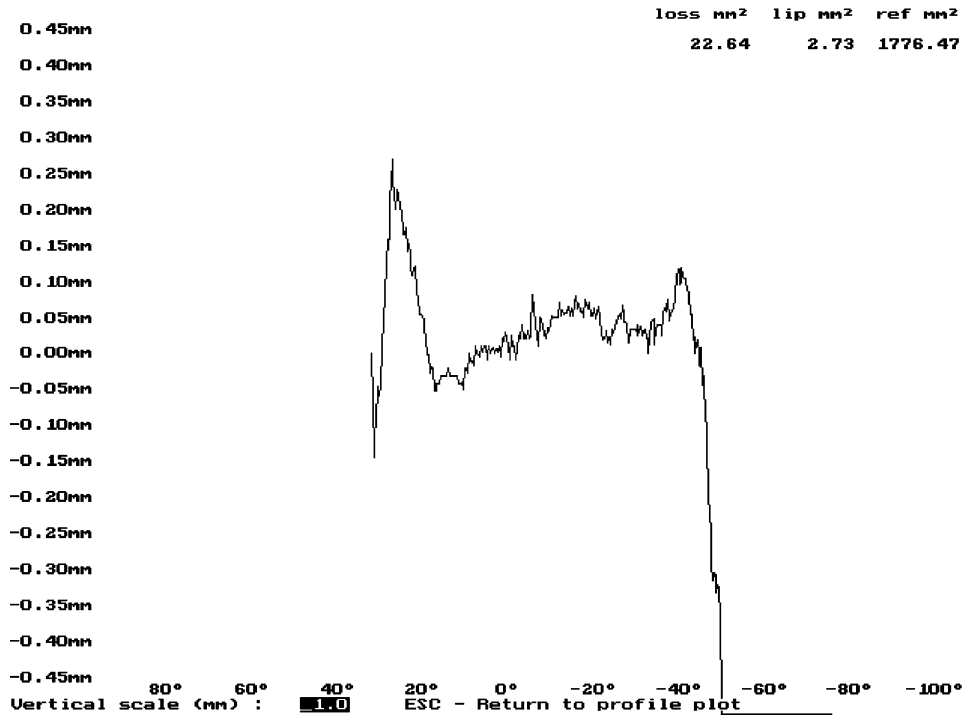
Fig. 4. Correlation of reference profile and low rail profile (ground to MB profile with ±0.5 mm tolerance).

The use of these points of alignment and the type of monitoring of the transverse profile that has been undertaken are illustrated in Figs. 4–6. The upper part of each of these figures shows the measured profile aligned with the reference profile, while the lower part shows the difference between the two profiles (a negative difference indicates that the measurement lies “below” the reference). In Fig. 4, a measured low rail profile is aligned with the MB reference profile to which it has been ground, with a tolerance of ± 0.5 mm.

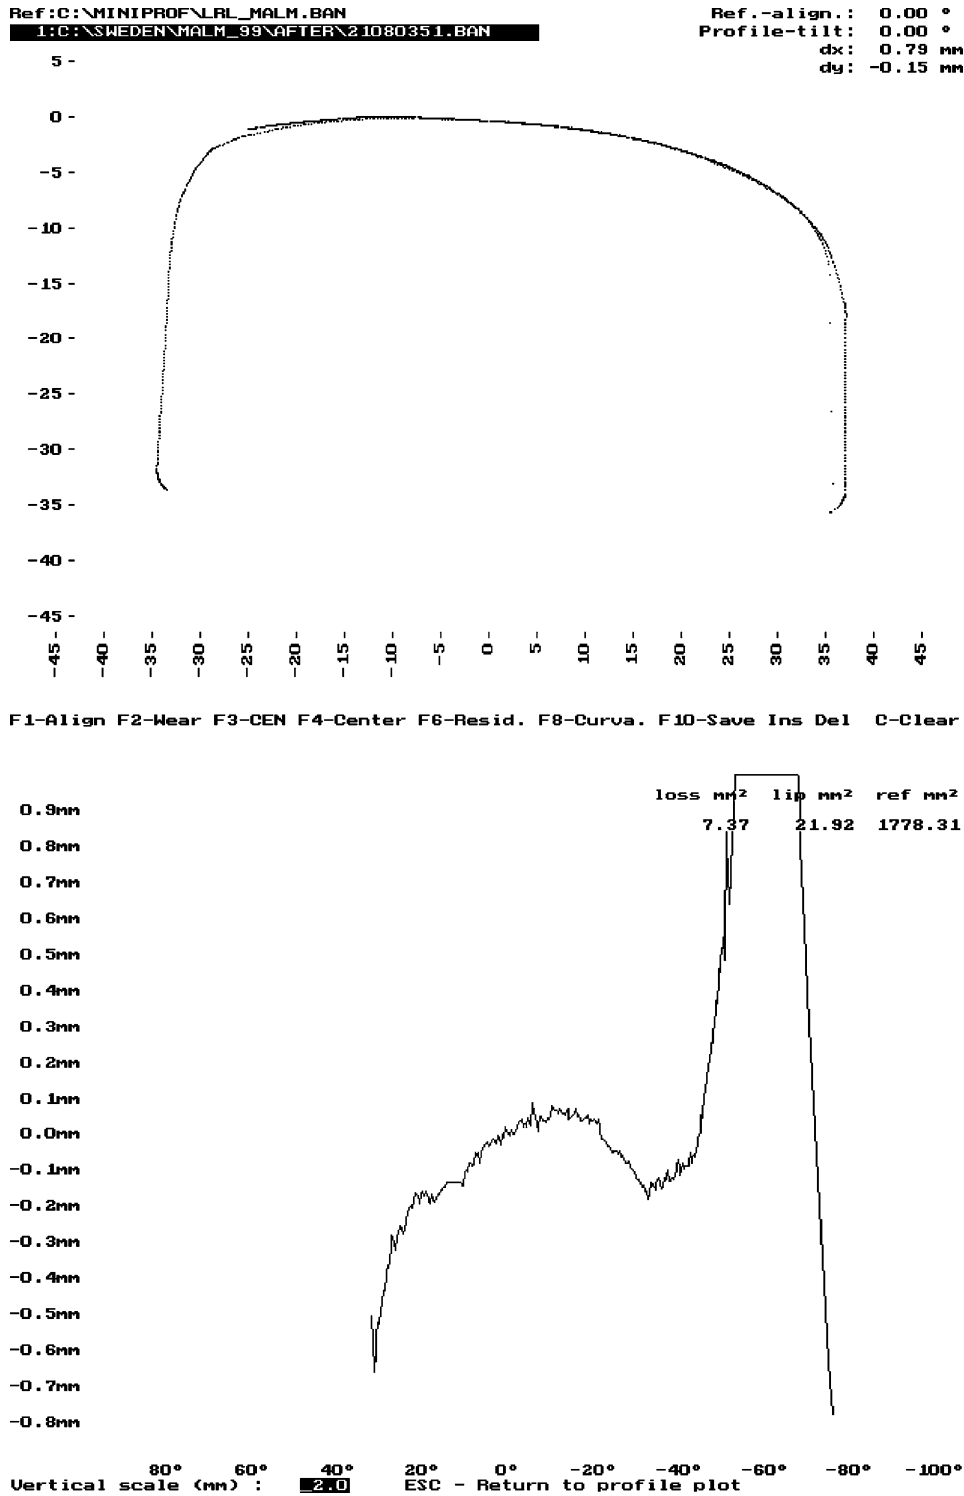
Fig. 5. Correlation of reference profile and high rail profile (ground to MB profile with +0.3/−0.7 mm tolerance).

Fig. 5 shows the same information for a high rail, ground to a tolerance of $+0.3/-0.7$ mm. Fig. 6 shows the measured profile of Fig. 5 aligned with the reference MB profile at about the 0° point and at a point 14 mm below the reference line. In Figs. 4 and 5 the measured profile is aligned with the reference profile approximately at the 0 and 45° points. These figures indicate that the profile has been ground quite closely, to a fit of within about $+0.15/-0.05$ and $+0.1/-0.2$ mm, respectively. We believe that the alternative alignment procedure illustrated in Fig. 6 (giving a difference of about $+0.14/-0.42$ mm c.f. $+0.15/-0.05$ mm) gives a misleading impression of how closely the measured profile corresponds to that desired over the area of the railhead that is in contact with a wheel.

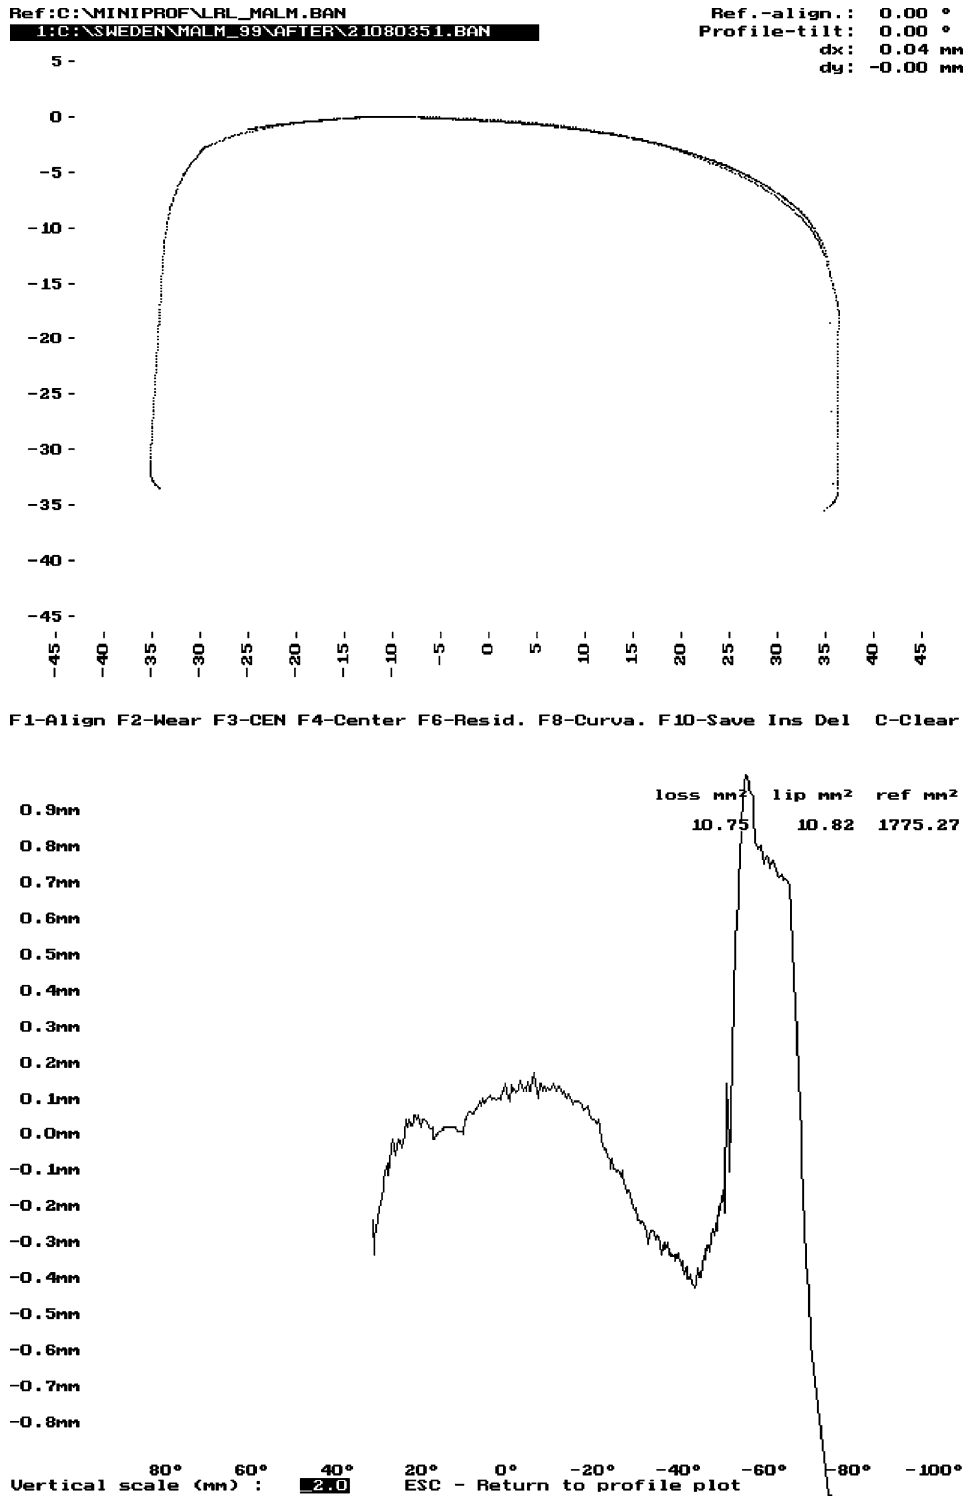
Fig. 6. Correlation of reference profile and high rail profile (illustrating the effect of different alignment procedure c.f. Fig. 5).

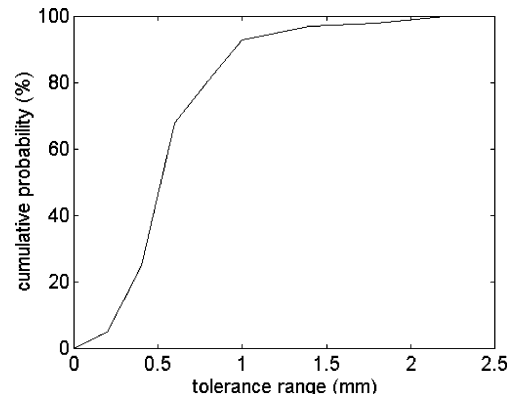
A quantitative assessment of the “quality” of the transverse profile of the ground track is given by the cumulative probability distribution (CPD) of the deviation of measurements from the appropriate reference profile. The CPD of transverse profile for the 1999 grinding campaign on the Malmbanan is shown in Fig. 7 as a function of the range of deviation. This shows, for example, that 93% of the measured profiles (from the 138 measuring points) lie within a range of 1.0 mm ($+0.3/-0.7$ mm for the high rail, $+/-0.5$ mm elsewhere) about the reference profile, and 25% lie within a range of 0.4 mm ($+0/-0.4$ mm on high, $+/-0.2$ mm elsewhere). There are a few measurements that deviate in a range of more than 1.0 mm from the appropriate

Fig. 7. CPD for maximum deviation of measured and reference transverse profiles, 1999 grinding.

reference profile. These large deviations are on low rails or in tangent track.

CPD curves such as Fig. 7 (or their inverse, an exceedance curve) are a sensitive way of showing the condition of both the transverse and the longitudinal profile, whether for ground or for worn track. The rapid rise and relatively short “tails” in the CPD curve are typical of ground track. (An “ideal” CPD for ground track might show 0% of the track in tolerance just below the limiting tolerance range, and 100% in tolerance just above this range. The CPD for track with an ideal profile would show 100% within a tolerance range of 0 mm.) For unground track, the CPD curves for both transverse and longitudinal profiles are very much “flatter”, indicating much greater variations in the standard of the transverse profile and of the corrugation depth.

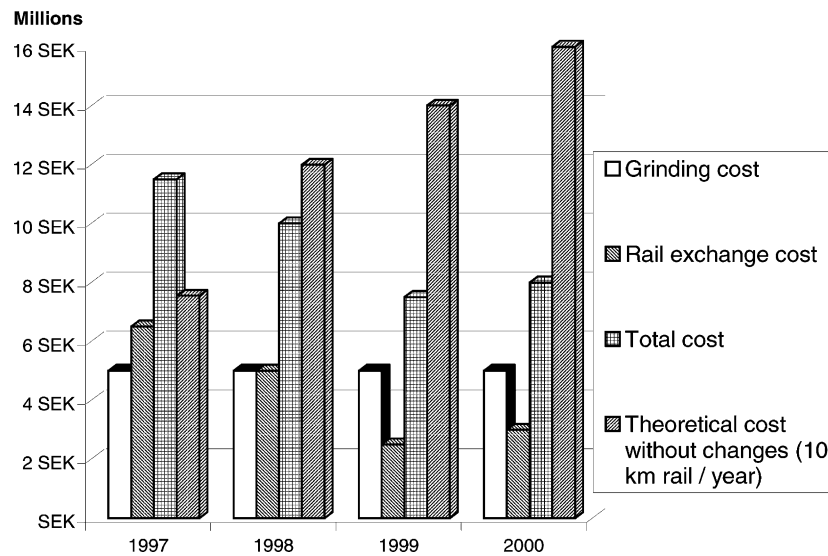
The principal saving has been in the purchase of rail: this declined by two-thirds over the period 1997–1999, from over 6 million SEK per annum to about 2 million SEK, while the cost of grinding over the period of the test has remained roughly constant at about 5 million SEK (Fig. 8). These

Fig. 8. Costs of grinding and rail for the period 1997–2000.

figures in fact underestimate the benefits that have been obtained since the savings incurred from regular grinding of switches are not included and also the effective cost of rail to the BV has doubled over the period (from SEK 755 per rail metre to SEK 1600 per rail metre). The total cost of rail and grinding in 2000 (Fig. 8) is accordingly *half* of what it would have been had the changes not been implemented and if 10 km of rail were replaced per annum. (This is significantly less than was replaced in 1997, hence the “theoretical cost” is less than the true “total cost” for this year).
