Permeation grouting for remediation of dam cores

DongSoon Park^{a,b,*}, Jeheon Oh^a

^a K-water Research Institute, 1689 Beon-gil 125, Yuseong-daero, Yuseong-gu, Daejeon 34045, Republic of Korea

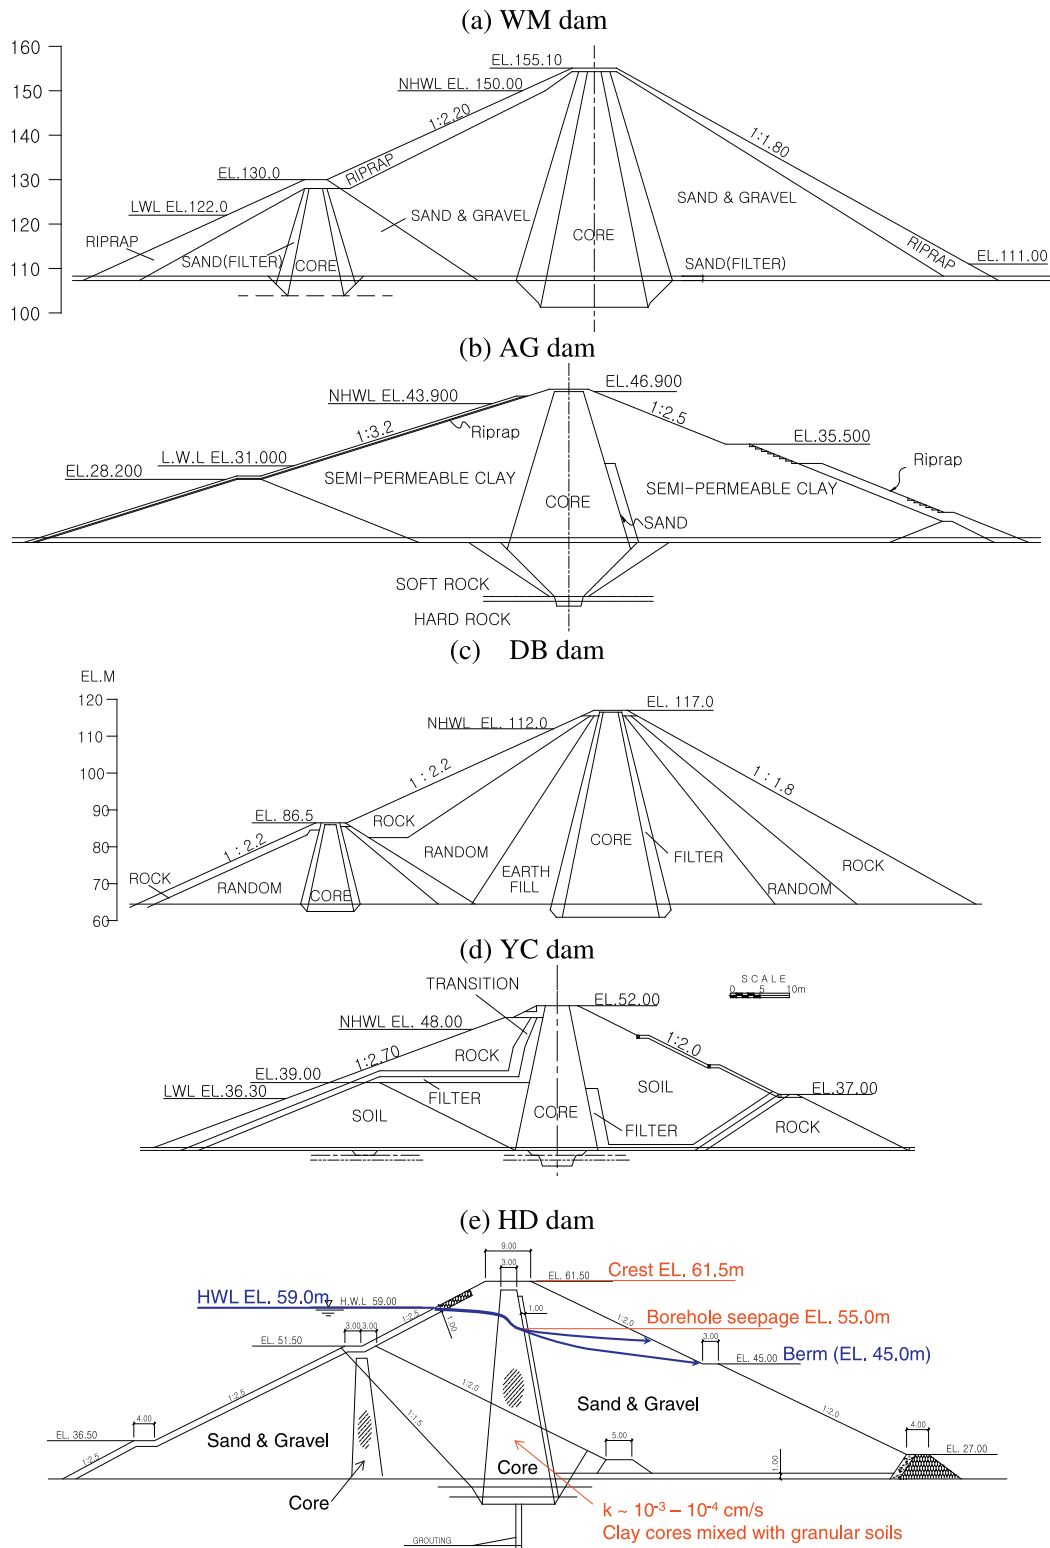
Fig. 2. Typical cross-sections of dams in this study (k = permeability coefficient).

Table 2 shows the basic dimensions, construction periods, deterioration, initial remediation measures, and dates of final remediation with a permeation grouting scheme for the five large earth-cored embankment dams investigated in this remediation case study, which are named as WM, AG, DB, YC, and HD dams, respectively. Among the dams, the WM, AG, and HD dams exhibited distinct incidents such as sinkholes, slope failure, excessive seepage, etc., whereas the DB and YC dams showed randomly developed fluidized cores of high water content with or without granular cores in the area adjacent to the dam crest. Fig. 2 shows typical cross-sections of the dams (K-water Research Institute, 2016b).

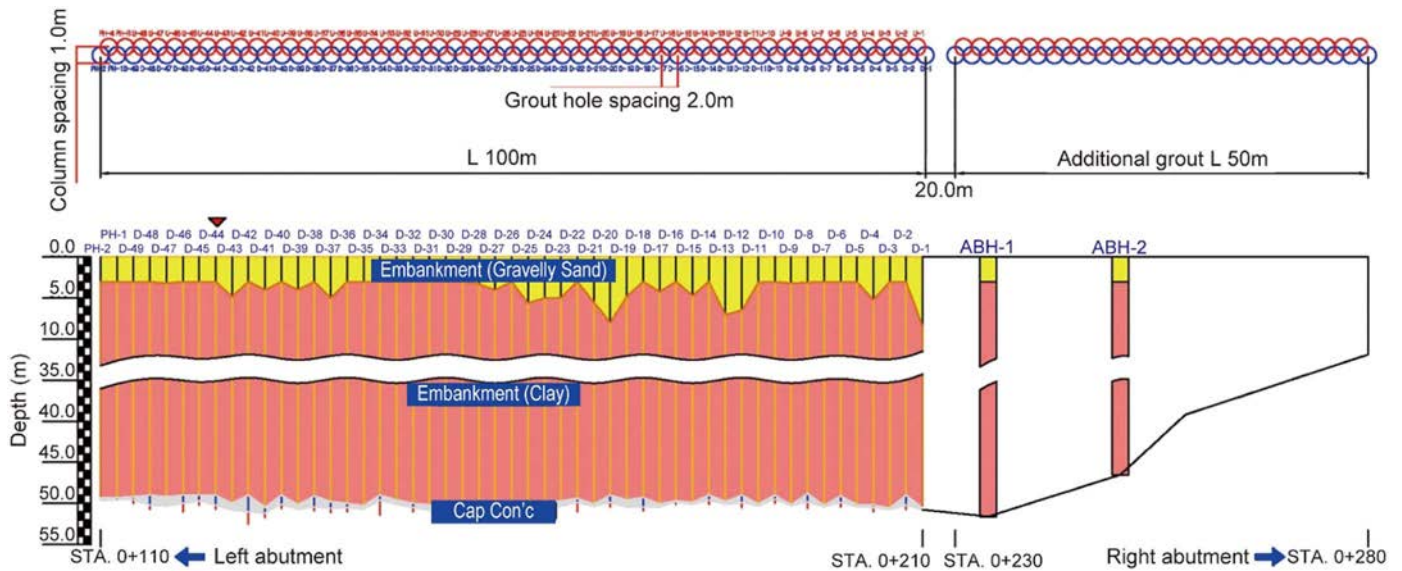
Fig. 9. Soil strata in DB dam embankment.

For the DB and HD dams, in addition to core layer permeation grouting, geotechnical investigations including borehole drilling and sampling and trench excavation on the crest revealed that significant amount of relatively granular coarse materials were mixed with clay cores adjacent to the NHWL, which may threaten the stability against seepage flow during reservoir operation at higher water levels (Fig. 9). Therefore, it was necessary to fill the large void near upper crest level; bentonite permeation grouting was selected to remediate the upper crest areas following the scheme shown in Fig. 10.
